SUBJECT: Service Update for Inventory and Customer Vehicles
Black Door Tape Cleaning / Replacement
Expires with Base Warranty

MODELS: 2013 Chevrolet Spark

Subject: 13232A – Service Update Bulletin
Black Door Tape Cleaning / Replacement
Service Procedure Revised

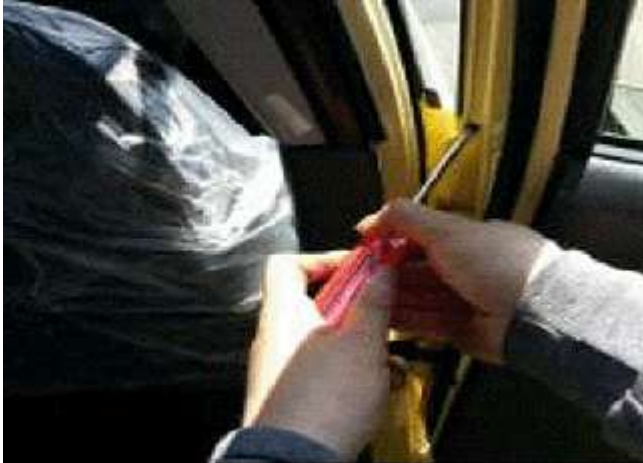
3512217

1. Remove the exterior door sill molding at the window.

- 1.1. Lower the door glass window fully and remove the screw from door glass molding (located in interior door jamb) with screwdriver. (FRT LH/RH, RR LH/RH)

Note: Be careful not to bend or damage the molding when disassembling it. If you lift it up step by step slowly, you can avoid door molding bending & damage.

Note: A new exterior door glass sill molding should be replaced if clips are broken during disassembly.
