**SERVICE BULLETIN FUEL FILL HOSE SEAT PLATE INTERFERENCE**

Models affected: Collins Bus Models with seats installed over the fuel tank fill hose.

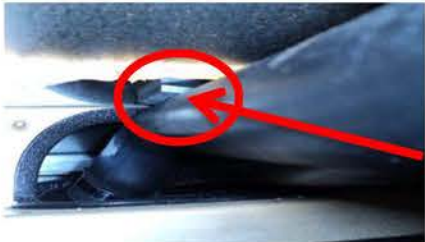
Fuel Fill Hose under bus behind driver's side skirt

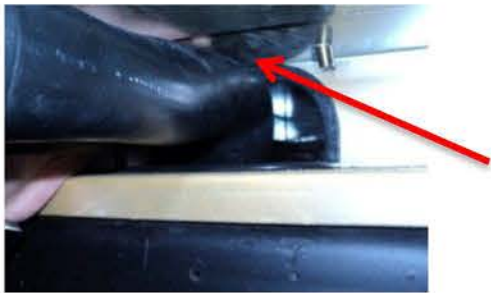
Seat mount plate sharp edge could rub on the fuel fill

If during inspection of the fuel fill hose to the mid-ship fuel tank you find the cut edge of the seat mount plate is directly above the fuel fill hose and making contact, a seat mount plate cover (442290) should be installed.  
Remove the seat bolt nut closest to the fuel fill hose.

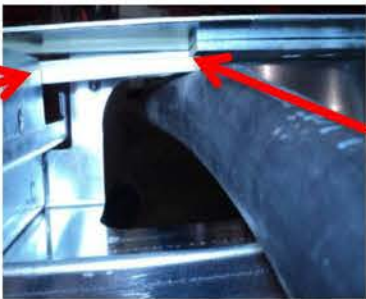
Seat mount plate cover

Seat mount plate

Slide the plate cover (442290) over the seat mount plate until the holes are aligned. This cover will keep the sharp cut edge on the seat mount plate from making contact with the fuel fill hose.
