Summary: BRP has received reports concerning the brake light staying lit when the brake pedal is resting on the bump stop. This will cause battery drainage.

Type: General

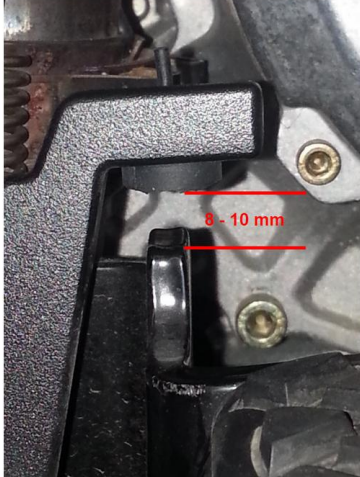
Normal distance between the bump stop and the brake pedal when the brake light turns ON is 8 - 10 mm (0.3" - 0.4").

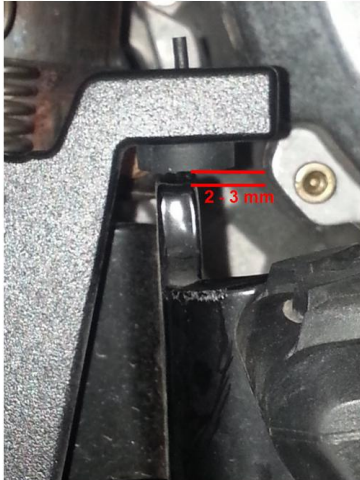
Normal distance between the bump stop and the brake pedal when the brake light turns OFF is 2 - 3 mm (0.08" - 0.12").
