TRP Number	Revision Level		Date	Group Number
T1559	А	31-OCT-2014		
Expiration Date (U.S. and Canada)		Expiration Date (International)		
01-MAR-2015		01-MAR-2015		
Engine Family Fuel System	Eucl System	Diant	Build Date	
	Plant	From	То	
ISX11.9	CM2250			
ISX11.9	CM2250

Temporary Repair Practice

ISX12 CM2250 Fuel Pump Repair Instructions for Ceramic Plunger Fracture or Roller/Cam Damage TRP

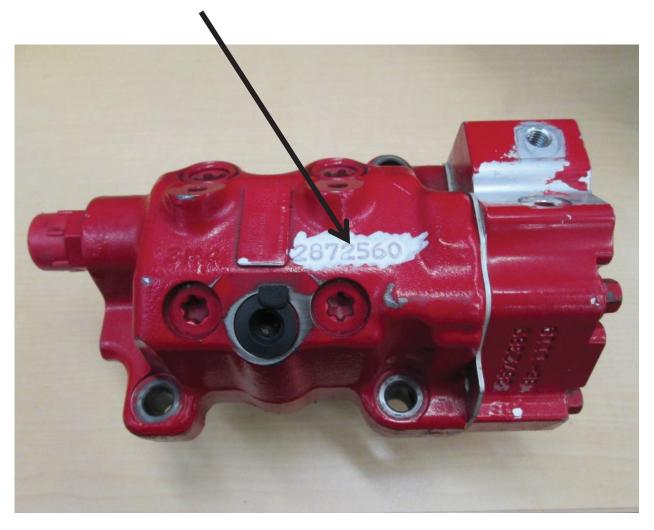
Mark the Fuel Pump Head part number with a paint marker after completing the campaign.

- 1. Please refer to TSB# 140019 for instructions to follow for inspection and repair procedures.
- 2. Mark the fuel pump head serial number with white paint, as illustrated in Attachment B, to signify completion of this field action.
