TECH TIPS

Subaru Service and Technical Support Line Newsletter

01 INTERIOR REAR VIEW MIRROR SEPARATION

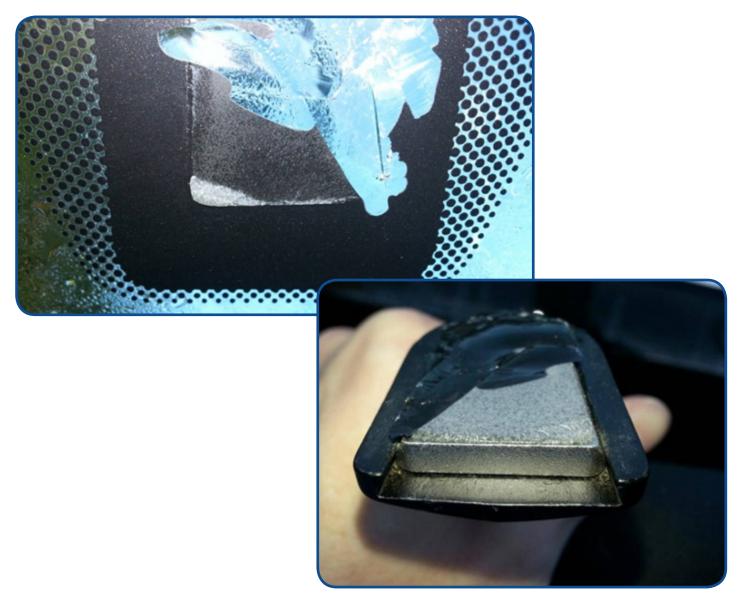
Example photos showing the mirror base and windshield glass following application of high (unusual) shear force and the expected results. This will not occur during normal mirror adjustment.

Techline has received several glass repair authorization requests where the interior rear view mirror has separated from the windshield and in the process, pulled some glass from the windshield. This type of failure is a result of abnormal (high shear) force being applied to the mirror. The mirror mounting is designed to meet the FMVSS (Federal Motor Vehicle Safety Standard) for required separation in the event of specified impact forces being applied to it during a collision to reduce bodily injury. These forces exceed the normally applied forces found during standard mirror adjustment. The application of high shear force to the mirror through sudden, forceful movements or an unusual level of force being applied against the mirror when it reaches or has reached the end limit of its range of travel, may duplicate the force required to cause the mirror to shear from the windshield. This type of separation is not a result of any defect in the windshield glass and therefore not eligible for authorization through the Techline glass authorization process. If you believe some unusual circumstances occurred beyond the control of the customer resulting in this condition, those facts should be reviewed with your DPSM.
