DART: Bulb Seal Addition to CNG Line Cover

Property name and Top bus number: DART -304500-306500-313000-314000

Issue: CNG line cover contacting the roof of the bus

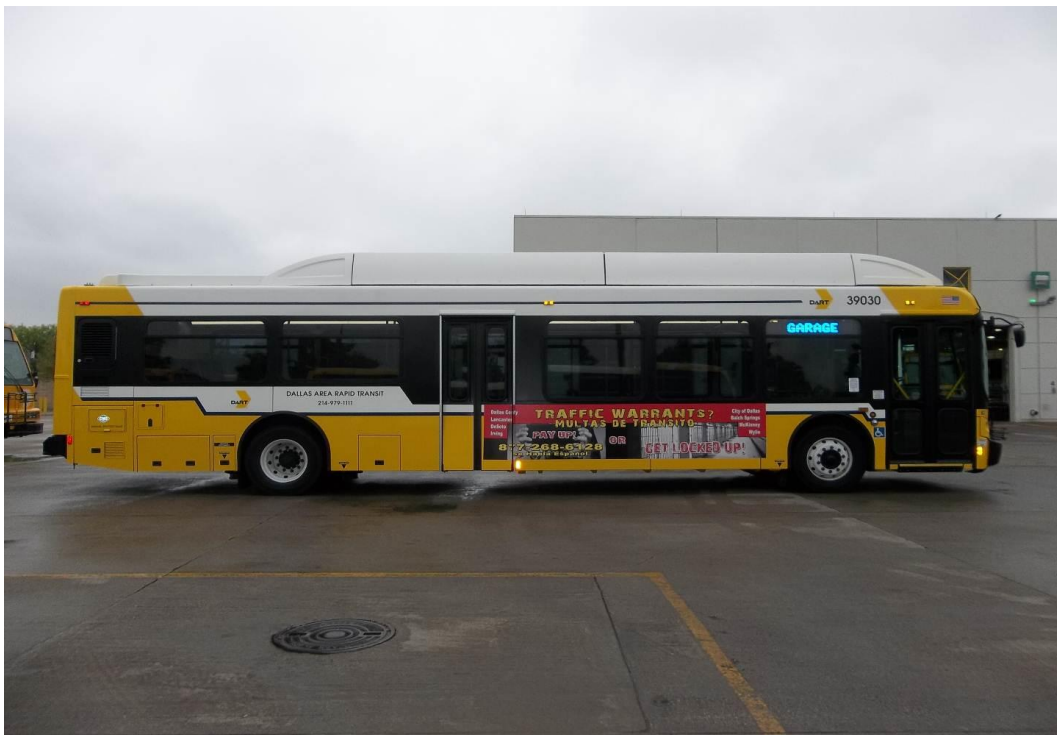
Reason/ cause: Cover needs an isolator

Solution: Add bulb seal per this work instruction.

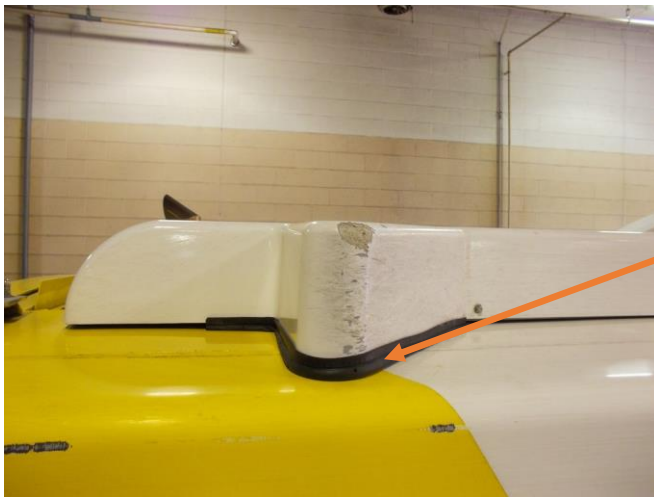
Add 2' of bulb seal as shown.

1. Park the bus and apply the parking brake.
2. Turn off main battery disconnect switch.
3. On the C/S roof where the CNG cover makes a "Y", add 2' of bulb seal as shown in the picture below.
