### SSM 72101 - Water beading across the surface of the convertible hood

**Models :** X152 - F-Type

# X152 Hood Beading Example

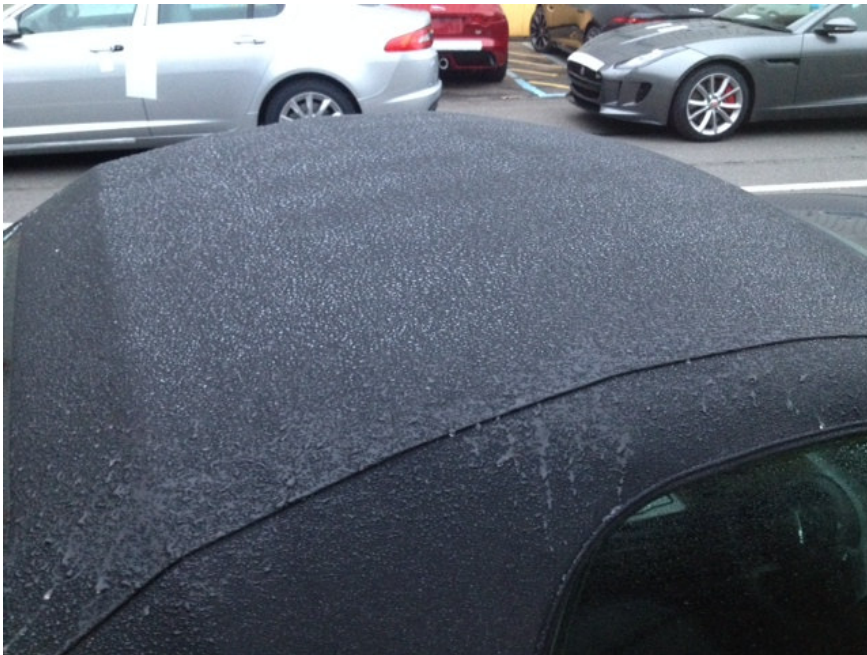
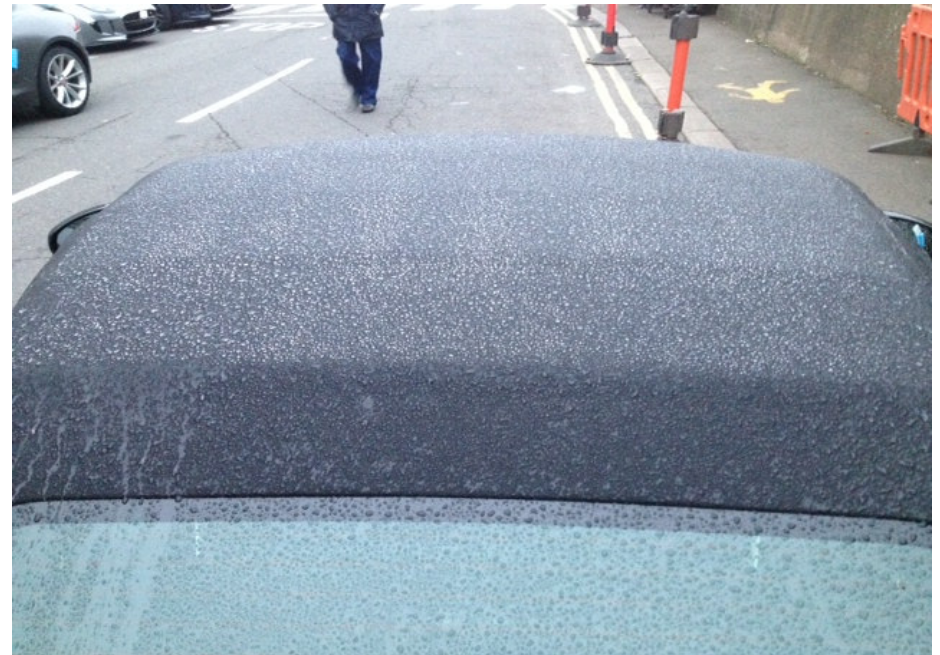
**Please Note –** The attachment shows a new vehicle water beading example, the longer the vehicle is in service there will be a reduction in the amount of water beading which is normal operation.

**Typical good example of new vehicle hood water beading**

**Action:** Please attempt to replicate the customer complaint by spraying water evenly across the hood surface and noting any coverage differences across the hood. If the customer complaint can be replicated, please submit an EPQR and attach pictures.
