## RECREATIONAL VEHICLE NOTIFICATION CAMPAIGN

### **SERVICE ADVISORY 14-215**

### ***Reason for this Notification***

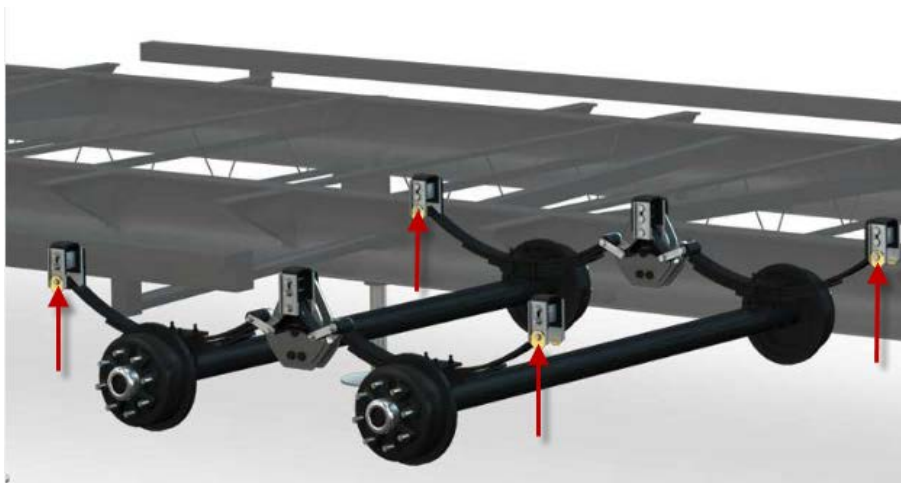
**Correct Track Cam Plate Locations**

No specific action is required as this notification campaign is for informational purposes in case you encounter this defect. The inner and outer octagon Correct Track cam plates are located on the front and rear axle spring hangers on both sides of the unit. Each unit has a total of eight (8) plates for tandem axle trailers and twelve (12) for triple axles. The correct measurement for the overall size of the plate is 3". Plates manufactured out of specification will be less than 3".

3" overall

**Correct**

less than 3"

**Incorrect**

Any plate found to be out of specification should be replaced with:

KRV part # 434259 - Plate Only – 3" x 3" – Yellow

KRV part # 449843 - Shackle Bolt /Lg Cam Assy - Yellow

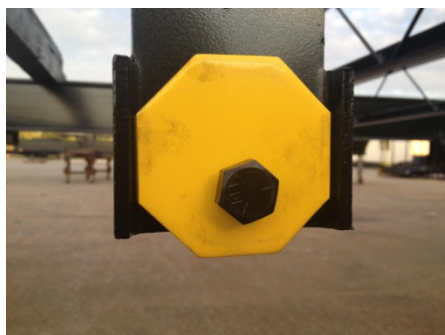
**Correct**

**Cam Plates Shown In Original Manufacturing Position**

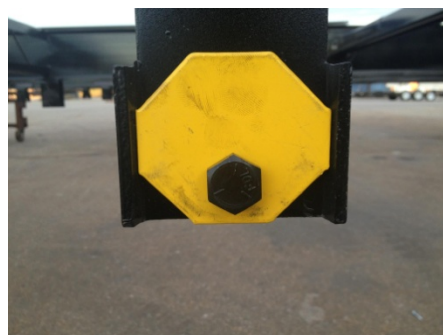
**Incorrect**

It has been determined that the octagon Correct Track cam plate on certain vehicles may have been manufactured out of specification. If the hanger has the defect part ***and*** the involved component ***has been adjusted*** from the original manufacturing setting, it may allow excessive suspension movement possibly causing abnormal wear of the suspension components or tires. The component, ***as installed and not having been adjusted***, poses no safety problem. This advisory is to make dealers (and retail owners by separate letter) aware of the condition and provide repair instructions if the defect is found.
