**TIB # 14-006**

Issue: On certain late 2014 and early 2015 Outlaw 29H and 35SG units, the garage sofa strap brackets may not be properly placed in the wall causing them to pull out and the sofa to open.

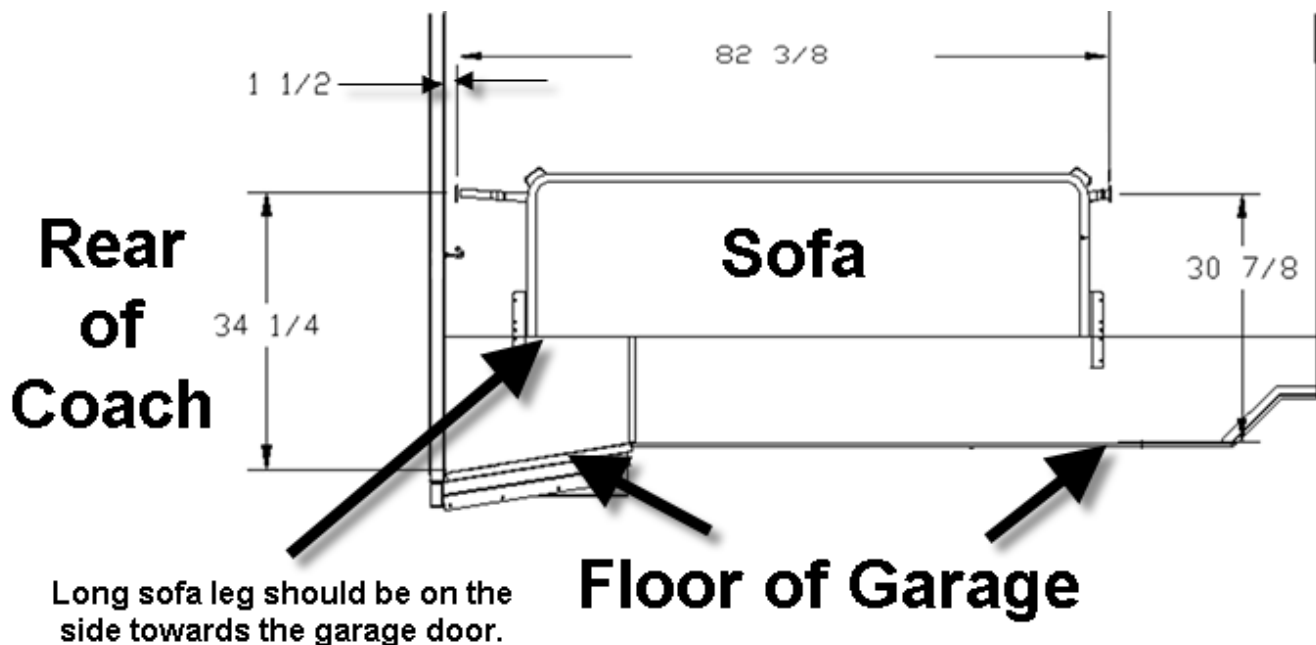
1. Look at the sofa and make sure the long sofa leg is over the beavertail at the back of the garage portion. If not, you will need to switch the sofa to the other side of the unit.
2. Measure the location of the sofa strap brackets.  
The rear most sofa strap bracket should be 1-1/2" from the rear corner of the garage and 34-1/2" from the floor. The front most sofa strap bracket should be 82-3/8" from the rear corner of the garage and 30-7/8" from the floor.  
Make sure the brackets are level in relation to one another.

3. If the brackets are not in the appropriate place, remove the brackets and reposition. Make sure you are hitting the 4" tube in the sidewall.
4. If the strap brackets had to be moved, fill the resulting holes with putty.
5. Repeat for the other side of the unit.
