TECHNICAL BULLETIN LTB00631NAS1 27 JAN 2014

SECTION: 501-14

Compact Key Handset - Lower-Level Service Repair

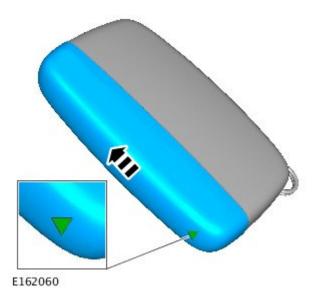
2. Remove the chrome cap; place to one side.

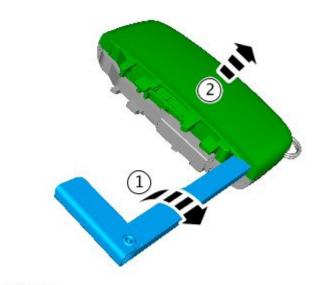
E162062

4. Using the key blade, remove and discard the lower case.

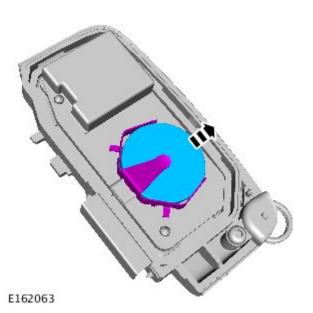
5. Remove the battery from the upper case.

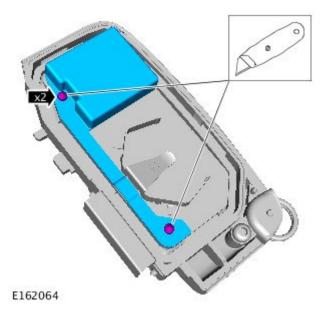
6. CAUTION: Make sure the Printed Circuit Board (PCB) is not damaged when removing the black anti-tamper cover. If the copper coil antenna is damaged, the unit will be unserviceable.

Using a suitable tool, cut the fixings of the black anti-tamper cover and lift away from the Printed Circuit Board (PCB).

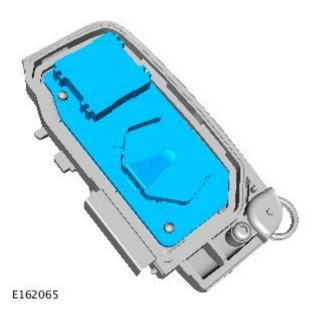
7. CAUTION: When removing the PCB, only handle the outer edges of the board.

Remove the PCB; place to one side.

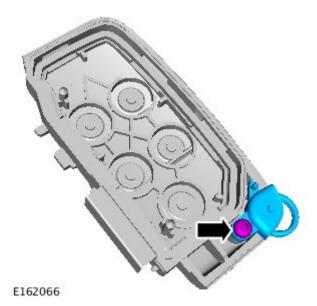
8. Remove the key ring retainer; place to one side.

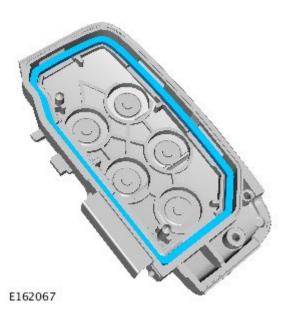
- **9.** Remove the silicone seal from the lower case; place to one side.
 - Discard the upper case.

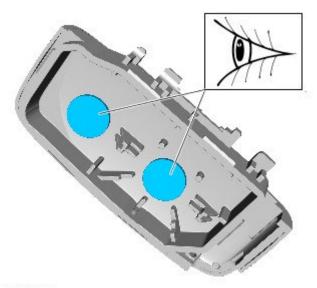
E162068

10. Make sure the foam pads are installed in the lower case as shown.

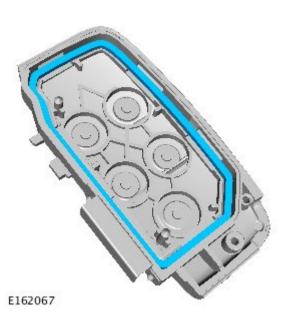
11. Install the silicone seal to the upper case.

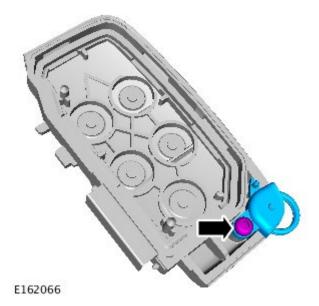
- **12.** Install the key ring retainer to the upper case:
 - Tighten to 1Nm.

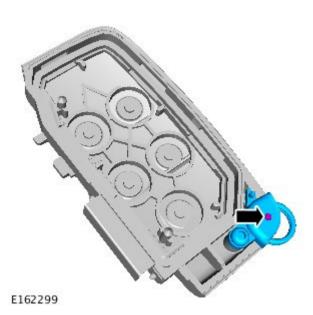
13. Make sure the key ring retaining pin is present in the upper case.

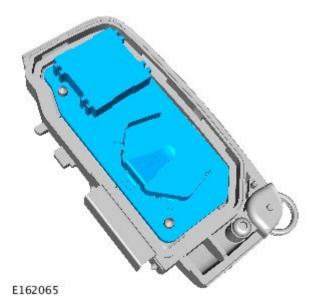
14. CAUTION: When installing the PCB, only handle the outer edges of the board.

NOTE: The PCB and cover are held in position with the foam pads on the new upper case.

Install the PCB to the upper case. $\,$

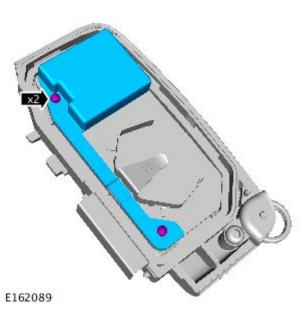
15. Install the PCB anti-tamper cover.

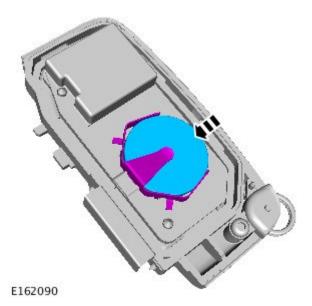
16. NOTE: Make sure the battery is installed positive (+) side up.

Install the battery to the upper case.

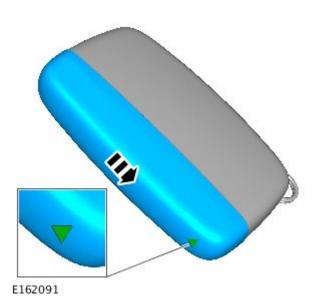
19. Install the chrome cap.
