TECHNICAL BULLETIN  
LTB00676NAS1  
05 AUG 2014

**SECTION: 501-09**

Door Mirror Judders During Powerfold Operation

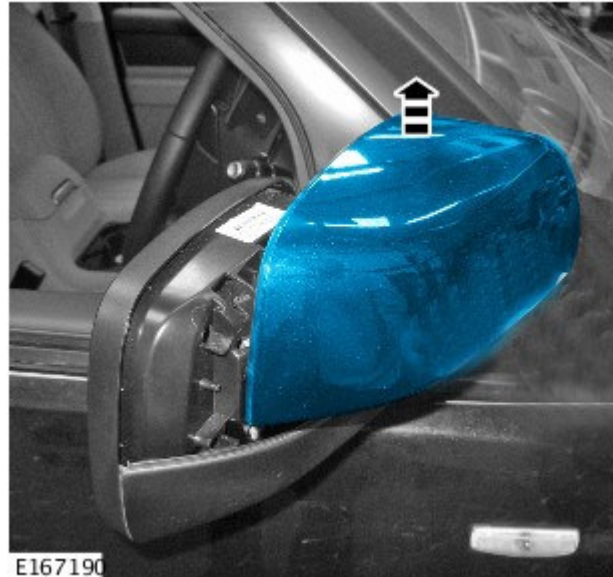
1.

**NOTE: Right-hand side shown; left-hand side similar**

Remove the door mirror cover.

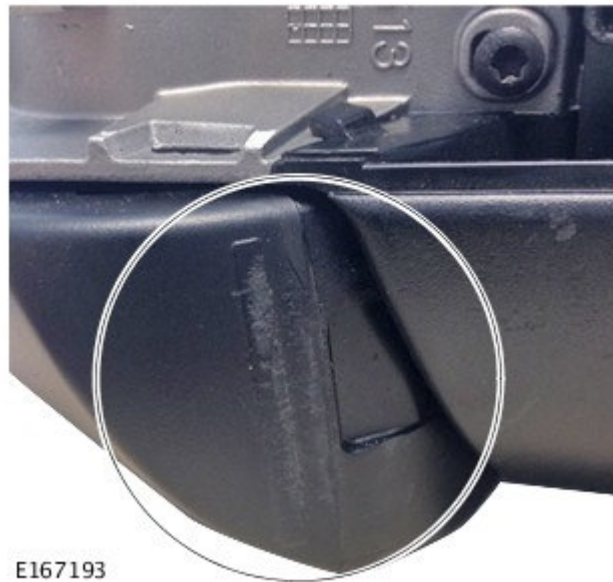
2. Check for wear mark damage on the door mirror.

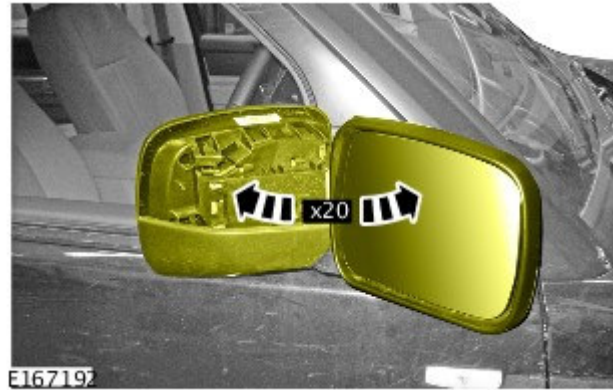
3.

**CAUTION: Make sure no damage is caused to the door mirror.**

Move the door mirror forwards and backwards manually 20 times.

- After 20 cycles, return the door mirror to the central position.

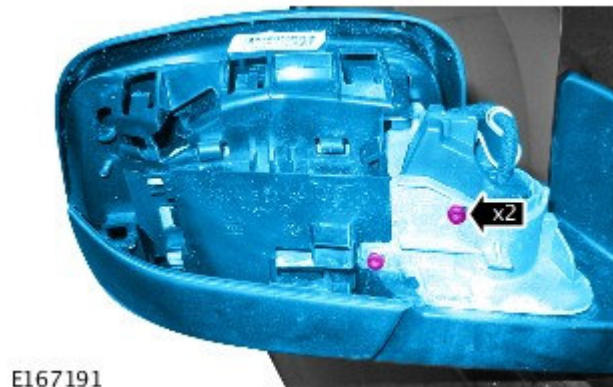
4.

**NOTE: If the screws are loose, the mirror head will be loose, wobble, or vibrate.**

Tighten the door mirror head screws.

- Torque 2 Nm.

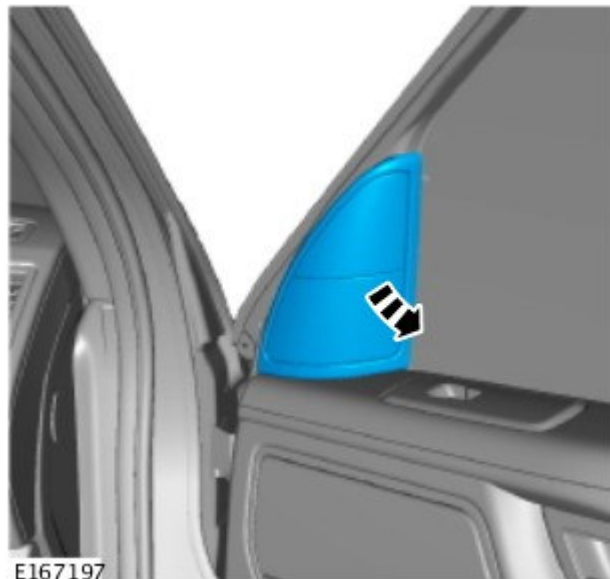
5.

**NOTE: Do not disconnect the door mirror trim electrical connector.**

Release the interior door mirror trim.

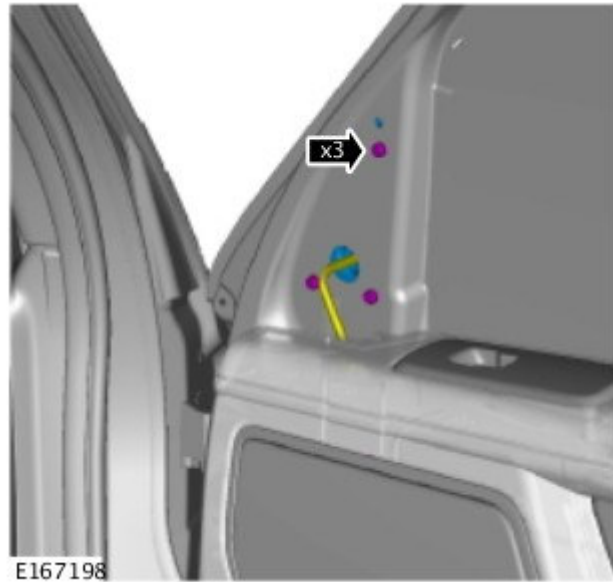
6.

**CAUTION: Take care not to damage the paint on the vehicle.**

**NOTE: Do not disconnect the door mirror electrical connector.**

Release the door mirror.

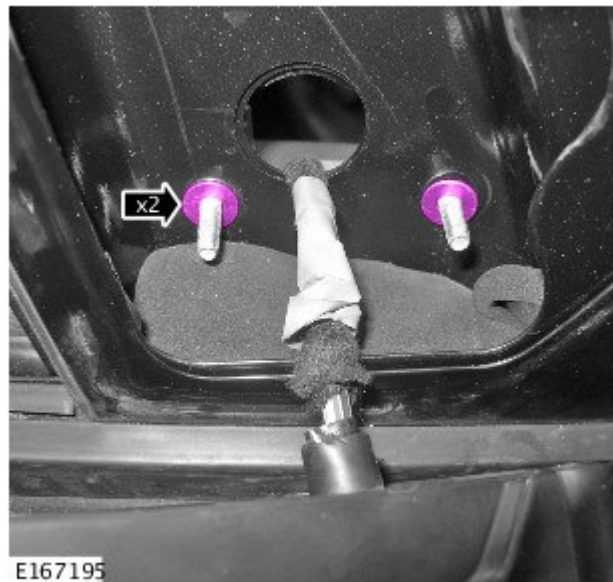
7. Install the washers to the door mirror lower retaining bolts only.

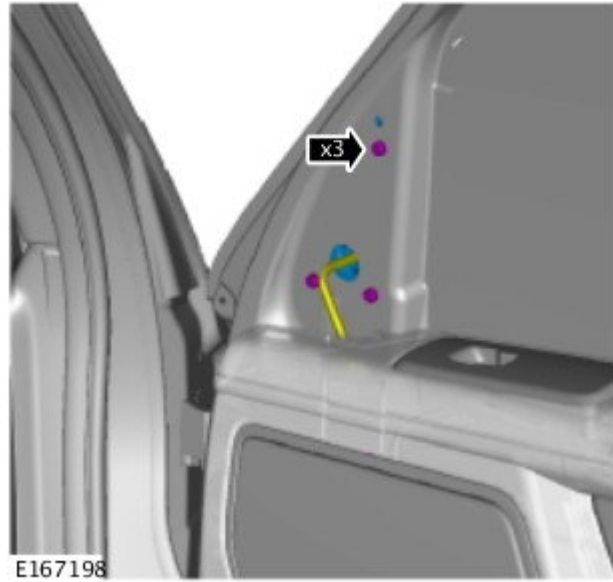
8. Install the door mirror.

- Torque 6 Nm.

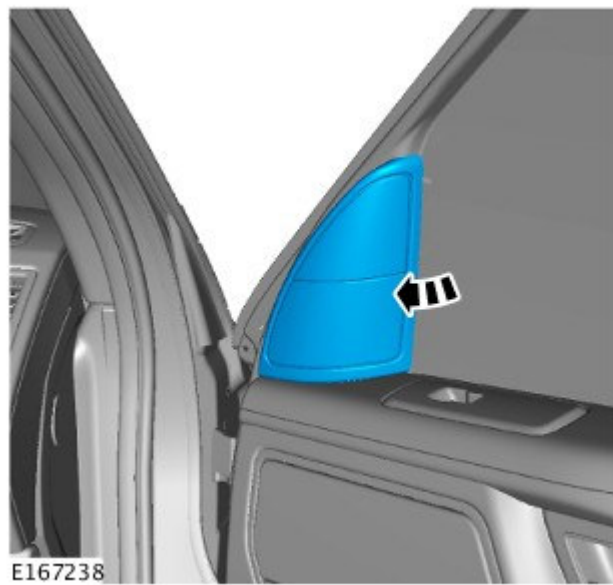
**9.** Check the operation of the door mirror.

**10.** Install the interior door mirror trim.

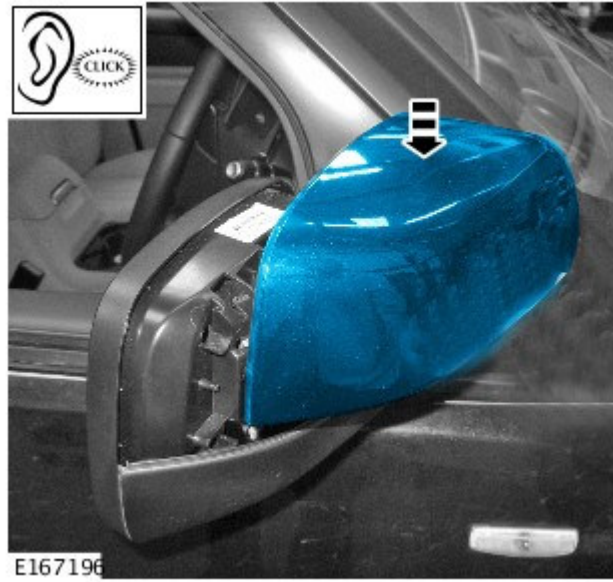
**11.** Install the door mirror cover
