3rd Row Seat Rear Leg Latch Squeak/Rattle - Manual Seat Only

Service Category Vehicle Interior

Section Seat

| YEAR(S) | MODEL(S) | ADDITIONAL INFORMATION |
|---|---|---|
| 2011 – 2014 | Sienna | Plant Code(s): S WMI(s): 5TD |

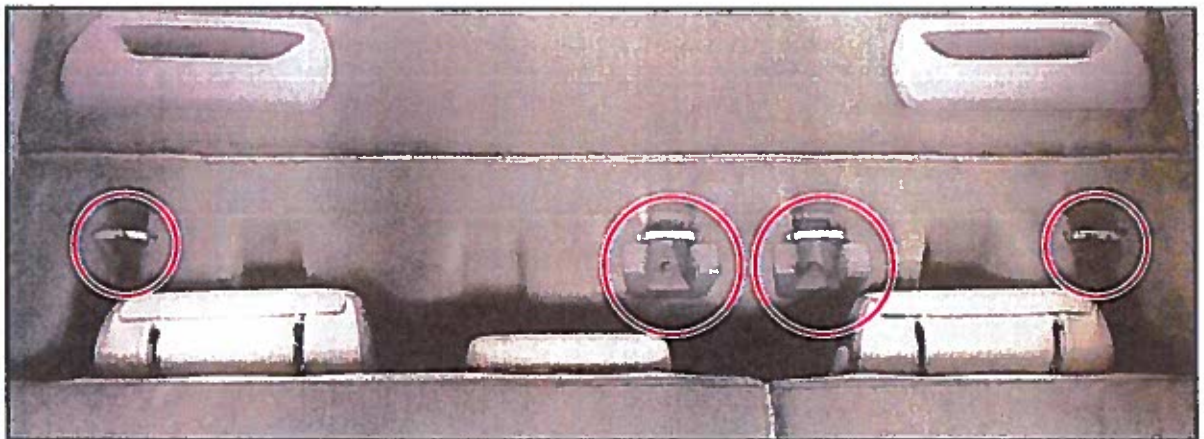
Figure 1.

2. Stow both the 60% and 40% side of the 3rd row seats.
3. Replace the W-cups (Seat Leg Box Protectors) and outside bumpers (Seat Cushions).

- A. Remove the W-cups and outside bumpers from the vehicle by prying on them.
- B. Install the NEW W-cups and outside bumpers into the vehicle and ensure they are seated properly.

Once the W-cups are removed, they will no longer be usable.

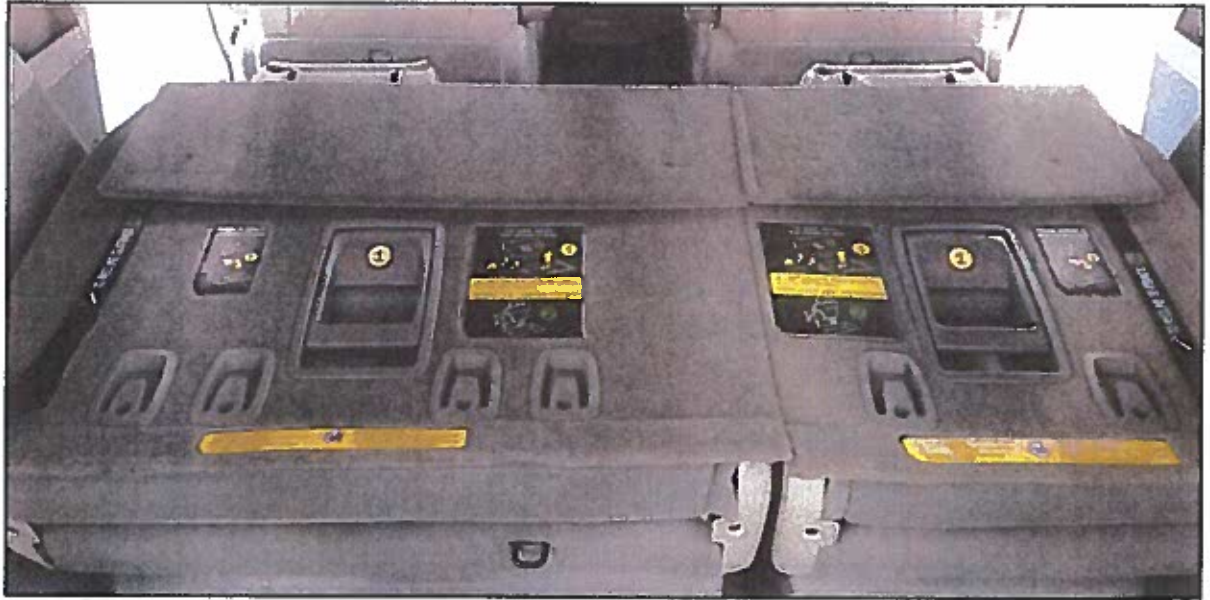
Figure 2.

4. Latch the 3rd row seats in the table-top position.

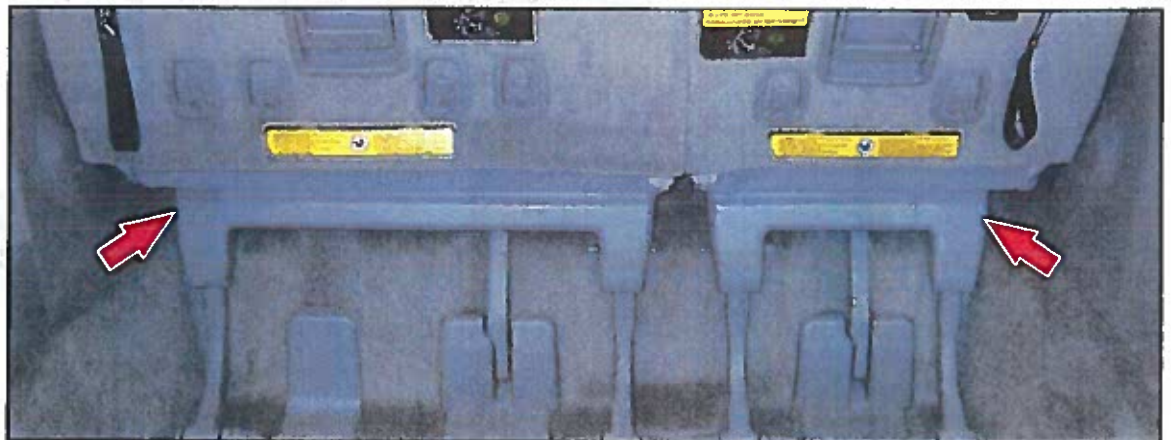
Figure 3.

5. Adjust the tension on the rear legs for the 3rd row seats on the side the noise is coming from.
 - A. Remove the upper garnish from the 3rd row seats.

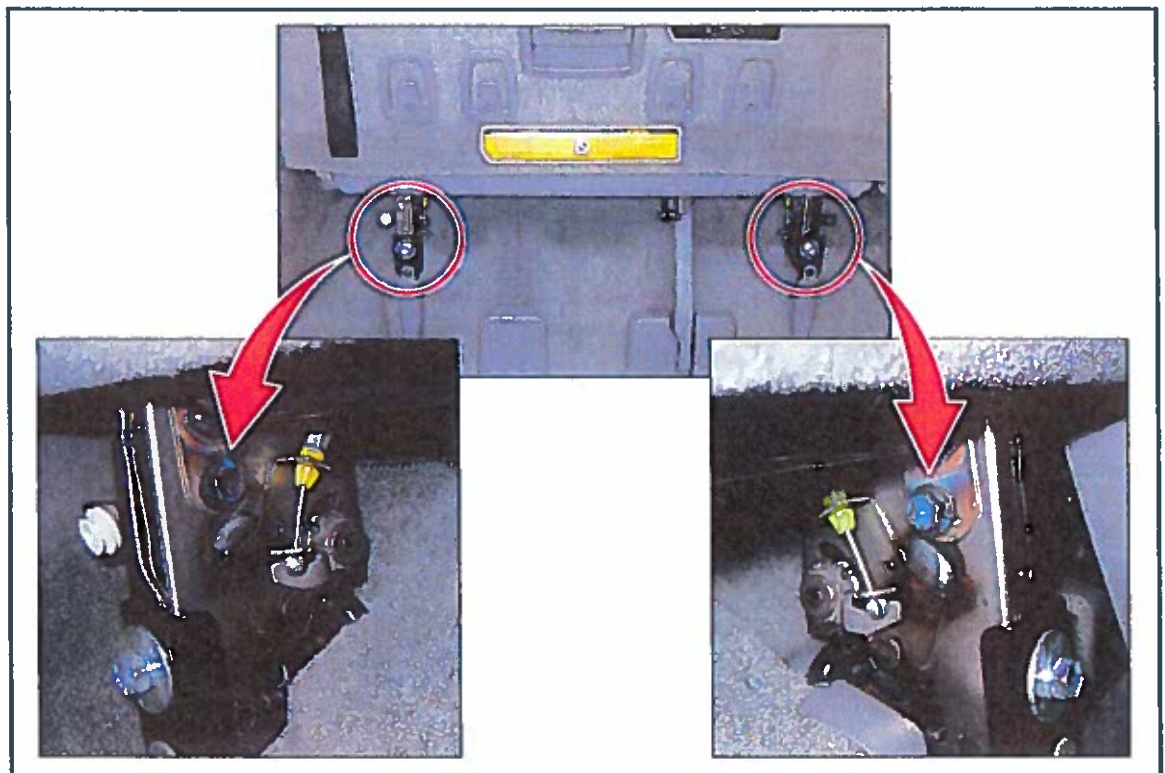
Figure 4.

B. Loosen the 10 mm rear leg bolts on each leg one full turn.

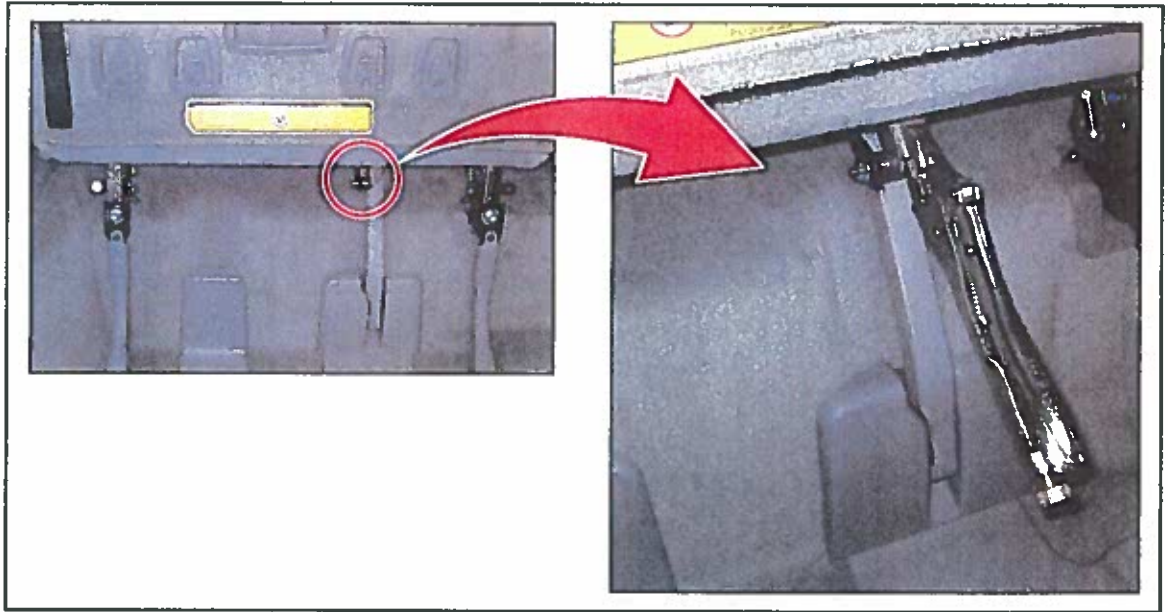
Figure 5.

- C. Place locking pliers, or similar tool, on rear damper bracket.

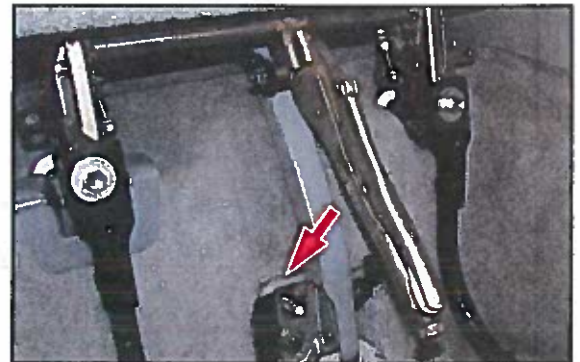
Figure 6.

- D. Push down on the locking pliers to add tension to the leg bracket dampener.

While pushing down, make sure to hold even pressure on the locking pliers and ensure they are pushed down until you feel a stop, then retighten the 10 mm rear leg bolts beginning with the outer leg first.

Torque: 7 N*m (71 kg*cm, 5 ft*lbf)

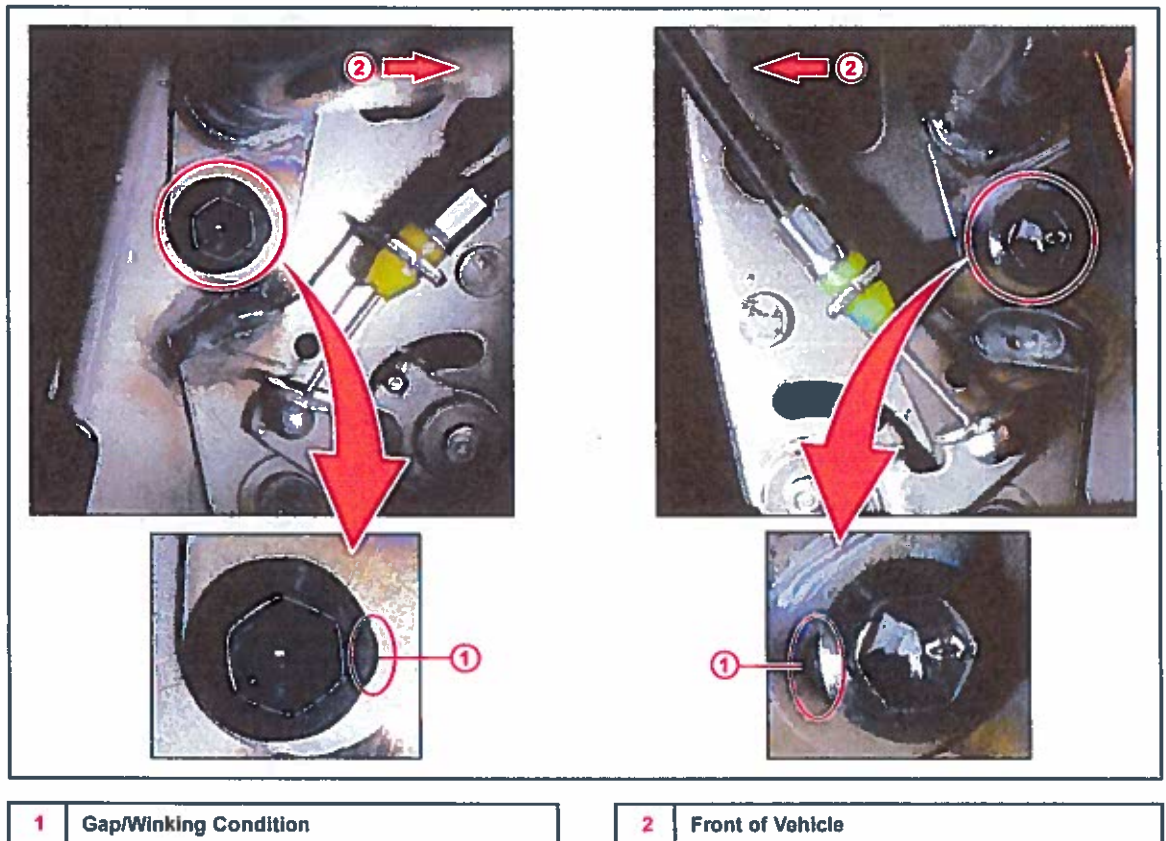
Figure 7.

- E. If the tensioning procedure was performed correctly, a gap should be present on the forward section of the bolt head on the inboard facing bolts that were previously loosened. This gap condition, also known as "winking" condition, should point towards the front of the vehicle.

NOTE
Winking condition will vary by vehicle and seat assembly. Please reference Figure 7 for examples of correct winking condition.

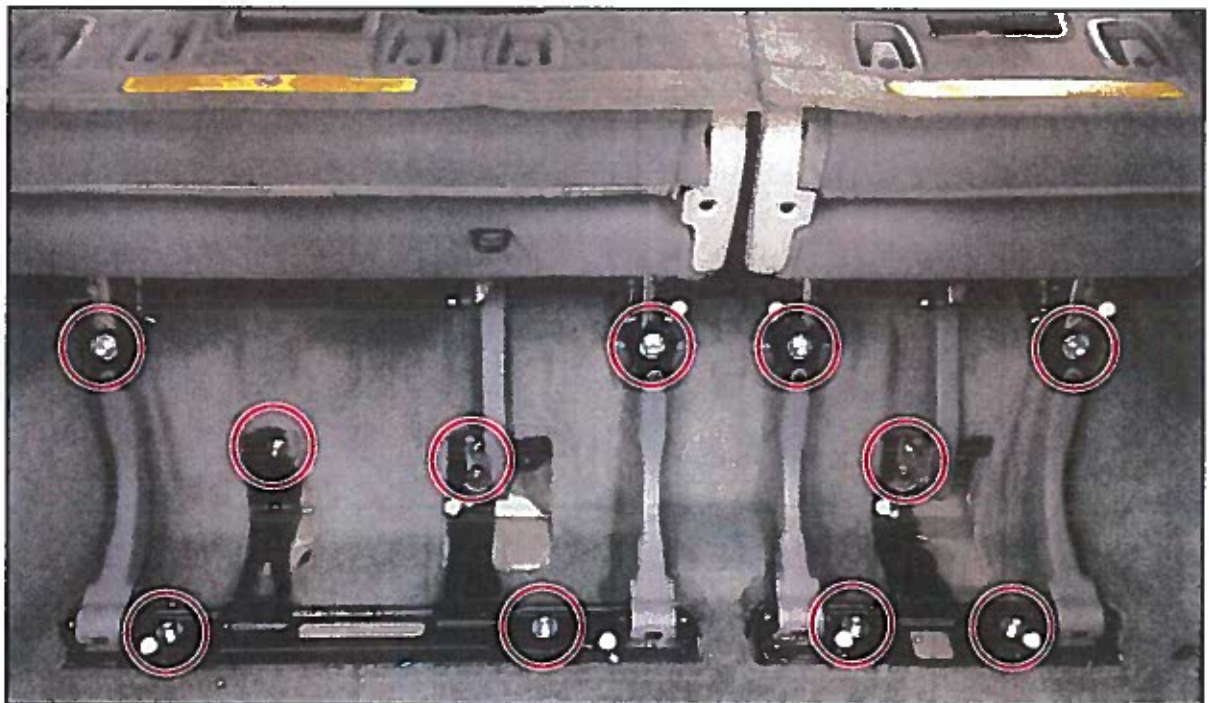
Figure 8.

7. Loosen up all seat mechanism bolts to allow the seat to settle.

It is important that **NO** excessive weight is placed on the seat assemblies after performing this step.

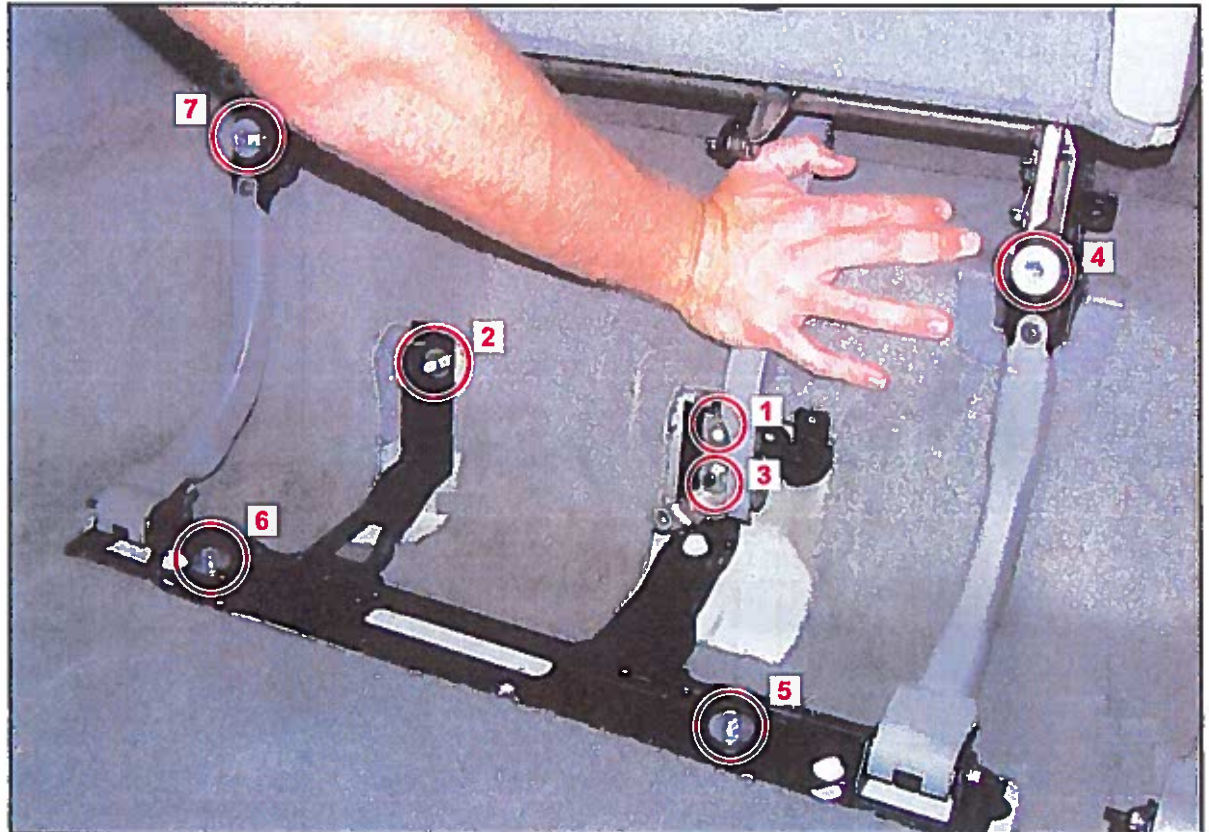
Figure 9.

8. While consistently pushing forward on the torsion bar, tighten the bolts on the 60% side, in the sequence shown in Figure 9, to the following specifications.

Torque: 19 N*m (193 kgf*cm, 14 ft*lb)

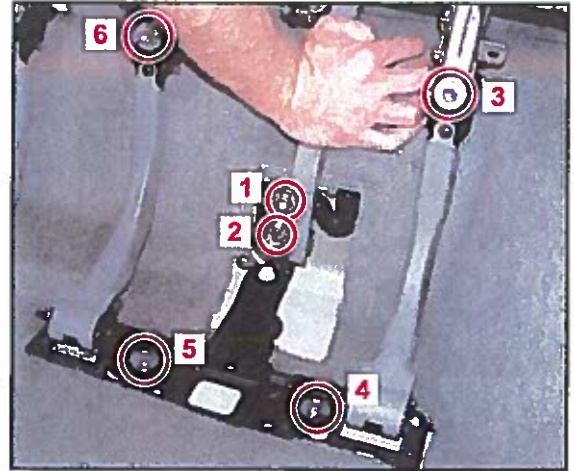
Figure 10.

9. While consistently pushing forward on the torsion bar, tighten the bolts on the 40% side, in the sequence shown in Figure 10, to the following specifications.

Torque: 19 N*m (193 kgf*cm, 14 ft*lbf)
