# Spring Spacer Removal During PDS

YEAR(S)	MODEL(S)	ADDITIONAL INFORMATION
2015	FR-S

The 2015 model year FR-S has a new accessory package known as Release Series 1.0 that includes a suspension kit. To minimize vehicle damage during transportation, spacers have been installed on the front shock absorber piston shafts to hold the front of the vehicle up approximately two (2) inches over normal ride height. These spacers must be removed during Pre-Delivery Service (PDS).

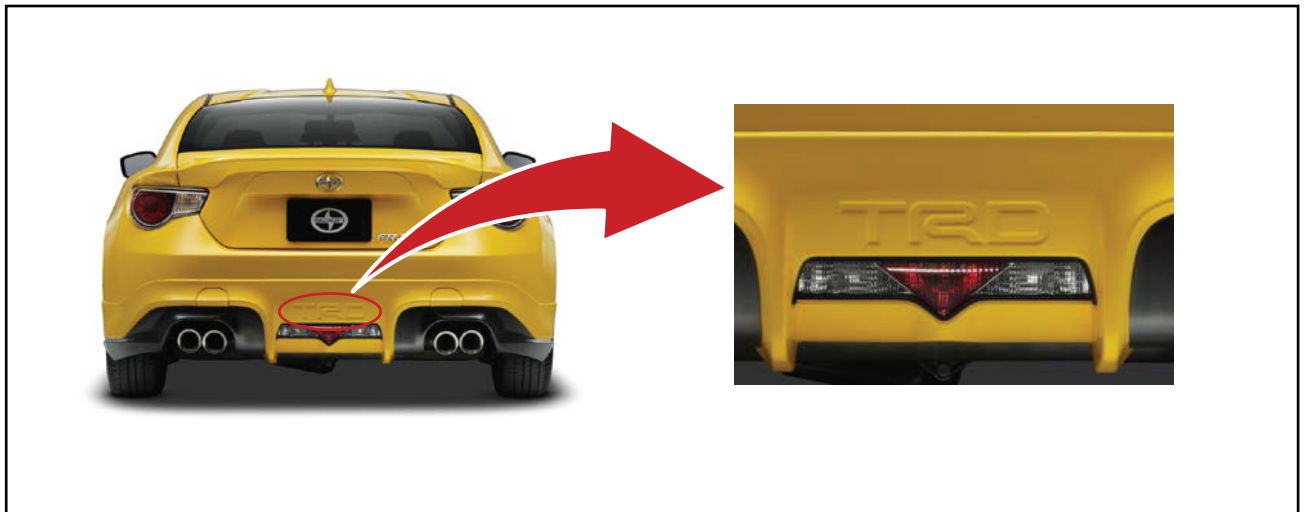
The Release Series 1.0 package can be identified by a number of ways, two of which are:

1. “Yuzu” vehicle paint.
2. Embossed TRD logo in the rear fascia.

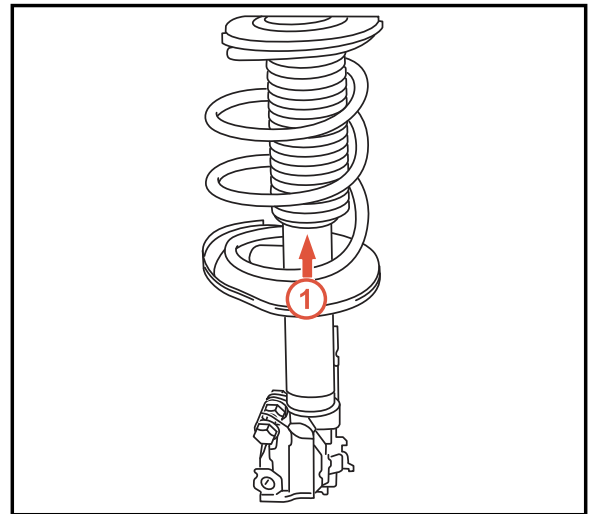
Figure 1.

1 Dust Boot

1. Raise the vehicle on a hoist.
2. Lift corrugated dust boot on the front shock assembly.

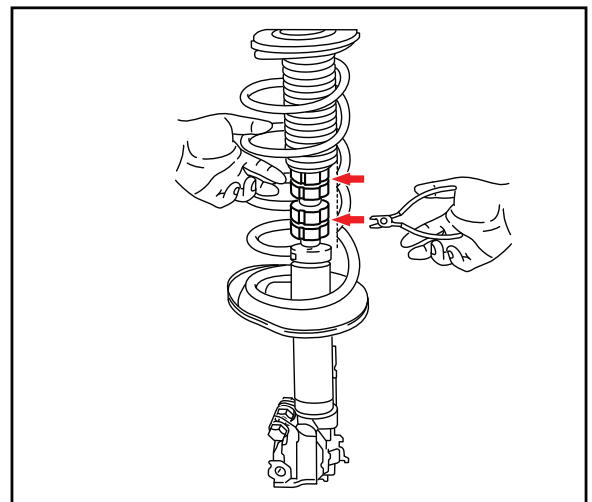
Figure 2.

- There are two spacers on each front shock absorber.
- Make sure the dust boot is properly in place when finished.

3. Clip the nylon tie from the red spring spacer.
4. Remove the red spring spacers and nylon ties from the shock absorber and pull through the open spring coil.
