GROUP
Engine

MODEL
All GDI equipped
models

NUMBER
PS315

GDI INJECTOR SPRAY TIP DEPOSITS

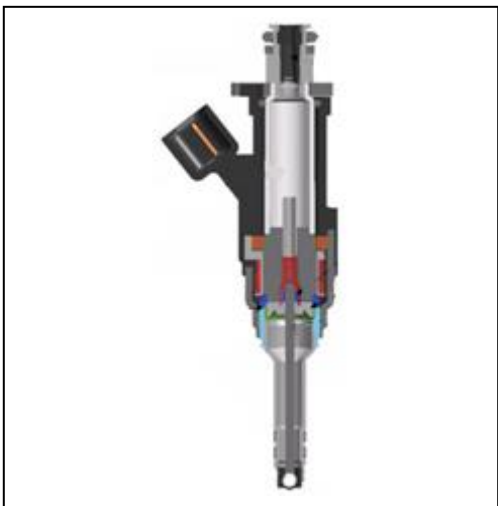
The internals of the Injector are designed to minimize the formation of deposits

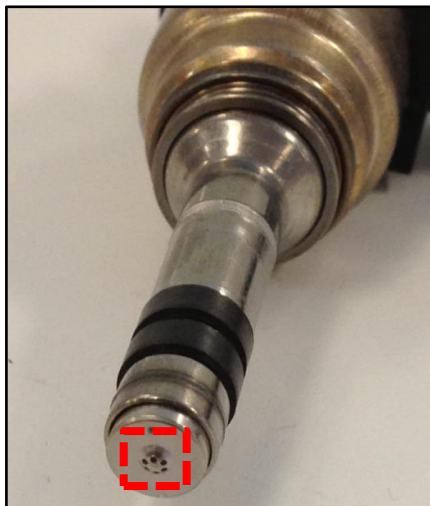
New injector showing location of Spray Orifices

NOTE: Ultra-sonic or mechanical cleaning of GDI fuel injectors should never be done in an attempt to improve vehicle drivability or injector performance. Attempting to remove spray tip deposits through mechanical means, such as wire brush cleaning or scraping, will damage the spray orifices and degrade injector performance.

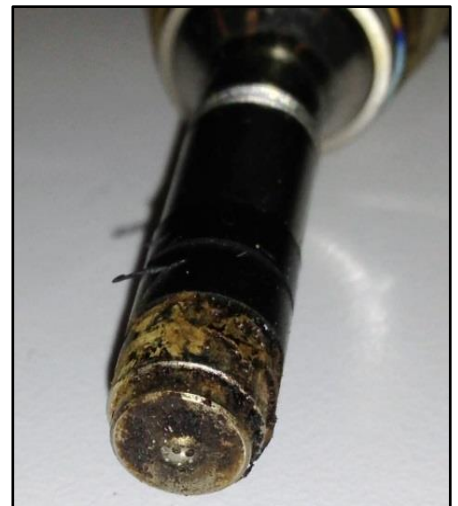
A design feature of vehicles equipped with a Gasoline Direct Injection (GDI) system is the placement of each fuel injector directly into the engine cylinder head assembly. Therefore, it is completely normal for the combustion process to create deposits on the injector spray tip surfaces. Although spray tip deposits may appear to be heavy enough to affect injector performance, there is actually no change in the fuel delivery or spray pattern. GDI injectors operate at high pressure and deliver fuel through small spray orifices near the center of the injector tip, at a high velocity. As a result, combustion deposits that form near the injector spray orifices are washed away as fuel is delivered. In addition, the injector ball and seat are engineered to reduce any potential effects of carbon coking.

Normal injector appearance while in service
