GROUP
Engine

MODEL
Optima (QF/TF)

NUMBER
PS322

SUBJECT: DTC P0456 AND CHARCOAL CANISTER LEAKS

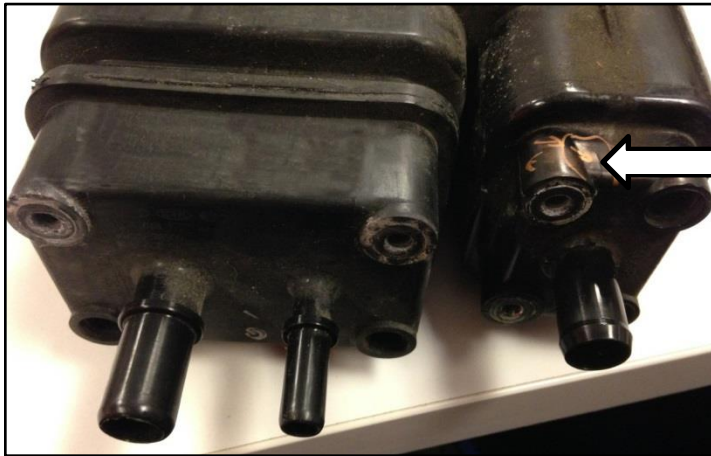
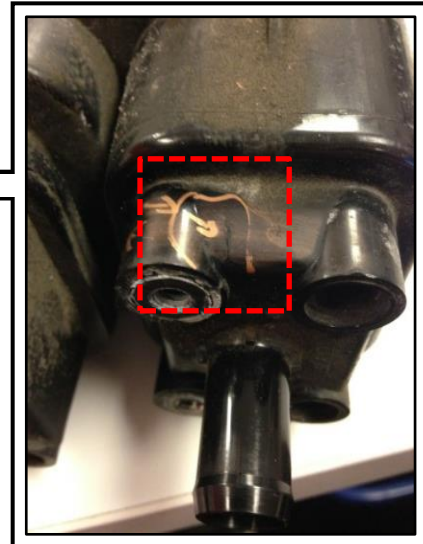
When addressing a concern related to a DTC P0456 (Evaporative Emissions System – Small Leak Detected), and an inspection of the vapor lines, connections and fuel cap reveal no abnormalities, closely inspect the mounting holes of the charcoal canister for visible cracks (refer to the images below). If cracking is found, replace the charcoal canister per the applicable procedure on KGIS. If no cracking is found, proceed with normal evaporative system diagnostics.
