MODEL  
2015MY  
Sorento (XMa)

NUMBER  
106 (REV 1, 06/04/2014)

## TECHNICAL SERVICE BULLETIN

**SUBJECT:** PAINT PEELING OFF DOOR PANELS (SA166)

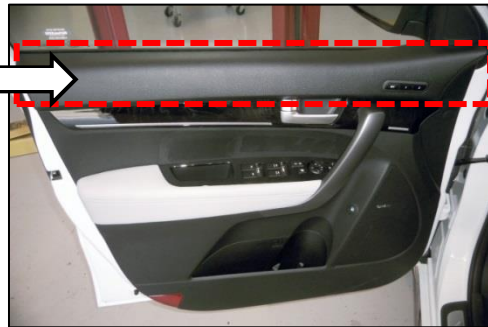
This bulletin provides information related to an inspection of the door panels on some 2015MY Sorento (XMa) vehicles, produced from April 21, 2014 through May 2, 2014, which may exhibit paint peeling, flaking or bubbling from the upper surfaces of the door panels (see images below). All four doors should be inspected (excluding rear doors with the sunshade option) and, if necessary, all affected door panels should be replaced with Techline approval and per the applicable procedure on KGIS. Kia is requesting the completion of this Service Action on all affected vehicles in dealer stock, prior to delivery. Before conducting the procedure, verify the vehicle is included in the list of affected VINs.

If defective panels are found, a photo needs to be submitted to Techline for approval before replacement occurs. All replaced door panels will be returned to WPRC for inspection. The paint must be peeling, as shown above, and not rubbed down to the minimum surface. Any claims showing excessively rubbed down panels may be subject to chargeback.

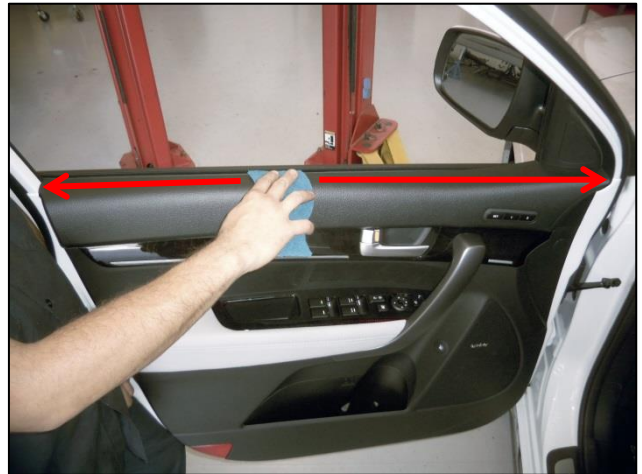
1. Use a non-scratch scouring pad to rub the upper horizontal surface of each door panel using light to medium pressure. Proceed across the entire surface in 2" to 3" sections at a time and avoid using long strokes.

Once finished, inspect the surface of the panel for signs of peeling or bubbling paint. If no damage is present, proceed to step 2. If damage is present, proceed to step 4.

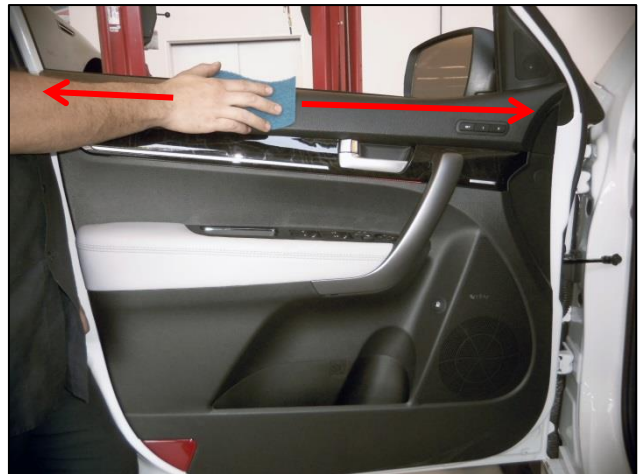
2. Use a non-scratch scouring pad to rub the upper vertical surface of each door panel using light to medium pressure. Proceed across the entire surface in 2" to 3" sections at a time and avoid using long strokes.

Once finished, inspect the surface of the panel for signs of peeling or bubbling paint. If no damage is present, proceed to step 3. If damage is present, proceed to step 4.

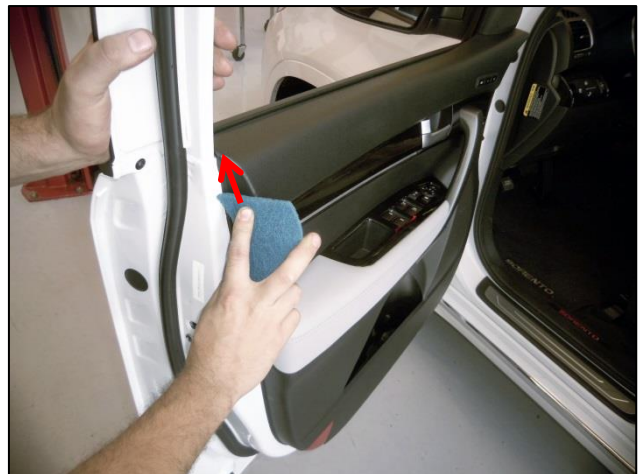
3. Use a non-scratch scouring pad to rub the rear edge of each door panel using light to medium pressure. Once finished, inspect the surface of the panel for signs of peeling or bubbling paint. If no damage is present, no further action is required. If damage is present, proceed to step 4.

4. Replace the affected door panel per the applicable procedure on KGIS.
