MODEL  
2011MY  
Optima (TF) Turbo

NUMBER  
099 (REV 3, 02/5/2014)

## TECHNICAL SERVICE BULLETIN

SUBJECT: SERVICE ACTION: OPTIMA (TF) EWGA INSPECTION AND  
ADJUSTMENT (SA078)

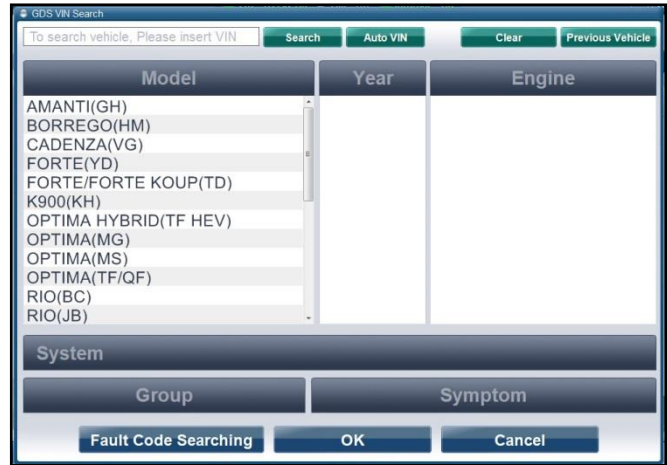
Connect the 16-pin DLC cable from the VCI into the vehicle's 16-pin connector under the driver's side instrument panel.

Turn on the VCI and GDS with the ignition in the ON position.

Enter vehicle information by pressing the **Auto VIN**, entering the VIN or selecting the vehicle model, model year, engine type, and **Engine Control** as the system, and then click **OK**.

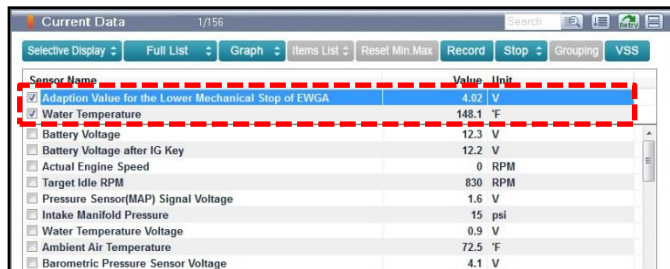
3. Under **Current Data**, select **Adaptation Value for the Lower Mechanical Stop of Boost Pressure** and **Coolant Temperature**.

- Inspect the voltage reading and refer to Table A (below) for target voltages based on engine coolant temperature.

If the voltage is not within the voltage ranges on Table A; then adjust the EWGA rod length following the **EWGA ADJUSTMENT PROCEDURE** below.

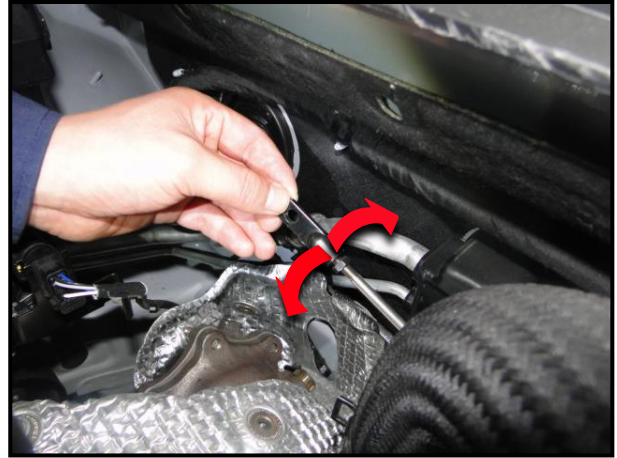
- Adjust the rod end by rotating it clockwise or counterclockwise until specification is within range (See Tables A and B below). Then, temporarily install the rod end and tighten the rod end lock nut. Check the **Adaptation Value for the Lower Mechanical Stop of Boost Pressure**, using GDS.
