MODEL  
2014~2015MY  
Sorento (XMa)

NUMBER  
PS334

**SUBJECT:** WIND NOISE AFTER CROSS BAR INSTALLATION

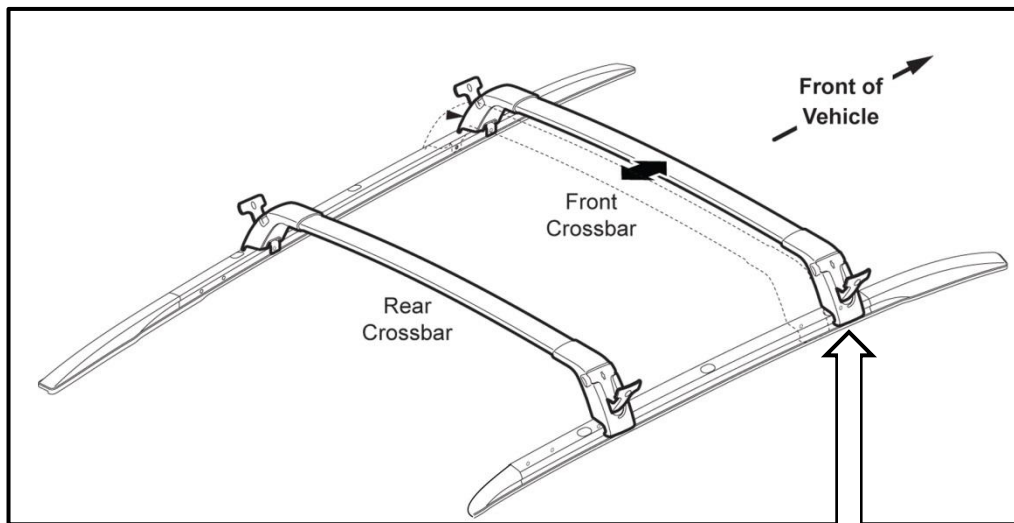
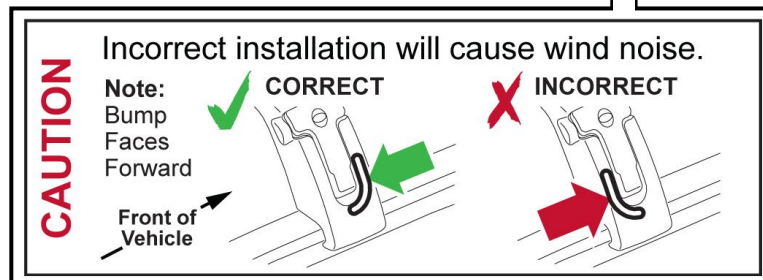
When diagnosing a concern related to wind noise coming from the roof area and the vehicle is equipped with the OE roof rack cross bars, check the roof rack cross bars to make sure they are installed correctly, using the diagram below. If the cross bars were installed incorrectly, remove the cross bars and reinstall them as shown below or by referring to the installation instructions included with the cross bar kit.
