DART - Add Insuliner to conduit housing CNG line

Property name and Top bus number: DART 304500 – 306500 – 313000 - 414000

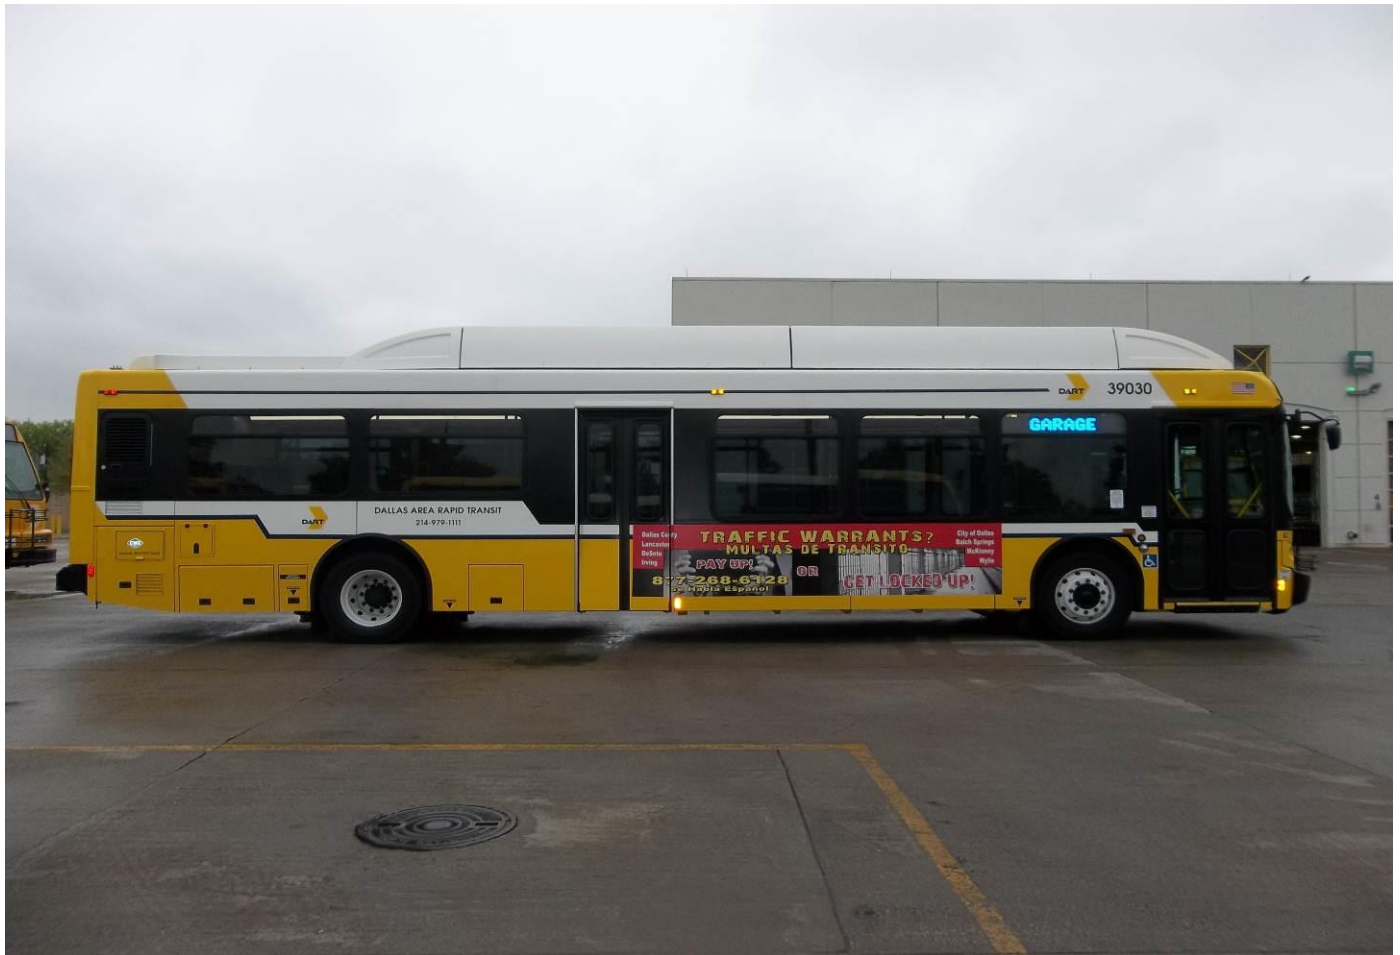
Issue: CNG line may touch the top of the conduit, if not properly formed or adjusted during installation.

Reason/ cause: Improper forming or adjustment of CNG line

Solution: Add Insuliner to top of conduit to prevent possible contact of fuel lines with conduit

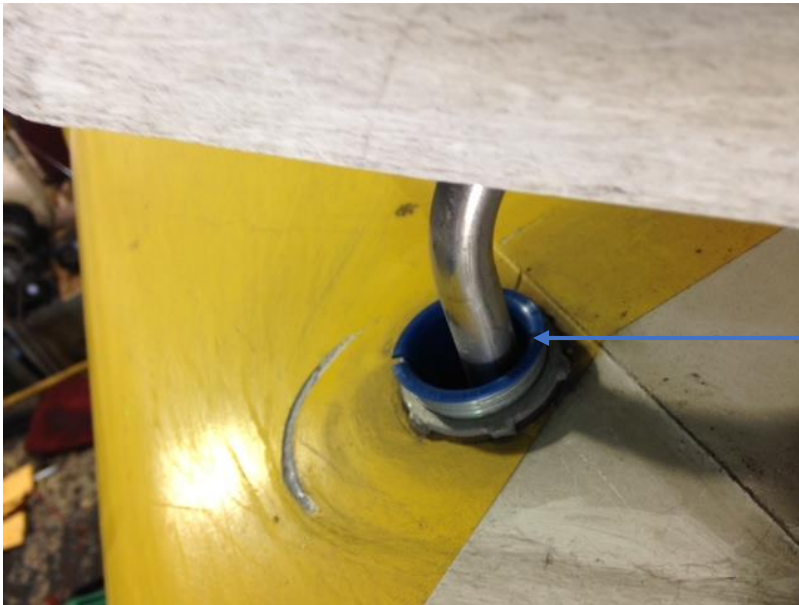
Blue insuliner to be installed between conduit and CNG lines

1. Park the bus and apply the parking brake.
2. Turn off main battery disconnect switch(es)
3. On the c/s rear of bus remove the CNG line cover. Locate the CNG line coming through the roof. Add blue insuliner between conduit and CNG line.

4. If the click bond studs have come loose sand all of the old adhesive off and clean with denatured alcohol. Using the adhesive plexus re-apply click bond studs making sure to line them up with the original location.
5. Check for completeness of work.
6. Remove all tools from working area.
7. Turn the main battery disconnect switch(es) on.
