NJT – Rear Bulkhead Seal

Property name and Top bus number: 305000

Issue: Sealant and foam sealant not installed in some areas of the engine compartment .

Solution: Inspect and apply specified sealant and foam sealant to areas noted in this Work Instruction

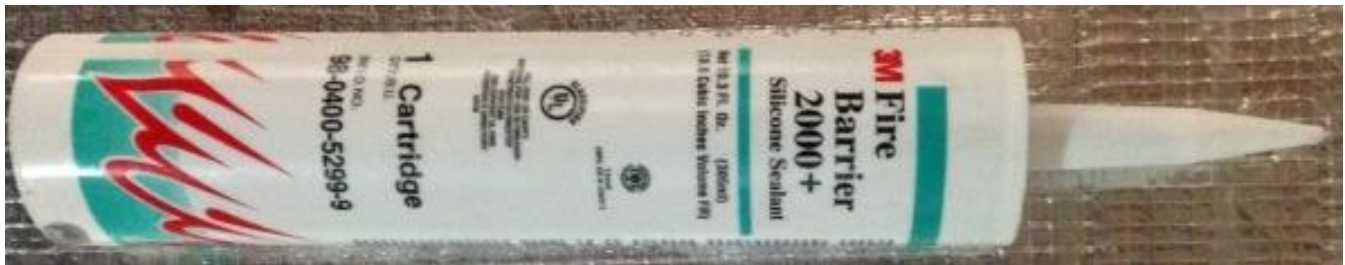
3M fire barrier, 2000+
3M Fire Block Foam,
Acetone,

NABI Part #: **75100-84856**,
NABI Part #: **NPN**,
NABI Part #: **NPN**,

1 tube / 4 buses,
1 can / 4 buses,
1 can / 40 buses,
