**NABI: Adjustable Konsberg Floor Pedal Inspection Instruction**

**Property and Top Bus Number:** NABI 40LFW and BRT city buses equipped with adjustable brake and throttle pedal assemblies.

**Issue:** Brake pedal may not fully release after the brake is applied.

**Solution:** Remove, clean and inspect the adjustable pedal assembly as noted in this work instruction.

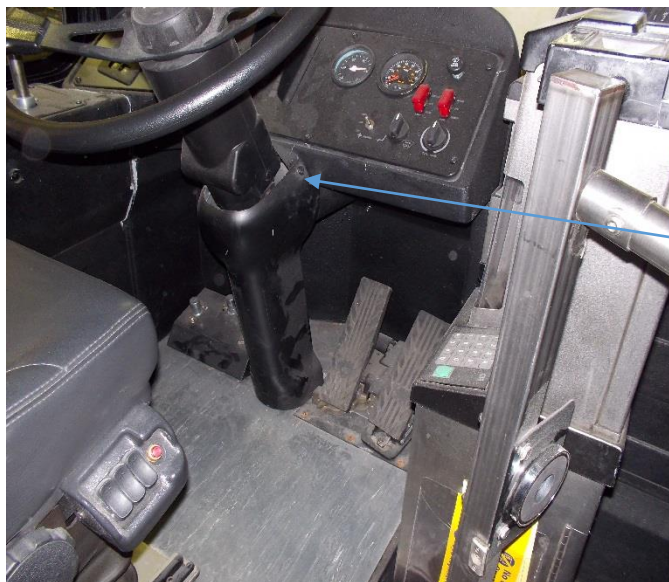
Remove two screws one on each side.

1. Park the bus and apply parking brake. Turn engine off.
2. Before starting, move pedal all the way to rearward position.
3. Remove the steering shaft cover by removing two screws.

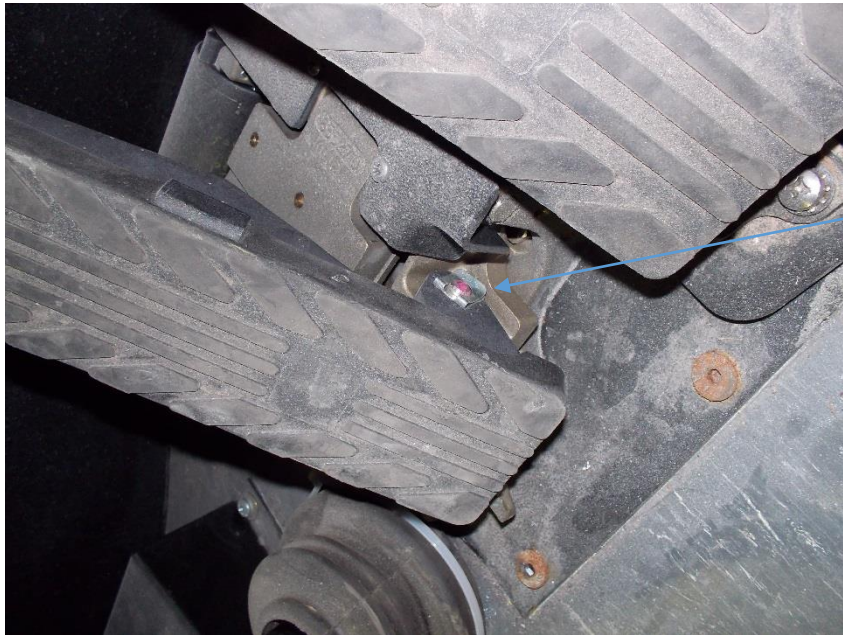
Clip that needs removed.

4. Remove treadle pin on brake treadle - locate pin clip and remove with a flat screwdriver.

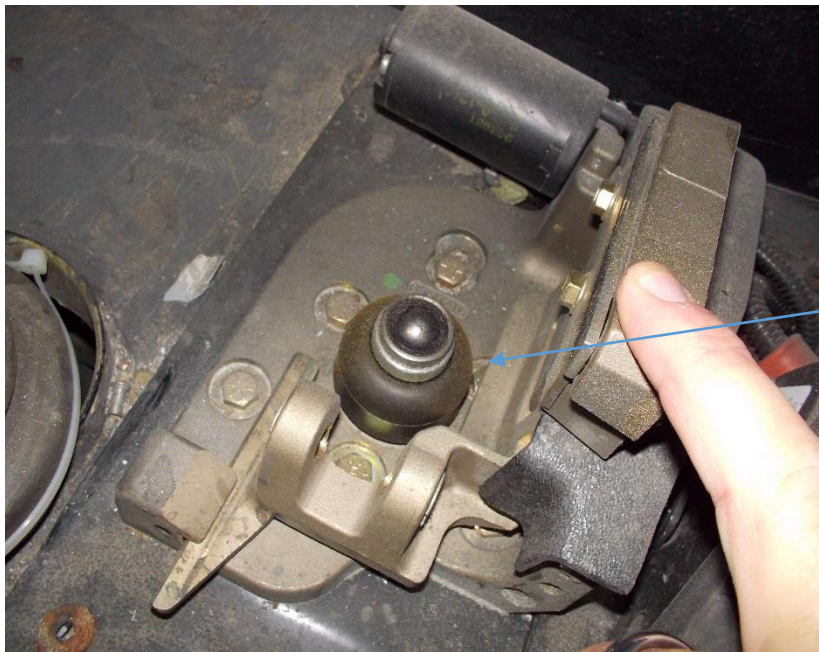
After the pin and pedal are removed, remove the plunger as shown

5. Remove brake treadle to expose plunger. Remove plunger and seal by pulling up on plunger. Clean grease from plunger.

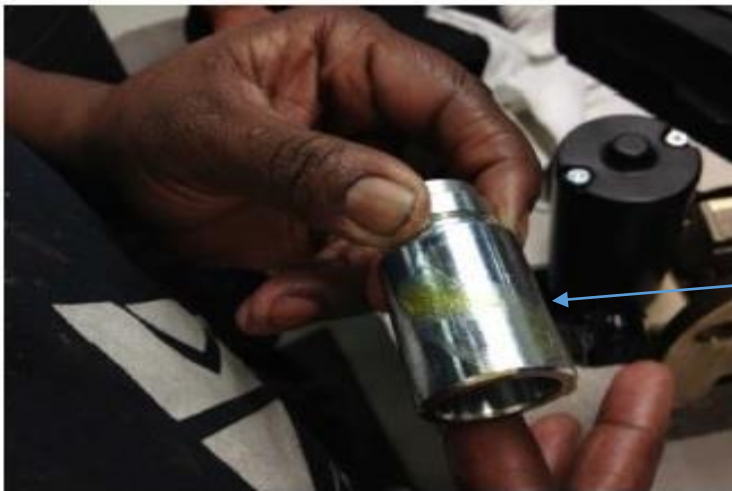
Check the  
plunger for  
scoring

6. Clean plunger hole. **Warning: if any wear, scoring, or damage is noted, either the plunger and/or valve casting (complete Adjustable Floor Pedal [AFP] unit) must be replaced. Failure to replace a damaged plunger or valve casting could lead to a sticking condition of the brake control.**

7. Clean the bore and inspect plunger, to ensure there are no metal shavings or dirt present. Apply a thin, even layer of grease to plunger and base hole and reinstall plunger and seal to base. Upper seal lip must be seated on plunger groove. Use Bendix grease provided by KA. **Warning: use only the grease specified. This is a very specific grease that has been fully tested and approved for this application and cannot be substituted with any other grease.**

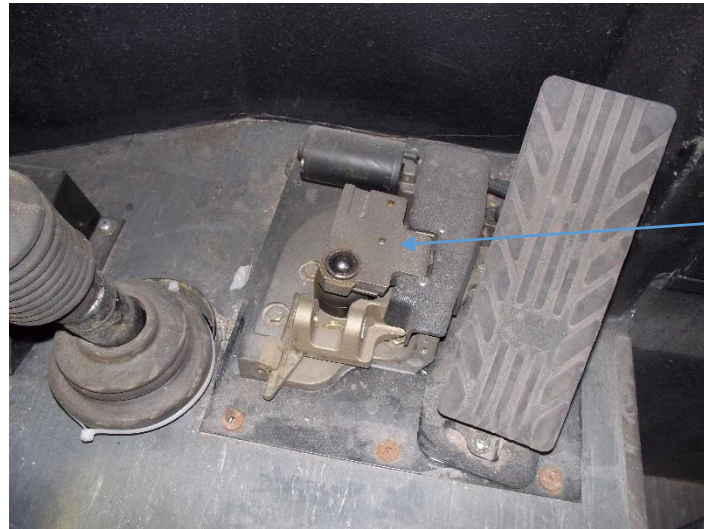
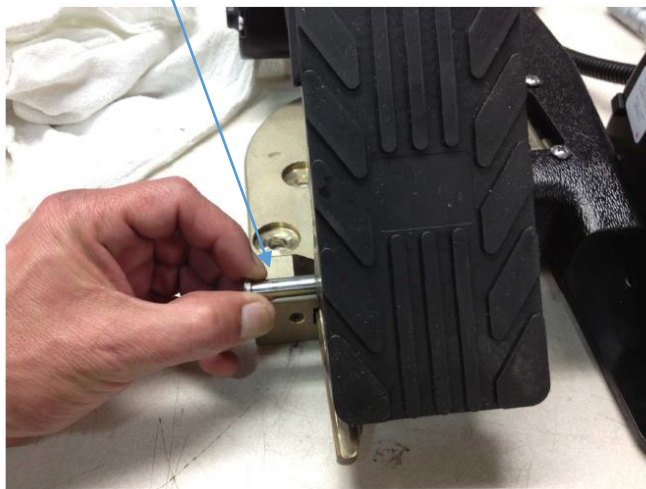
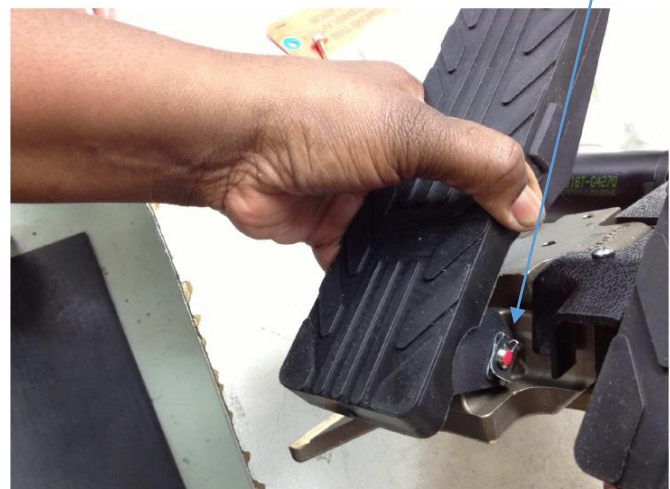
8. Reinstall brake treadle. Make sure you lower movable arm back in position (on top of plunger) before assembling treadle back on. Once treadle is on, push treadle pin in place.

9. Assemble clip to secure treadle pin in place. Use fresh clips provided by KA.
10. Check pedal for proper operation. **Warning: if any wear or looseness is noted on the brake treadle pivot pin or the brake treadle pivot holes the component parts must be replaced. A worn brake treadle pivot pin or brake treadle can lead to a sticking and/or binding condition of the brake treadle.**
11. Record bus number, mileage and date of completion.
