NJT: Compartment Door Hinge Replacement

Property name and Top bus number: NJT - 305000

Issue: Compartment door hinges may be incorrect on some units / paint on hinge “pins” causing the hinges to seize over time

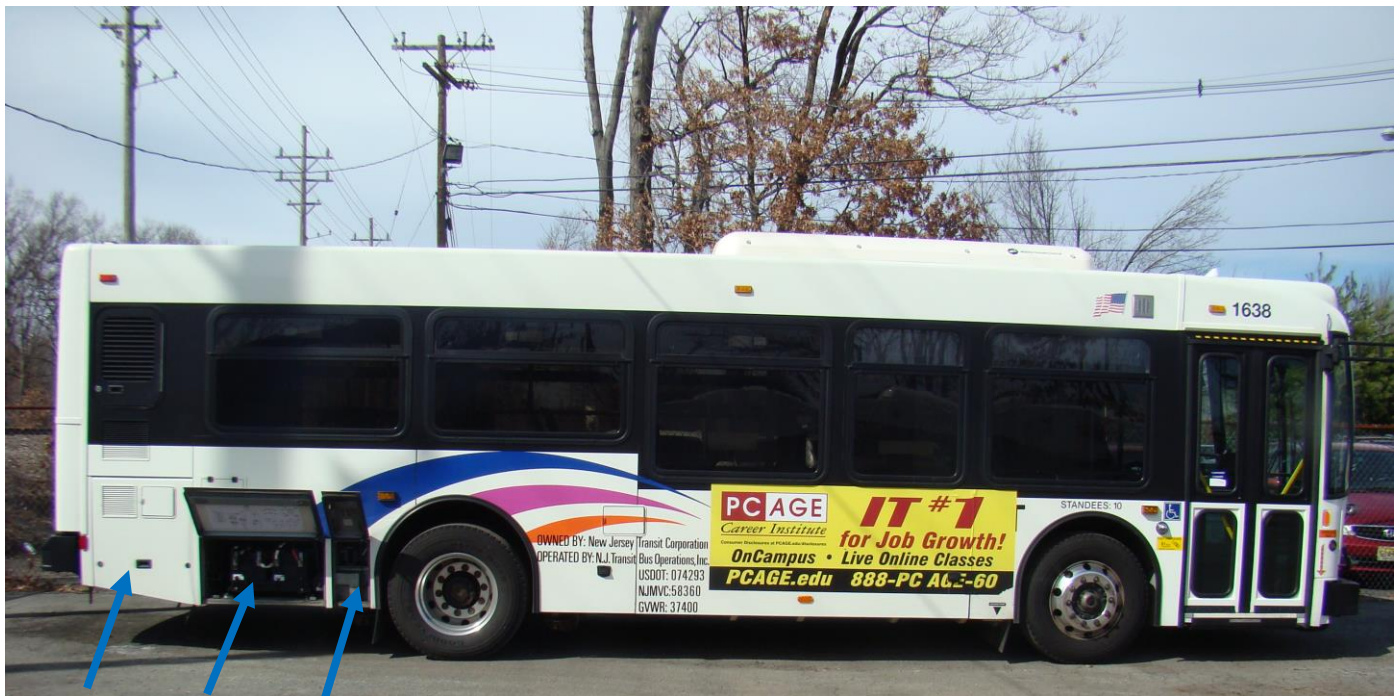
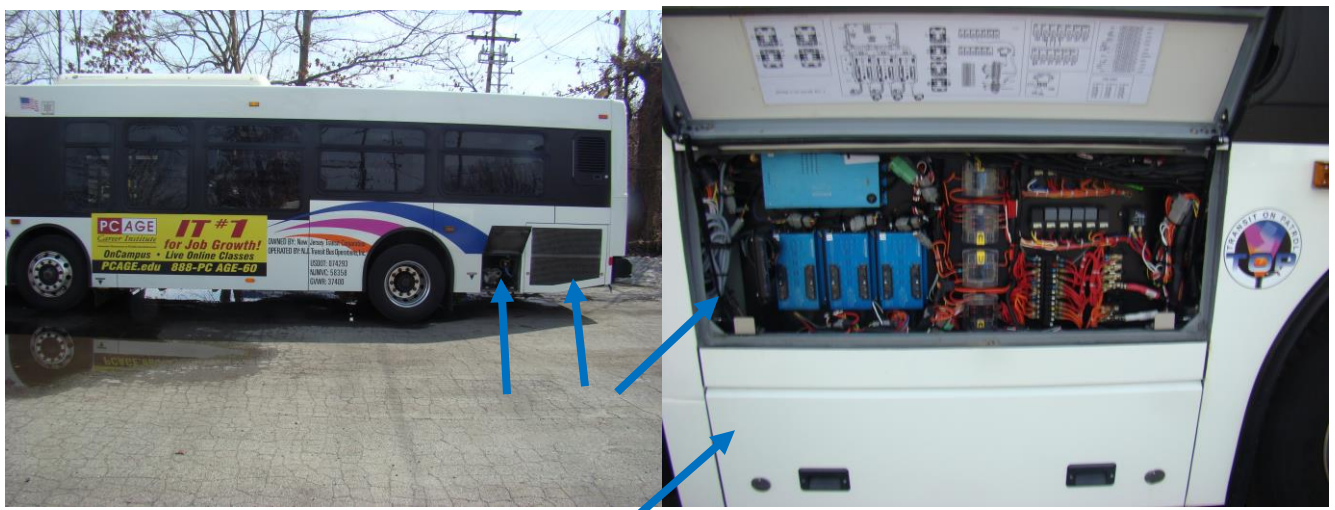
1. Park the bus and apply the parking brake.
2. Turn off main battery disconnect switch(es).
3. Locate the access doors that need the hinges to be inspected/repaired (see below).

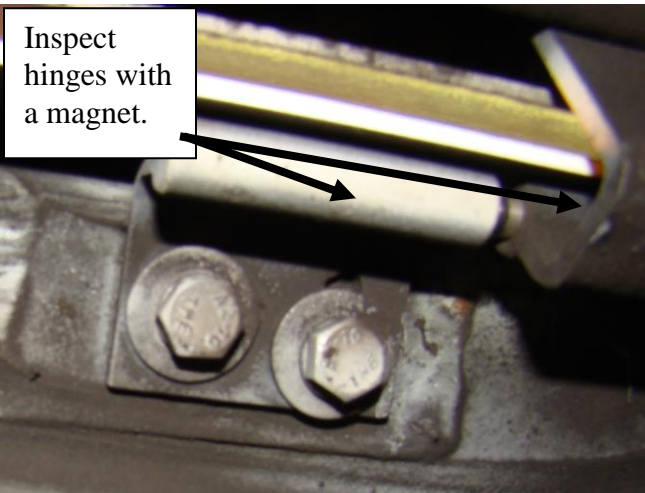
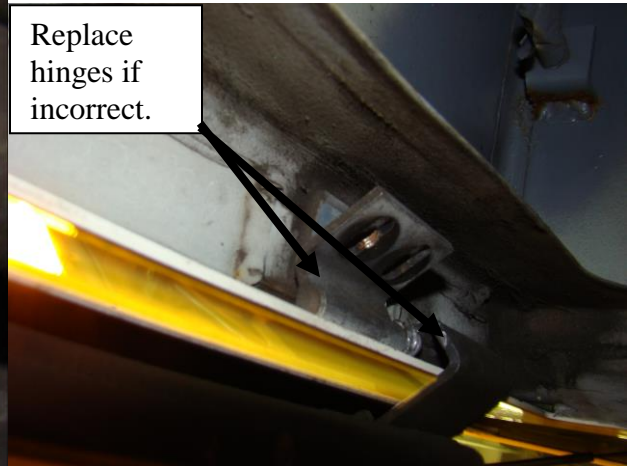
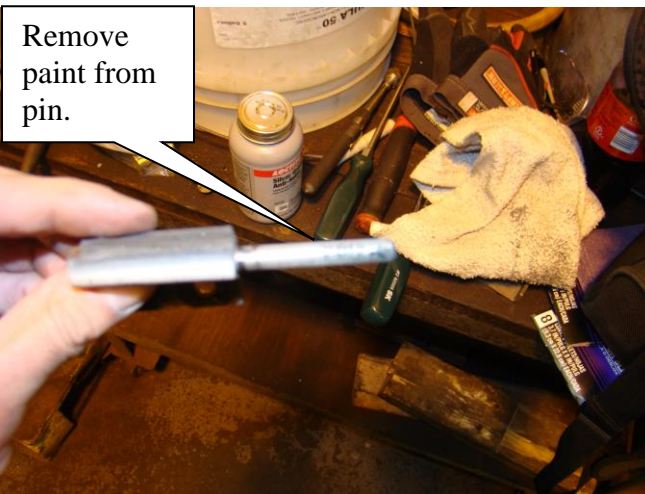
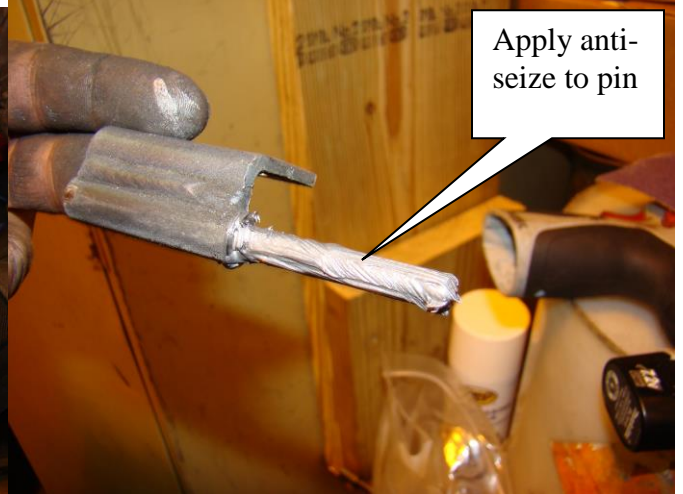
4. Inspect the access door hinges with a magnet to verify that they are stainless steel or steel hinges (Steel hinges must be replaced with stainless steel hinges). Remove bolts from hinge bracket attached to the bus. Remove the gas springs from the door. Unbolt the hinges from the door and install the new hinges as required. If the hinges are correct, the hinge pins need to be removed and the paint needs to be removed from the hinge pins (see below). Reinstall door reusing the existing hardware and adjust accordingly. Do this for every door except the radiator door.

IMPORTANT: When reinstalling the hinges it is very important that the doors are properly aligned with the body of the bus or damage to the doors and/or the body of the bus may occur. Note any body damage from previously mis-aligned panels.

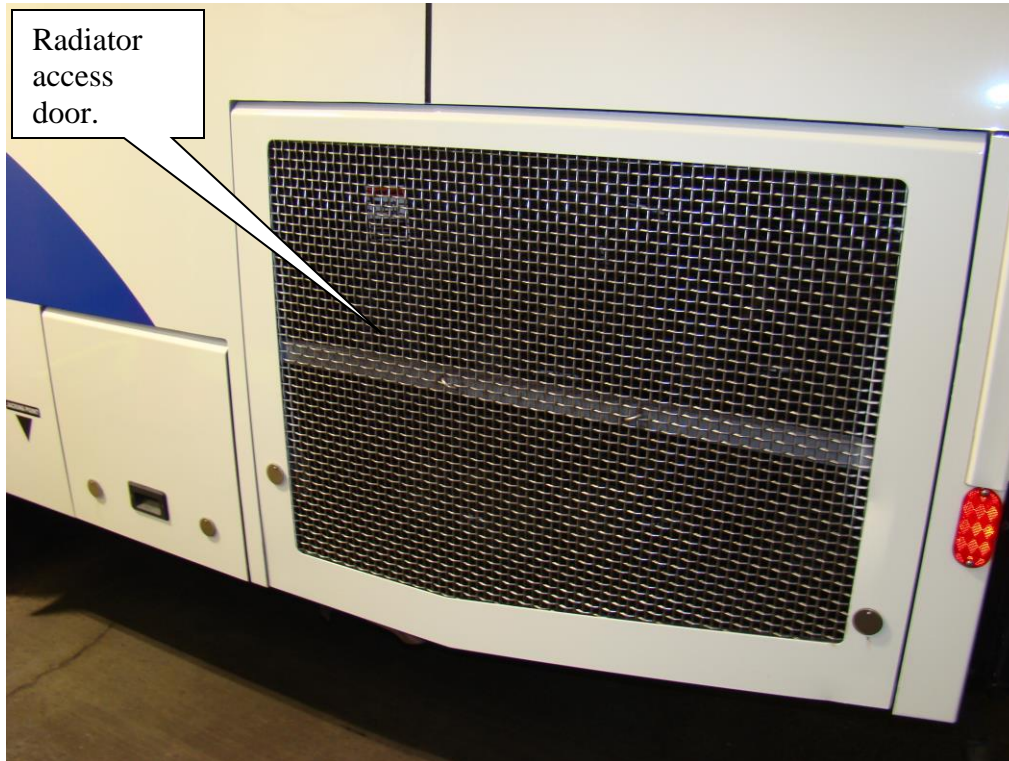
5. Use the same steps as performed in step 4 for the radiator access door however if the door side hinges need to be replaced the screen on the radiator door must be removed in order to replace hinge. Drill out the 15 rivets in order to remove the screen for the door. After replacing the hinge reinstall screen using rivet PN: 2406RHSS04 (3/16 x 1/4").
