NJT Side Panel Seal

Property name and Top bus number: **NJT: 305000**

Issue: Debris Getting Behind Side Panels

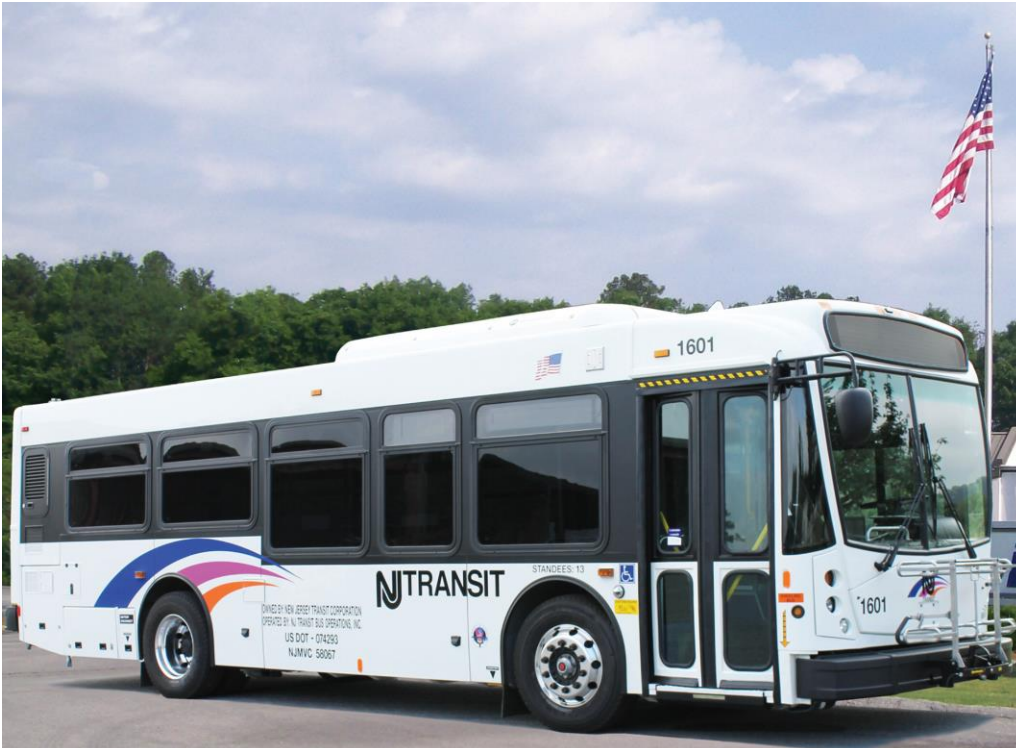
Reason/ cause: Bottom of Panel not Sealed

Solution: Seal Bottom of Panel with Sikaflex

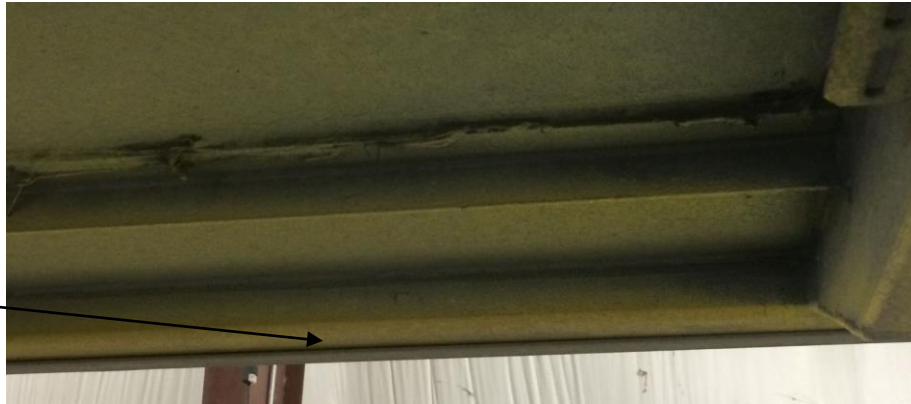
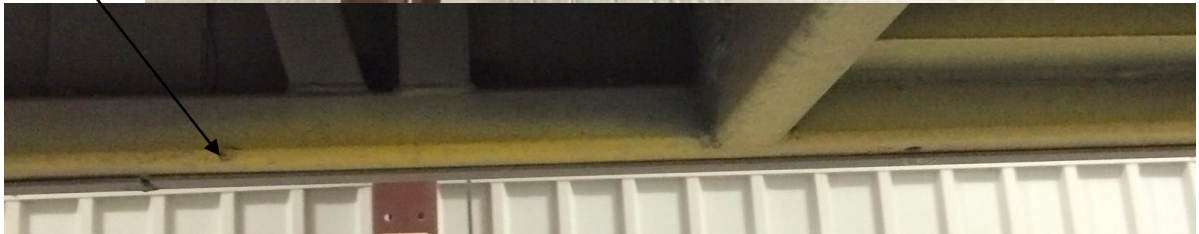
Seal along the edge where the side skin and frame meet

1. Park the bus and apply the parking brake.
2. Raise bus in the air.
3. Seal side panels with sikaflex as shown

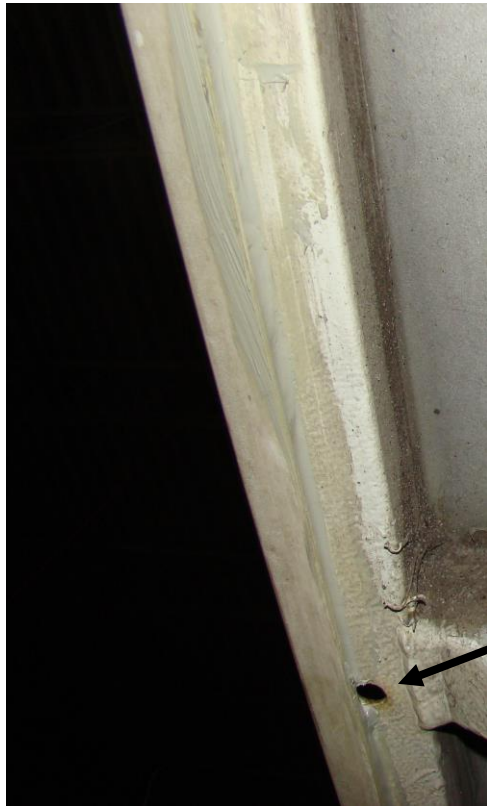
Do not seal
drain holes in
frame.

4. Don't seal up the frame plug holes along the frame.
