**PREVOST**

**WARRANTY  
BULLETIN**

**WB14-45C**

DATE :	OCTOBER 2014	SECTION :	06 - Electrical
EXPIRATION:	OCTOBER 2016		
SUBJECT :	R49 "ACM RELAY" REMOVAL

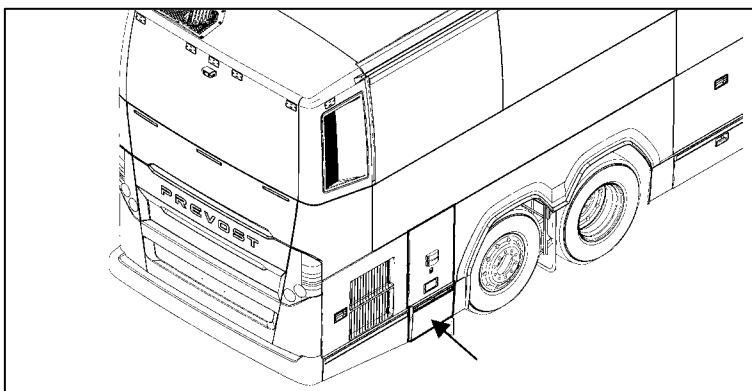
Figure 1: H Series

On the vehicle, curb side (Right side), open the rear electrical compartment.

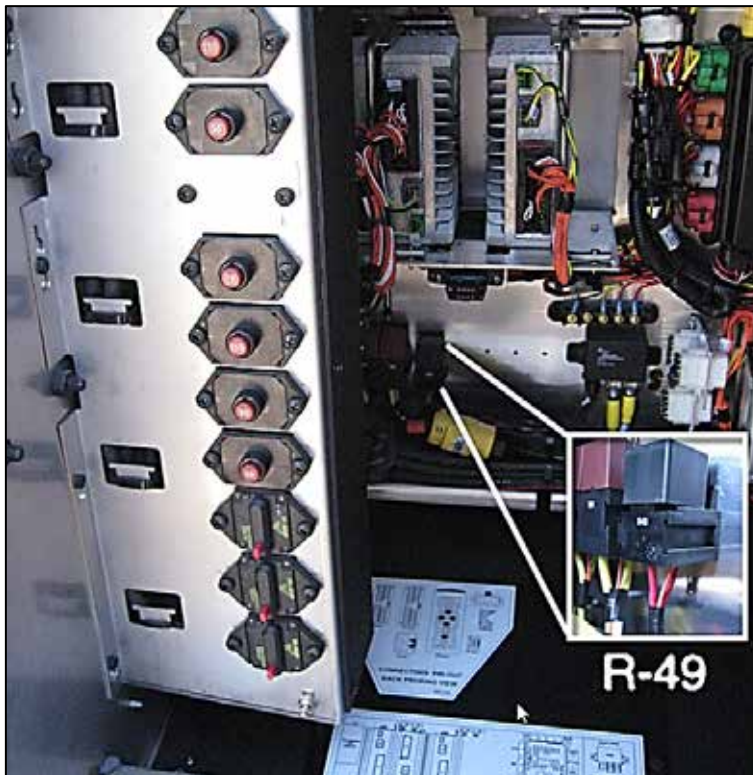
Figure 3 : H-series vehicles

On *H series* vehicles, relay is located on the lower left section of the rear wall. (Fig. 3)

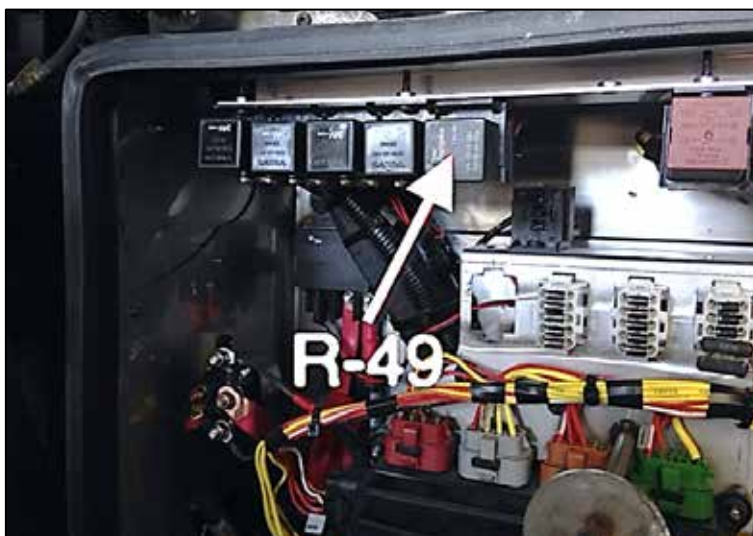
Figure 4 : X-series vehicles

On *X series* vehicles, remove the vertical cover of the electrical compartment above the battery compartment.

Relay is located in the upper left corner of the electrical compartment. (Fig. 4)

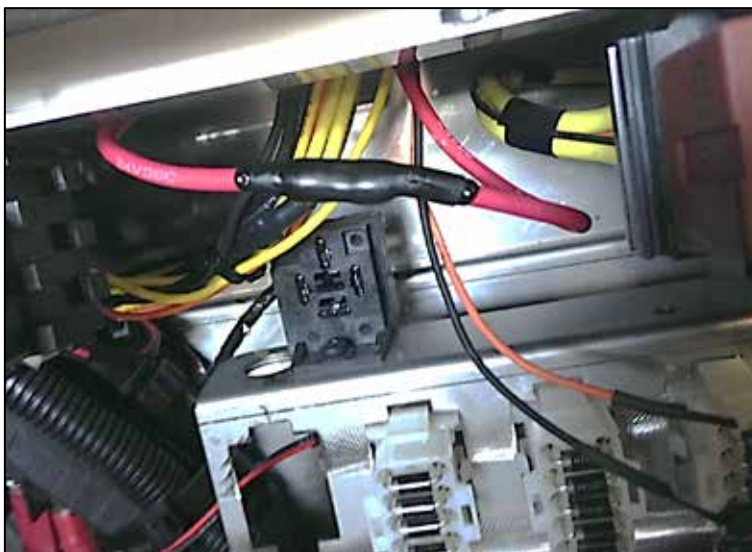
Figure 5: Heat shrink tube. X-Series shown

Slide shrink tube over crimped terminal and heat to seal connection. (Fig. 5)

Protect remaining smaller gage wires 425 and 00B with 2 in lengths of shrink tube #561918. (Fig 5)

Slide a 2 in. length of shrink tube # 560784 over one of the red **24VD8** cable.

Connect cables **24VD8** and **24VD8C** with butt splice terminal #562230.

*Crimp and solder the connection.*

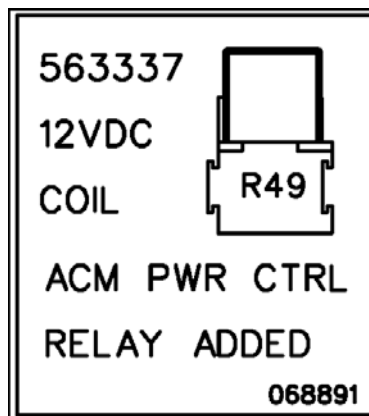
Figure 6 : Decal 068891I

Remove decal "ACM PWR RELAY ADDED" on compartment main decal.
