# PREVOST

## WARRANTY BULLETIN

### WB14-55

| SUBJECT : | SHOCK ABSORBER MOUNT NUTS ON IFS | | |

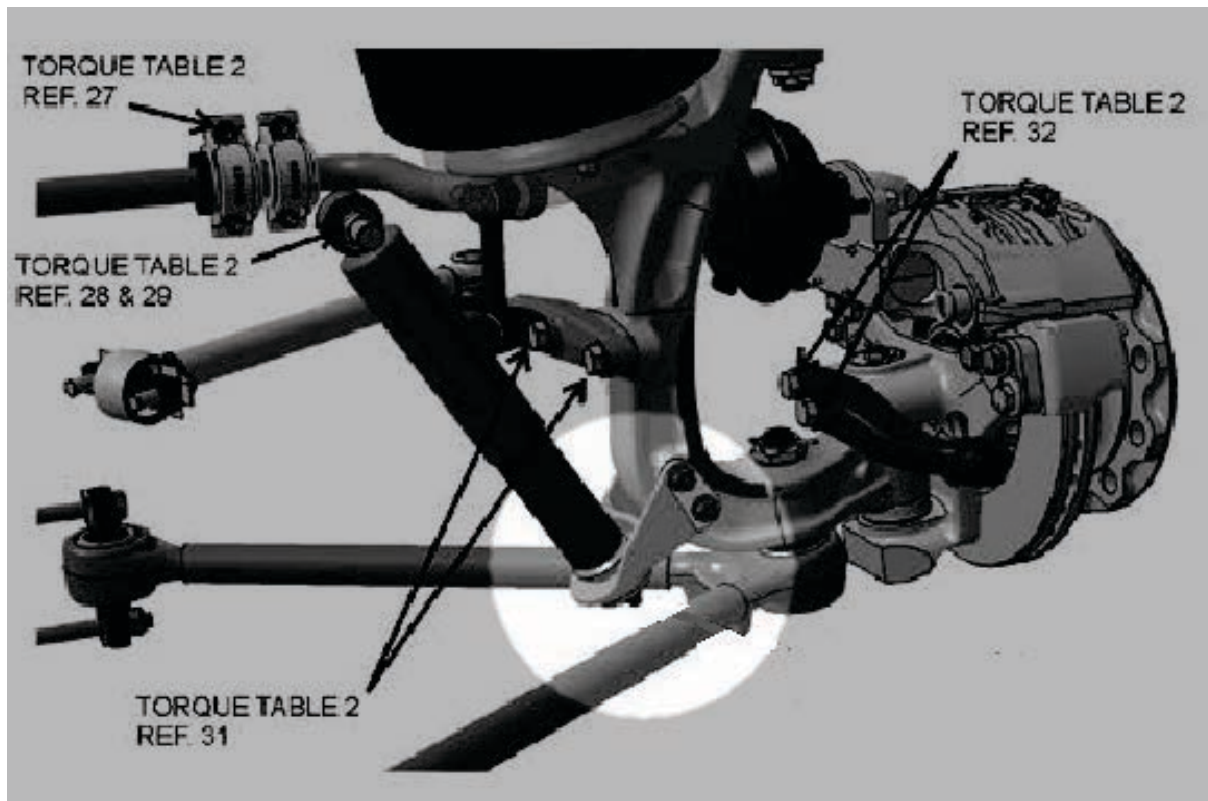
Figure 1

1. Inspect the nut head profile on the anchor bolts of the shock absorber mounting.(Fig.1)
2. Nut head profile must not show rounded corners. (Fig 2)
3. If round corners are found, replace bolt 5001790 and nut 5001771.
4. De-grease contact surfaces before re-assembly.
5. De-grease mounting bolt and let dry.
6. Tighten to 155 lbf-ft.
7. Apply Valvoline anti-corrosion agent.
