# Service Bulletin

**Subject:** Proper Return Process for Shifter Handles to Warranty Parts Center

**Models:** 2014 Cadillac CTS Sedan VIN A

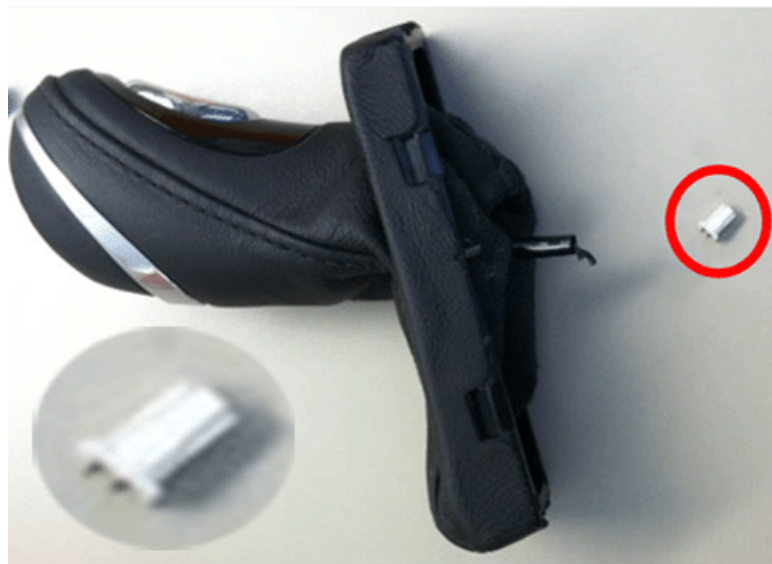
Some shifter handles returned to the Warranty Parts Center (WPC) have had the wires separated from the small white connector and the connector was not returned with the shifter knob. The connector has a wire crimp inside it which is crucial to analyzing the root cause of this issue.

Please see photo below – the white connector is circled.

If the white connector is separated from the wires on the shifter knob, please locate it and ensure it is returned with the shifter handle when parts are returned to the WPC.
