# Service Bulletin

**Subject:** 2010 Through 2013 6.6L Duramax Fuel Injection Pump Part Restriction

**Models:** 2010 through 2013 Chevrolet Express, Silverado  
2010 through 2013 GMC Savana, Sierra  
Equipped with the 6.6L Duramax Diesel Engine RPO codes LGH and LML

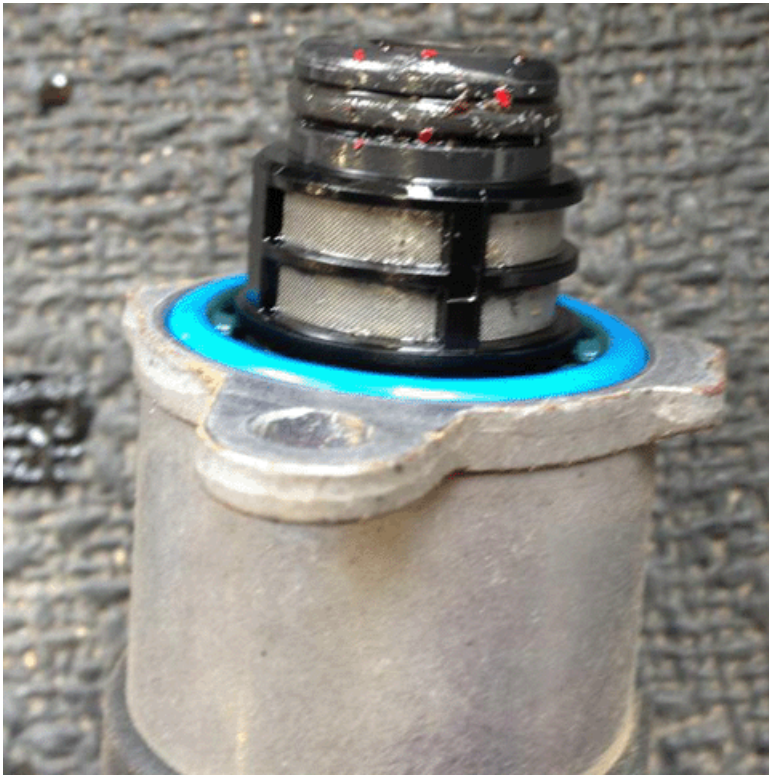
Questionable Fuel Pressure Regulator 1 (View A)

If the debris on the Fuel Pressure Regulator compares closest with Group B; more diagnosis is needed. Remove the Fuel Rail Pressure Sensor and/or Fuel Pressure Regulator 2 (Pressure Relief Valve) for inspection.

- If the same debris is found and the debris is magnetic, the Fuel Injection Pump is experiencing the condition described in the latest version of PIP4949. Call PQC to request the Fuel Injection Pump.
- If there is no debris found or non-magnetic debris found, the Fuel Injection Pump is not experiencing the condition described in the latest version of PIP4949.

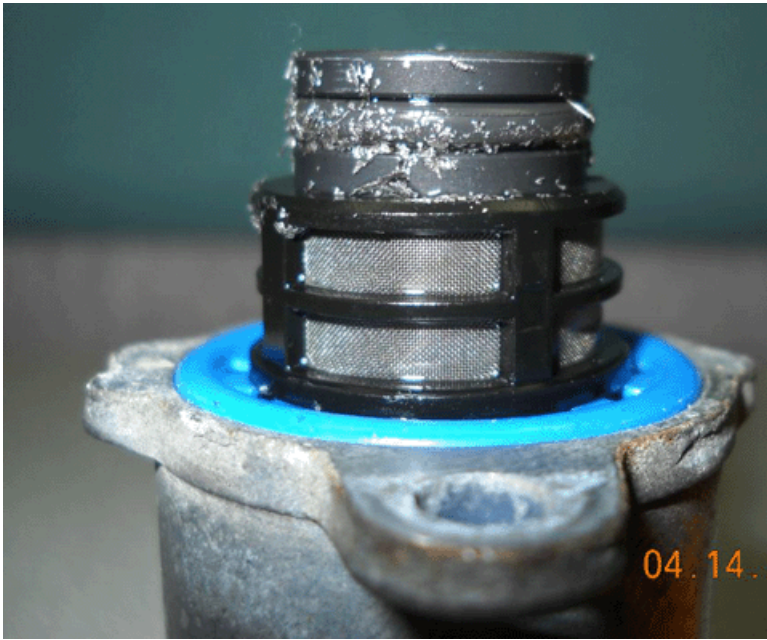
Contaminated Fuel Pressure Regulator 1 (View B)

If the debris on the Fuel Pressure Regulator compares closest with Group C and the debris is magnetic; the Fuel Injection Pump is experiencing the condition described in the latest version of PIP4949. Call the PQC to request the Fuel Injection Pump.
