# Service Bulletin

**Subject:** Service Engine Soon Light On DTC P0442

**Models:** 2013 - 2015 Cadillac ATS Sedan  
Built prior to 8/9/2014

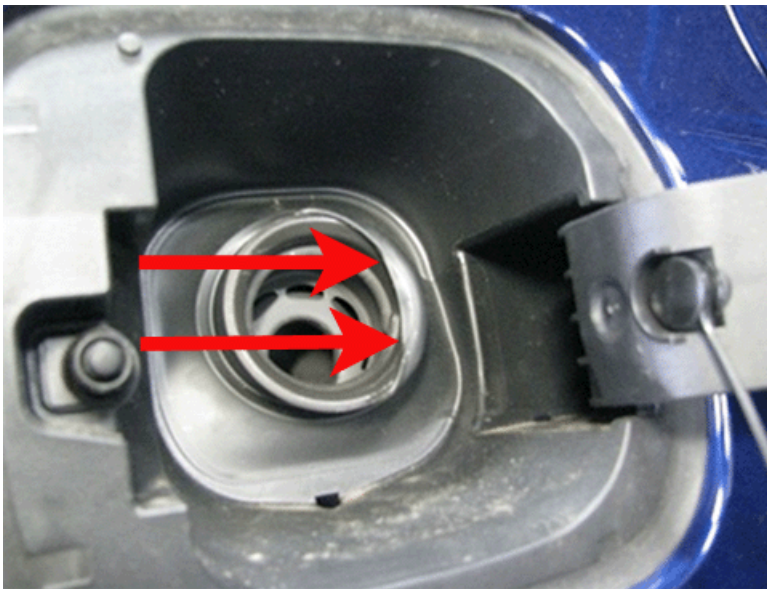
Please check the fuel filler pocket rubber insulator to make sure it is not rolled over the fuel pipe neck as per the picture below.

If the rubber is rolled over the filler neck, roll the rubber back over to the correct position. Check fuel filler cap to make sure the seal on the cap has not been damaged.
