Service Bulletin

Bulletin No.: P11335

Subject: HVAC Vent and Floor Mode Selection Inoperative

Models: 2007-2014 Chevrolet Express
2007-2014 GMC Savana
Equipped with 6.6L Diesel Engine (RPO LGH)

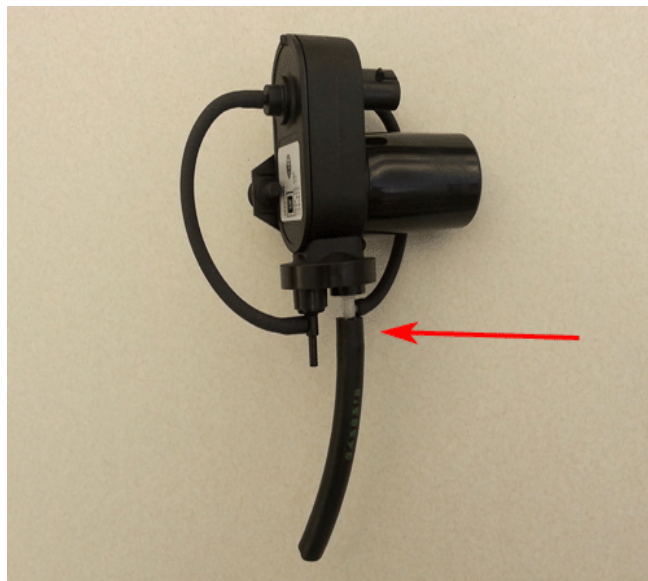
3957659

Some customers may comment that the HVAC air delivery mode controls do not change from the defrost mode. This may be caused by the HVAC vacuum pump becoming inoperative due to being contaminated by water or debris being ingested through the pump discharge port when the pump shuts off and moisture may be sucked back into the pump.

Technicians should follow the steps below and replace the vacuum pump and add a 101 mm (4 in) piece of 9/32"ID GM6147M or 5/16"ID GM6198M hose to the white discharge port as shown above.

1. Open the hood and install fender covers.
2. Remove the vacuum pump assembly. Refer to Vacuum Pump Assembly Replacement in SI.
3. Cut a piece of hose 4 inches in length to be attached to the white discharge port on the pump.
4. Push the hose onto the discharge port over the flange about a 1/4 inch to the adjacent rubber port.
5. Install the new vacuum pump assembly. Refer to Vacuum Pump Assembly Replacement in SI.
6. Remove the fender covers and close the hood.
