# Service Bulletin

Bulletin No.: P11337

**Subject:** Front Seat Back Panel Falls Off or Becomes Unattached

**Models:** 2013-2015 Cadillac ATS  
2015 Cadillac ATS Coupe  
2014-2015 Cadillac CTS (VIN A)  
Vehicles Built Prior to August 5, 2014

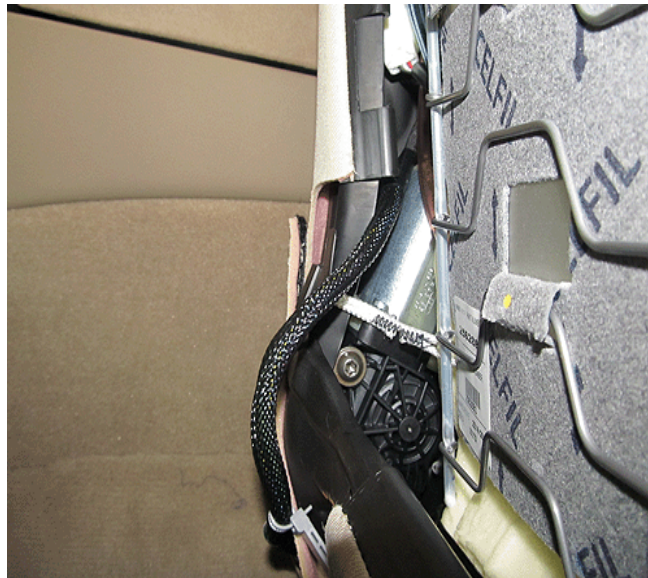
4001719

1. Remove the seat back panel. Refer to Front Seat Back Cushion Finish Panel Replacement in SI.

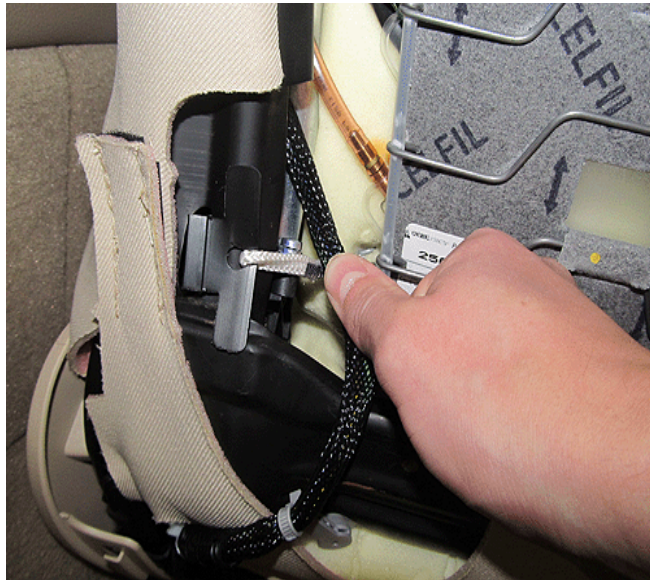
4001723

2. Pull the harness outward to gain as much slack from the harness as possible.

**Note:** Be sure to not use excessive force as this could cause harness damage.

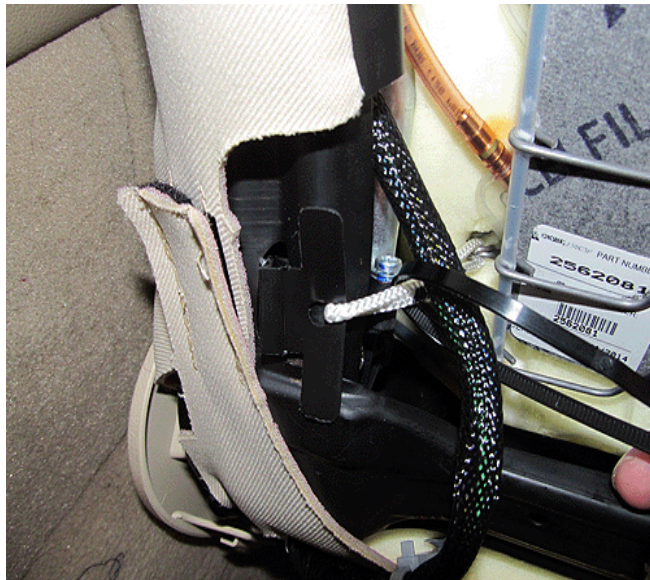
4001729

3. Push the harness upward towards the cushion tie down strap.

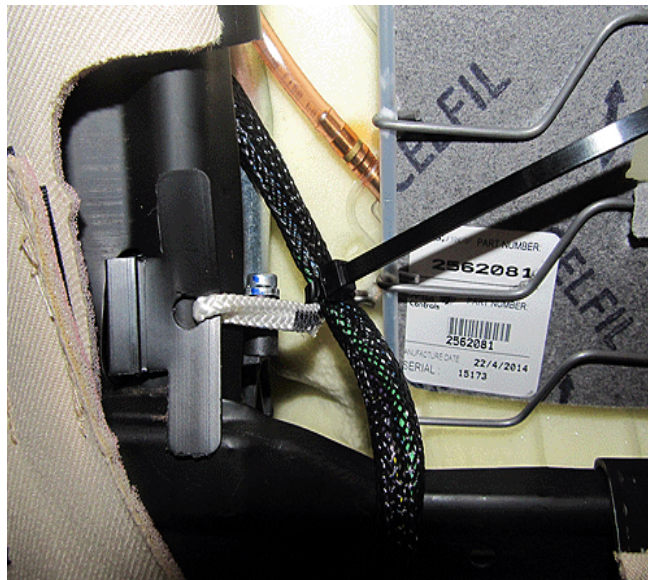
4001734

4. Install a tie strap (P/N 11509086) around the harness and the middle of the cushion tie down strap as shown above.
5. Cut excess slack off of the tie strap.

**Note:** Be sure to not leave a sharp point on tie strap as this could cause damage to the seat.
