Bulletin No.: P11338

Service Bulletin

Subject: Front Doors Hard to Open in Cold Temperatures

Models: 2015 Cadillac Escalade Models
2014-2015 Chevrolet Silverado 1500
2015 Chevrolet Suburban, Tahoe
2014-2015 GMC Sierra 1500
2015 GMC Yukon Models

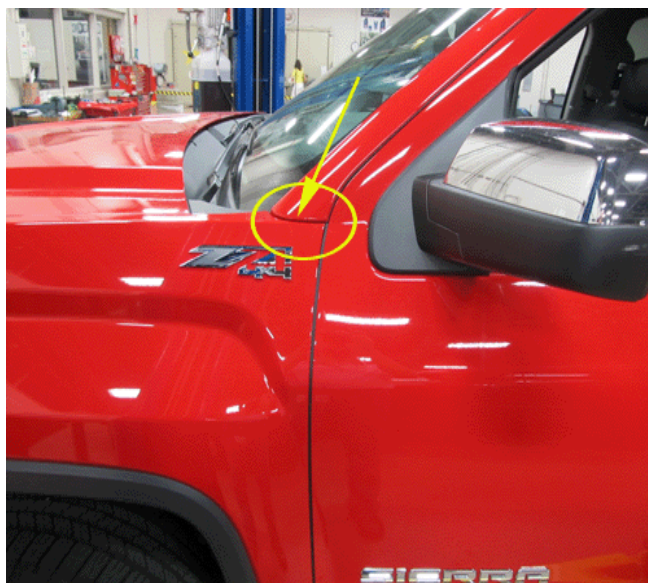
3975698

This may be caused by ice buildup behind the front door hinges.

Note: Water enters into this location as shown above.

After verifying ice buildup in either the driver's and/or passenger's door jamb area, installation of a closed cell foam should be performed on the right and left side of the body to divert water from entering into this area.

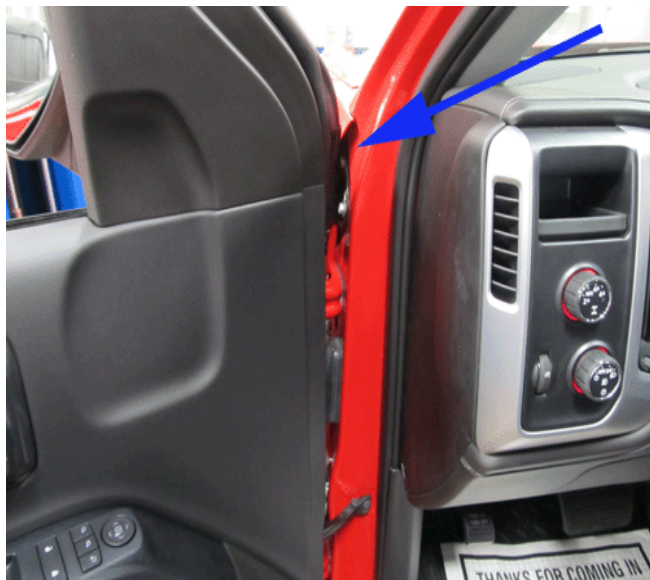
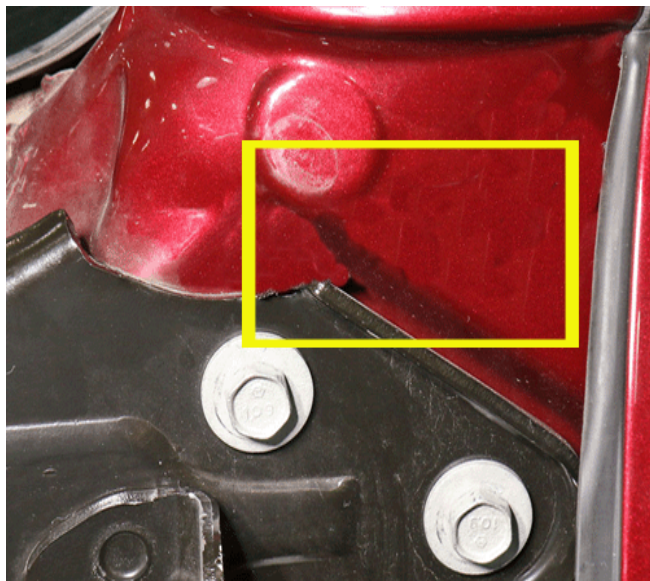
1. Open the front doors and remove any ice buildup.

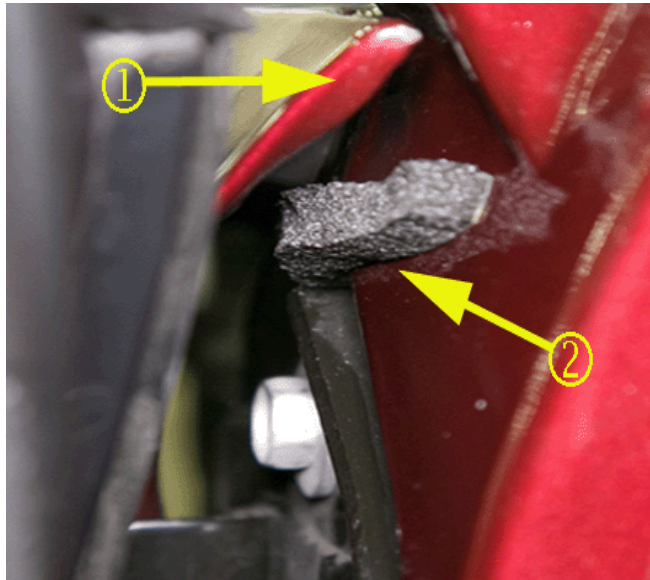
3987527

2. Clean the area with an alcohol prep wipe and allow to dry before installing foam.
3. Cut 75 mm (2.95 in) in length from the 3M™ Vinyl Foam Tape 4504 or equivalent.

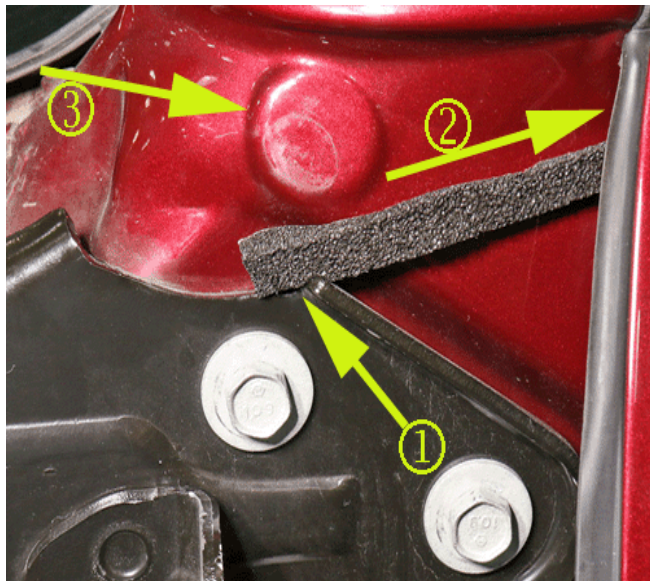
3982093

Note: In this procedure the front fenders (1) do NOT need to be removed to install the foam (2).

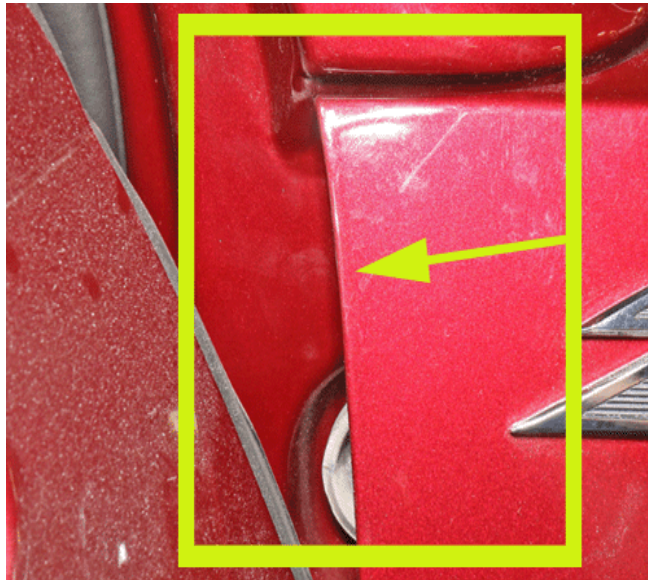
3982096

4. Install the 3M™ Vinyl Foam Tape 4504 or equivalent to the left and right side of the body.
 - Ensure the foam contacts the front fender upper bracket (1) as shown above.
 - The foam must be installed in an upward angle (2), front to rear, as shown above.
 - The foam must stay below the form (3) as shown above.

5. Verify the foam is not visible from the outside of the vehicle.
