Service Bulletin

Subject: Itch Squeak Type Noise From HUD Area

Models: 2015 Cadillac Escalade Models
2015 GMC Yukon Models
With Head-Up Display (RPO UV6)

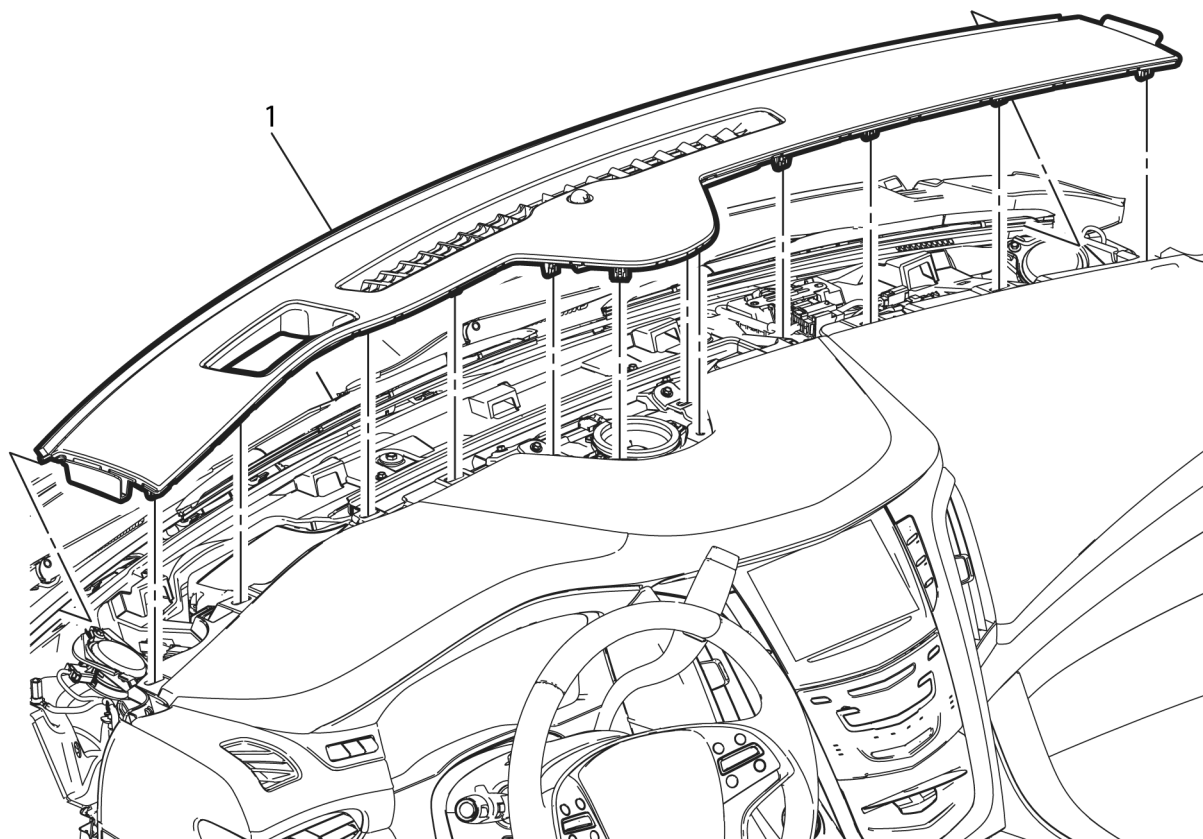
The noise could be caused by the Heads-Up Display (HUD) lense rubbing on the HUD shroud. The HUD shroud is part of the Upper Instrument Panel Extension, as shown below.

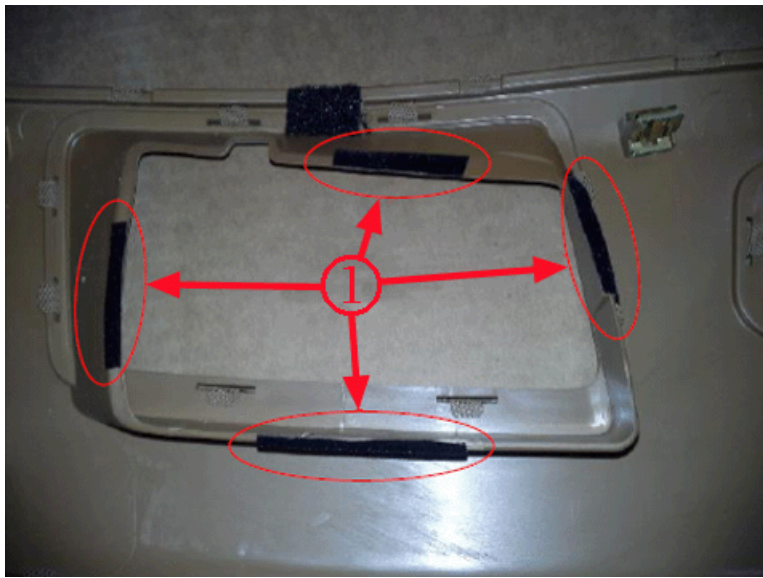
The HUD shroud may have four areas with felt tape (1), as shown below, which is inadequate to eliminate this noise.

To correct this concern, add 1 mm thick felt tape, obtained locally, to the full perimeter of the HUD shroud (2), as shown below.
