BTB 51970-01293 REV3 (1412)

Recall: Driver's Airbag Inflator May Produce Excessive Pressure After Long-Term Exposure to High Absolute Humidity

Supersedes 14-029, dated September 26, 2014; to revise the information highlighted in **yellow**

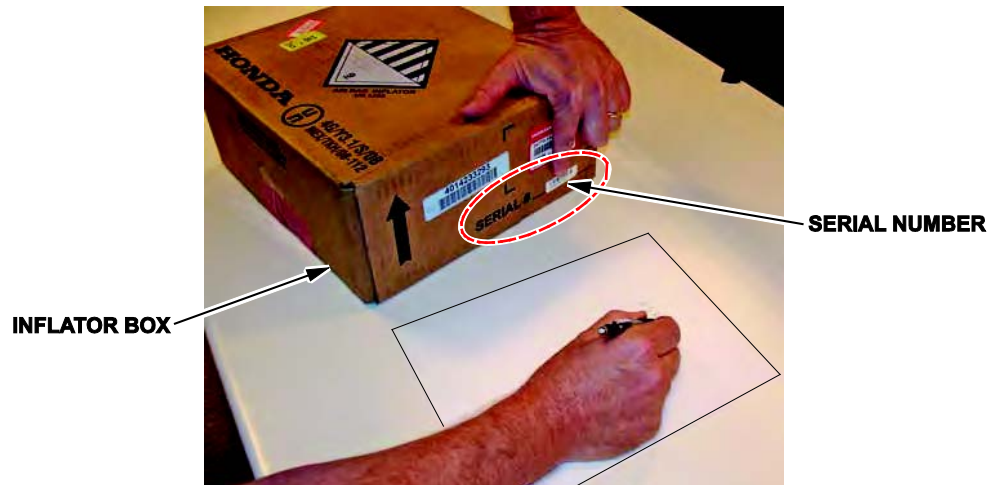
- Be careful not to damage any parts when replacing the inflator, and **follow the procedure exactly**.
 - If, before removing the airbag, you suspect that it may be the incorrect airbag for the vehicle or a counterfeit, **do not remove the airbag**. Contact your DPSM for assistance.
1. Remove the driver's airbag.
 2. Write down the serial number located on the right side of the new inflator's box. For the warranty claim to be paid, your warranty clerk must enter this serial number in the Diagnostic Trouble Codes field on the warranty claim.

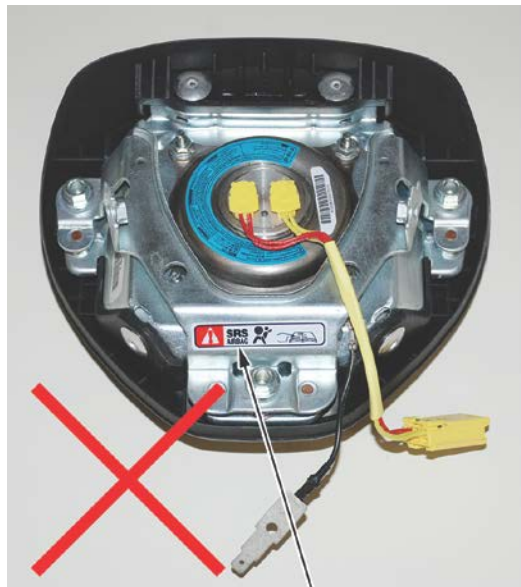
NON-STANDARD
SAFETY LABEL

3. Place the airbag, face down, on a clean shop towel.
4. Visually inspect the airbag and the inflator for any unusual writing or markings.
 - If there is nothing unusual about the airbag or the inflator, go to step 5.
 - If there are any unusual markings, like an incorrect label or a model year written in marker, the airbag and inflator may not be the correct airbag and/or inflator for the vehicle or it may be a counterfeit part. For more information about counterfeit airbags, you can refer to safercar.gov, enter keywords **MANAGING COUNTERFEIT**, and select **Recommended Dealer Guidance for Managing Counterfeit Air Bags** from the list. **If you suspect that the airbag or inflator is counterfeit, do not continue this procedure.** Contact your DPSM for assistance.

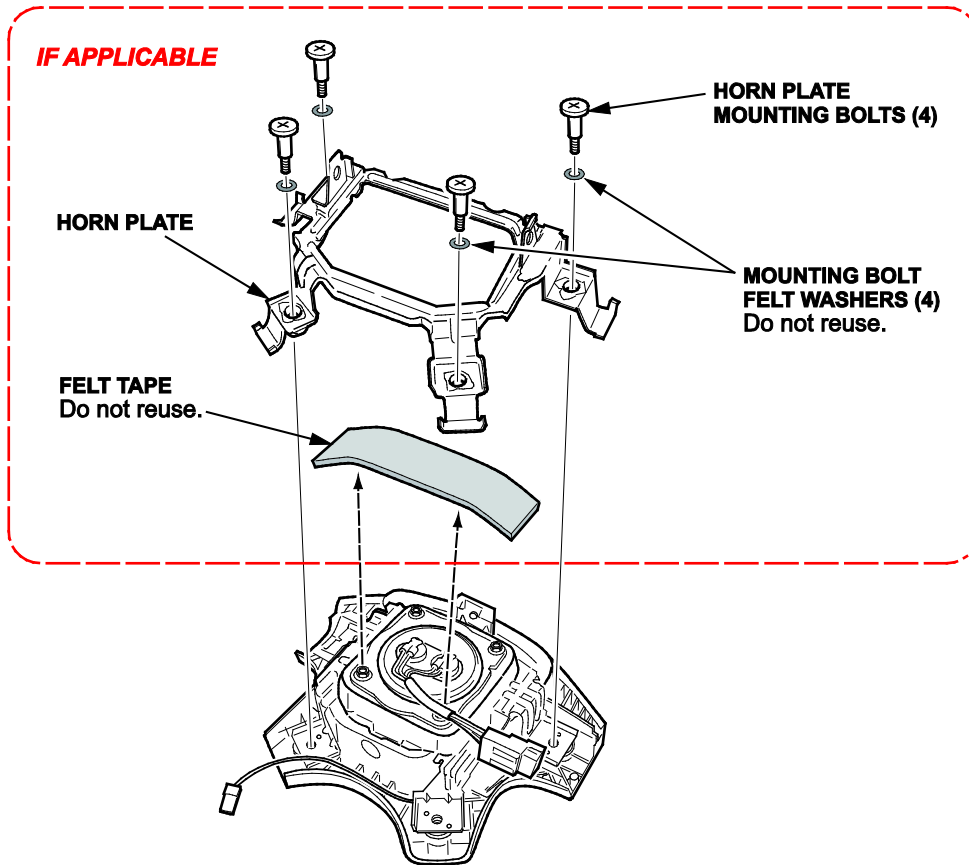
5. If there is no horn plate installed, go to step 7. If there is a horn plate installed, remove the four horn plate mounting bolts, the mounting bolt felt washers, the horn plate, and remove the felt tape covering the lower two inflator locknuts. The felt washers and felt tape will not be reused.

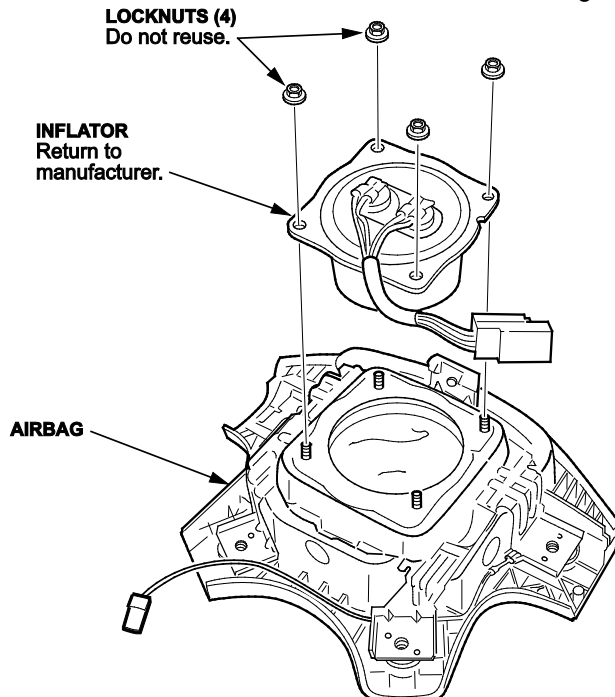
6. Using needle-nose vise grips or a 3/8 in. 6-point socket, remove the four locknuts from the inflator. The locknuts will not be reused.

NOTE: Do not remove the inflator from the airbag until you complete step 7.
