Title: Seat Back Panel Wear Plate on 9000's and 5000's

Applies To: All 9000's and 5000's built prior to 12/04/06

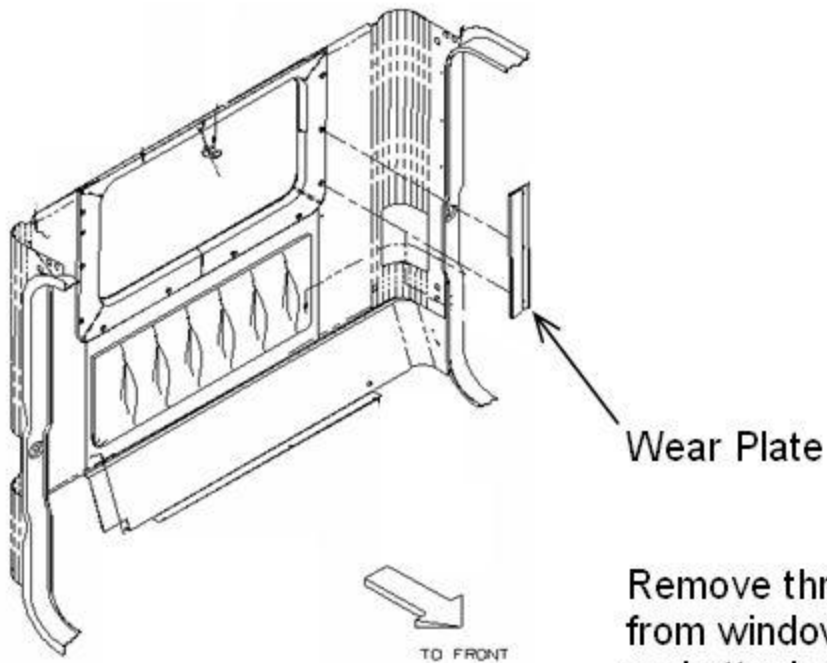
Wear Plate

The seats in 5000 and 9000 models can wear against the back trim panel when reclined and/or adjusted rearward.

Remove three fasteners from window surround and attach wear plate with original hardware.
