**Title:** ProStar Side Skirt Paint Mismatch

**Applies To:** ProStar

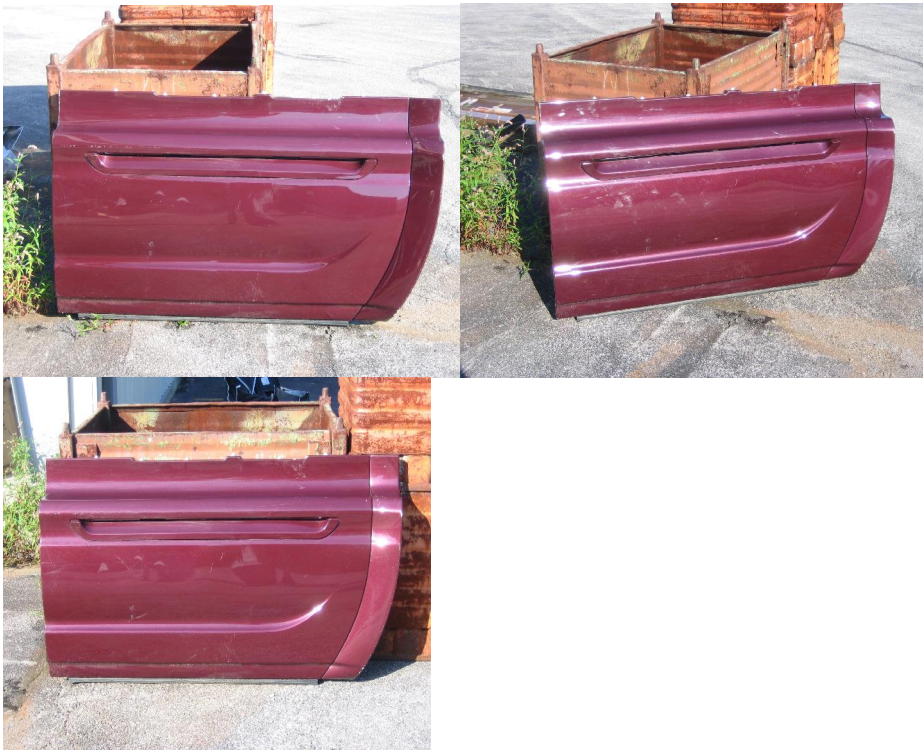
**Below is an example of how rotating the same part 45° and then 90° will completely change the appearance of the part.**

**Paint mismatch is an optical illusion due to the sun reflecting off the part at different angles.**

**The entire panel is molded and painted as one piece (the breakline is a molded breakline, not a joint between two parts).**

This rear piece is sharply angled from the main piece in order to increase aerodynamic performance. Making a change to improve paint appearance would require a compromise on aerodynamic performance.
