Document ID: IK1600063
Revision: 2
Created: 10/16/2007
Last Modified: 3/12/2014
Author: Patrick Gotschall

Title: ProStar Sleeper Curtain Getting Sucked into HVAC Duct

Applies To: ProStar

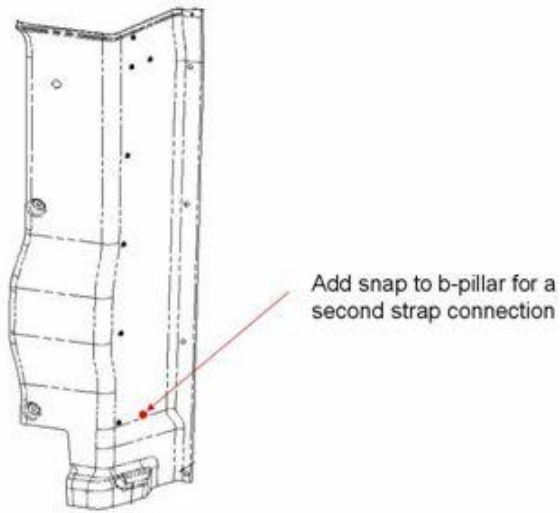
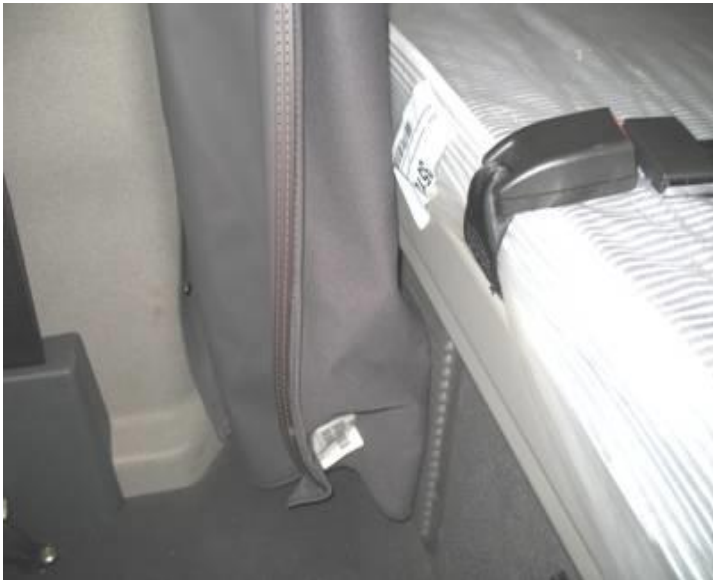
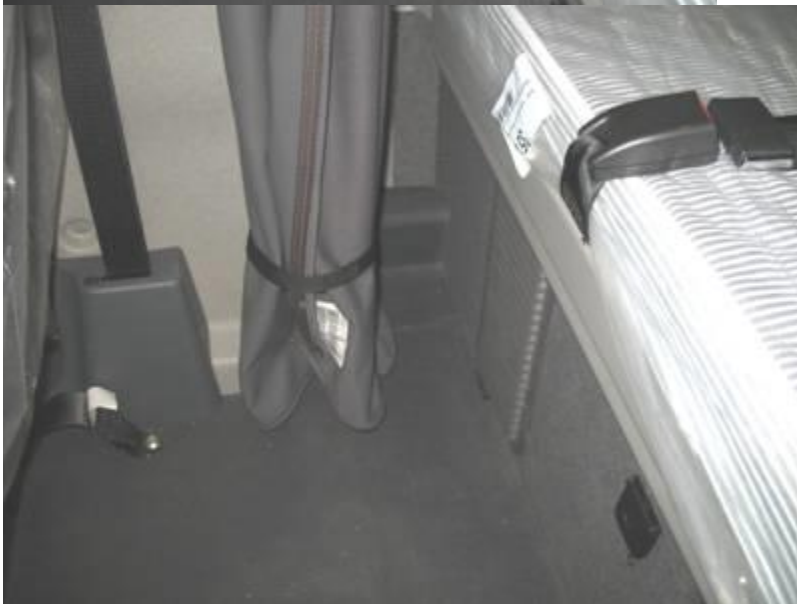
Short sleeper passenger curtain gets sucked into HVAC intake.

- Add additional snap to RH b-pillar in short sleeper.
- Use an additional strap to secure lower half of curtain, part number 3562663C1.
