| <b>Countries:</b> | CANADA, UNITED STATES, PUERTO RICO | <b>Document ID:</b> | IK1600104 |

**Title:** Lonestar Filler Panels Interfere With Door Operation

**Applies To:** Lonestar

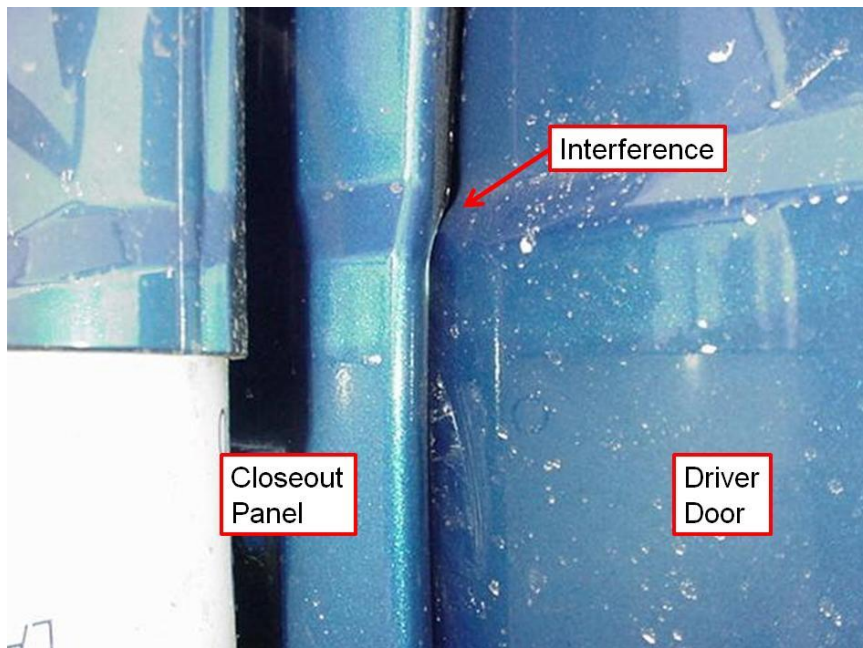
[Figure 1](#)

Cab filler panels interfere with the doors

- Paint damage and door operation

1. Verify the complaint ([Figure 1](#))
