BTB 51969-00412 REV4 (1412)

## **Recall: Front Passenger's Airbag Inflator May Produce Excessive Pressure After Long-Term Exposure To High Absolute Humidity**

Supersedes 14-030, dated September 12, 2014, to revise the information highlighted in **yellow**

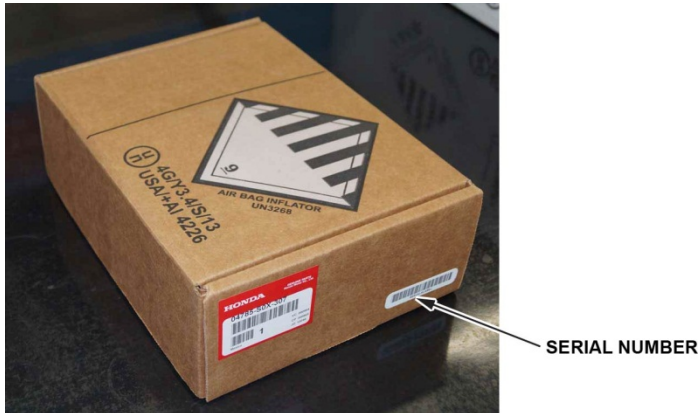
- If the VIN status inquiry indicates that the vehicle is subject to any open safety recalls, including the driver's airbag inflator, make sure to also complete those recall repairs before returning the vehicle to the client. If you are unable to complete any open recall, advise the client of the recall status and when the recall could be completed.
  - Be careful not to damage any parts when replacing the inflator, and **follow the procedure exactly**.
  - If, before removing the airbag, you suspect that it may be the incorrect airbag for the vehicle or a counterfeit, **do not remove the airbag**. Contact your DPSM for assistance.
1. Write down the serial number located on the right side of the new inflator box. For the warranty claim to be paid, your warranty clerk must enter this serial number in the Diagnostic Trouble Codes field on the warranty claim.

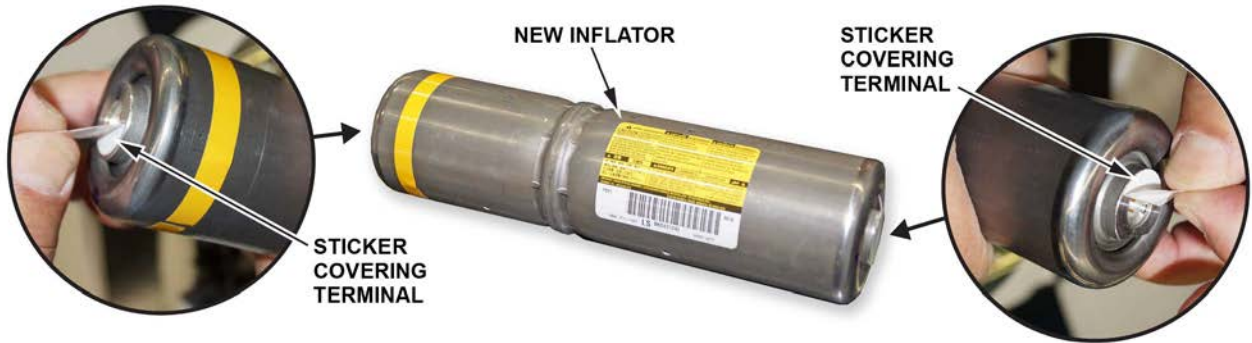
12. Remove the stickers covering the terminals on both sides of the new inflator.
