ATB 44796-01185 REV 5(1412)

Warranty Extension: Engine Block

On some 2006–08 and early production 2009 Civics, the engine (cylinder) block may leak engine coolant, resulting in engine overheating. To increase customer confidence, American Honda is extending the warranty of the engine block to 10 years from the original date of purchase, with no mileage limit.

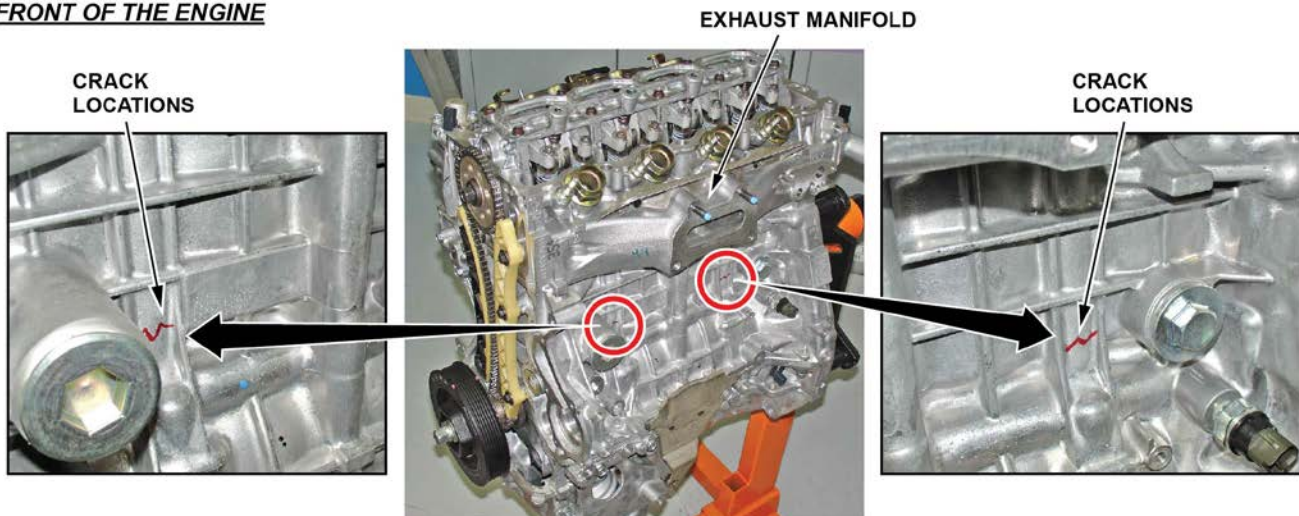
FRONT OF THE ENGINE

Look for coolant leaking from cracks in the block at the points shown below. On the back side of the engine, remove the oil/air separator cover so you can check beneath it. Pressure-test the cooling system if needed.

Is the block leaking coolant in any of the areas shown?

If confirmed by your diagnosis, install a new engine block.

1. Take a photo of the crack in the engine block. Refer to MANDATORY PHOTO REQUIREMENTS for more information.
2. Remove the engine and transmission assembly by referring to the electronic service manual. Enter keywords **ENGINE REMOVAL**, and select **Engine Removal (R18A1 Engine)** from the list.

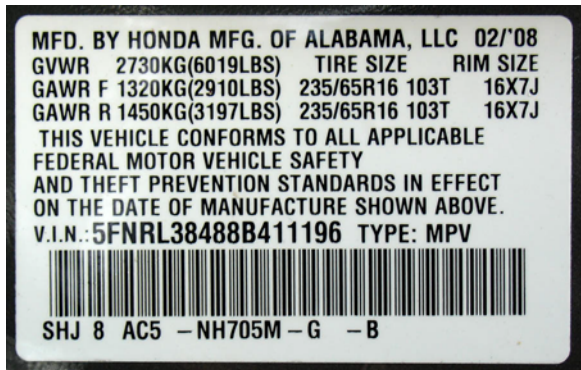
Photograph the doorjamb label that shows the VIN. The VIN and barcode must be clear and readable like the example shown below.

NOTE: If you are using the camera flash, make sure you can read the information because the flash's reflection could make the image hard to read.

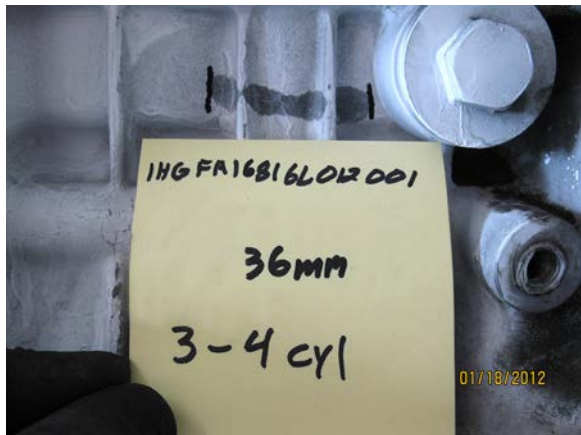
Photos 2 through 4

Photograph the crack in the engine block. The crack must be clearly visible and in focus in the block. Also include a post-it note that lists the VIN, the length of the crack and the crack location, for example, between cylinders three and four.

If the crack is not clearly visible, highlight the crack and its location with a penetrant inspection developer (Met-L-Check, D70, or other commercially available developer).

You must include at least one photo, but you may submit up to three photos to clearly show the crack and its location in the block.

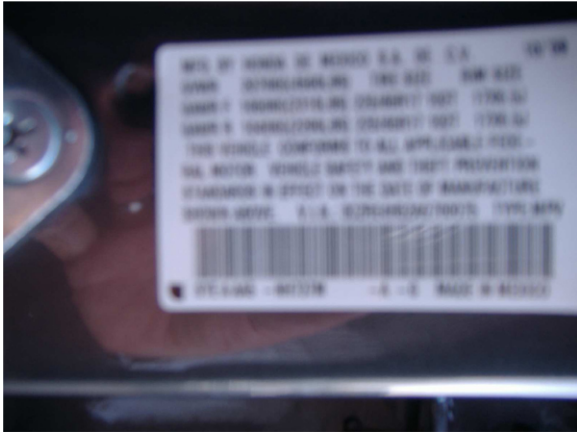
This photo is unacceptable for these reasons:

- It is out-of-focus and unreadable.
- The file size is too small (351kb).

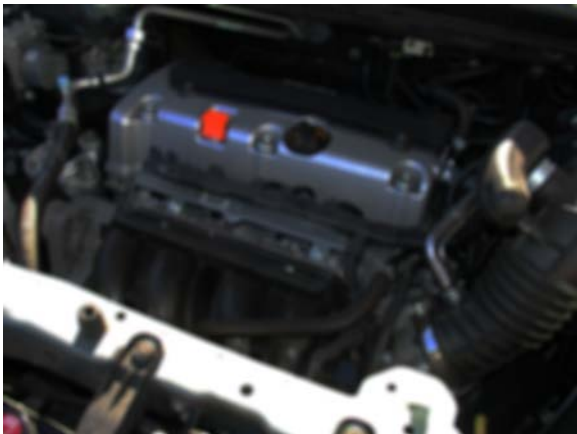
This photo is unacceptable for these reasons:

- It is too dark.
- It lacks focus, detail, and marking materials that identify the area and extent of the defect, as specified in this service bulletin and per warranty claim submittal standards.
