**Document ID:** IK1200739  
**Revision:** 12  
**Created:** 3/16/2012  
**Last Modified:** 6/9/2014  
**Author:** David Smith

**Title:** EGR Valve Diagnostics

**Applies To:** 2010 Emissions MaxxForce 11 & 13 Liter Engines, N13 SCR Engine, MaxxForce 15

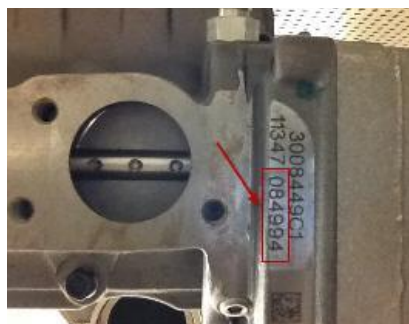
### Serial Number Identification Process shown below:

The generation of the valve can be identified by the serial number ( the 6 digit code highlighted in the red box in the picture above) if it starts with 1 it is considered to be an old valve (On 2010 Emissions MF11/13 only. NOT SCR equipped vehicles). If the serial number starts with a 2 it is a newer generation valve.

**Note :** If it starts with a 0 and has part number 5010697R1 stamped on it the EGR Valve is a New Generation. If it starts with a 0 and has part number 3008449C1 as illustrated above then it is an Old Generation EGR Valve.

| Diagnostic Steps (Table 1) | YES | NO |
|---|---|---|
| 2. Verify Generation of EGR Valve : Is it an Old Generation EGR Valve? (See Serial Number Identification process Below) | Replace the EGR Valve | Continue to Step 3 |

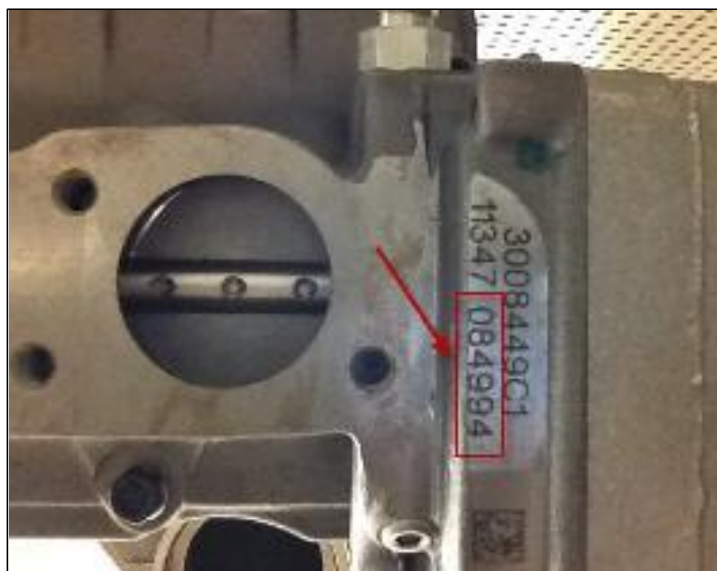
- **Requirement :** Include the Serial Number of the failed and new EGR Valve in the subsequent warranty claim "CCC" and the "Failed Serial #" fields (See Photo Below).
- **Requirement :** Be sure the replacement EGR Valve Serial # starts with a 2 (Serial Number location shown below. **Disregard for N13 SCR Engine, and MaxxForce 15**
- **Requirement :** Use PocketMaxx or an EZ-Tech to generate a Health Report which is now required for warranty reimbursement per [WPL13-009G](#). The Health Report will include DTC's and will link you to the Fault Code Action Plan.
