**Title:** Engine Low Mount Fan Drive Service Strategy

**Applies To:** Post 2010 MaxxForce 11L and 13L Engines, and N13 Engines with Low Mount Fan Drive

This iKNOW document describes the service strategy for low mount fan drives on 2010- 2013 MaxxForce engines and 2013 and later N13 engines.

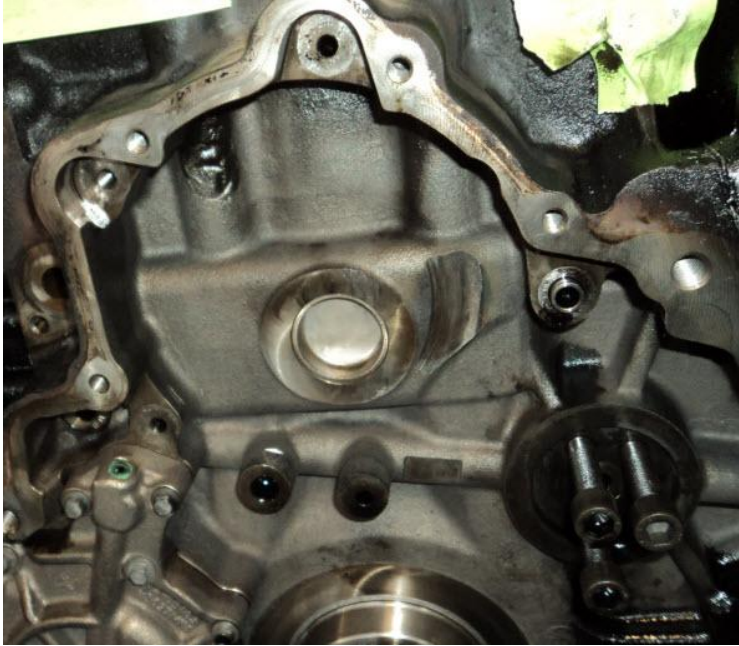
## Engine Block Examples

Below are photos showing serviceable engine blocks. These engine blocks should be reused, and will not loose performance/ longevity.

| Step | Fan Drive Failure Step By Step Service Strategy | Yes | No |
|---|---|---|---|
| 1 | Remove the front cover to expose the fan drive. Inspect for gear contact to the engine block | Go to next step | Replace the fan drive per the service manual |

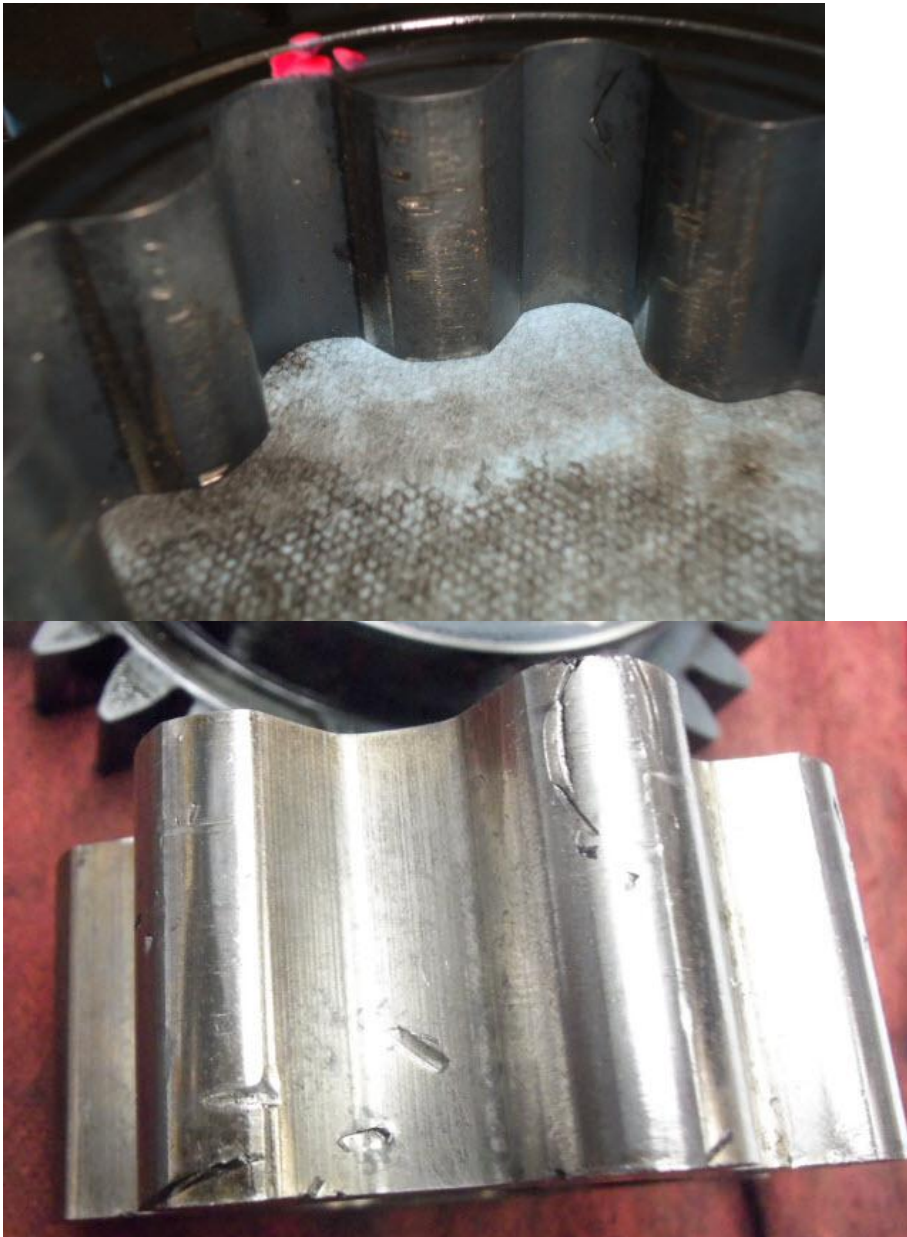
### Engine Oil Pump Examples

Below are photos showing the damage to an oil pump. If there are any deformities found, the oil pump should be replaced.

| Step | Fan Drive Failure Step By Step Service Strategy | Yes | No |
|---|---|---|---|
| 3 | Remove the engine oil pump. Is any damage found to the oil pump? | Go to next step | Replace the fan drive. Remove the engine oil pan and clean out any debris found. Replace engine oil filter and Bypass Centrifugal oil filter element, and flush housing. |

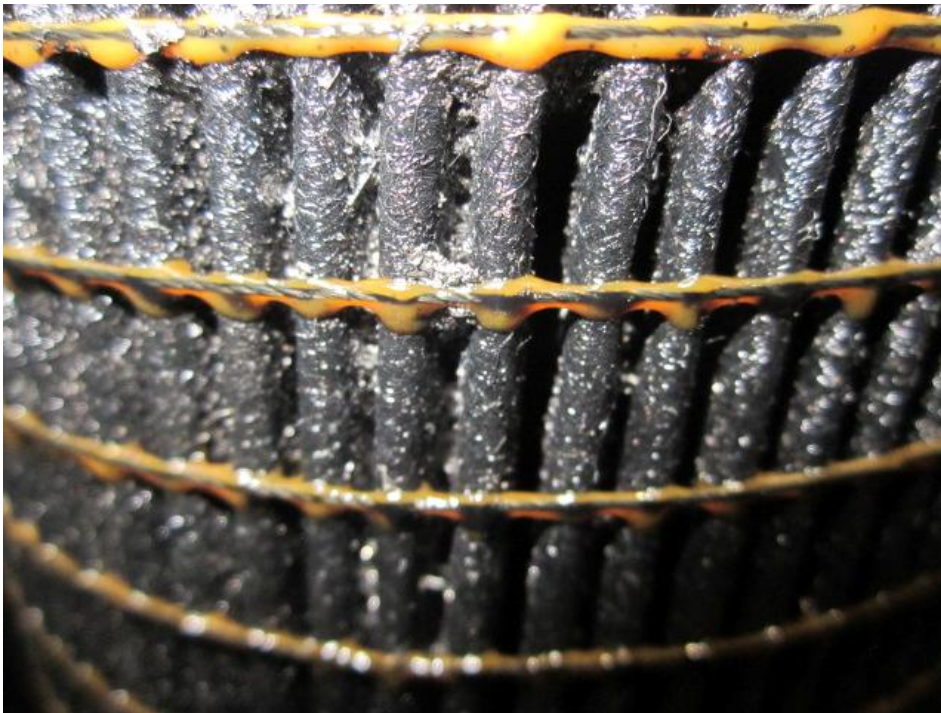
### Engine Oil Filter Example

Below is a photo showing the metal in an oil filter.

| Step | Fan Drive Failure Step By Step Service Strategy | Yes | No |
|---|---|---|---|
| 4 | Remove engine oil filter, cut open, and inspect for metal. Are metal flakes found in the oil filter? | Go to next step | Replace the fan drive, the oil pump and the oil filter. Remove the engine oil cooler and flush thoroughly. Remove engine oil pan and clean out debris. Replace engine oil filter and Bypass Centrifugal oil filter element, and flush housing. |

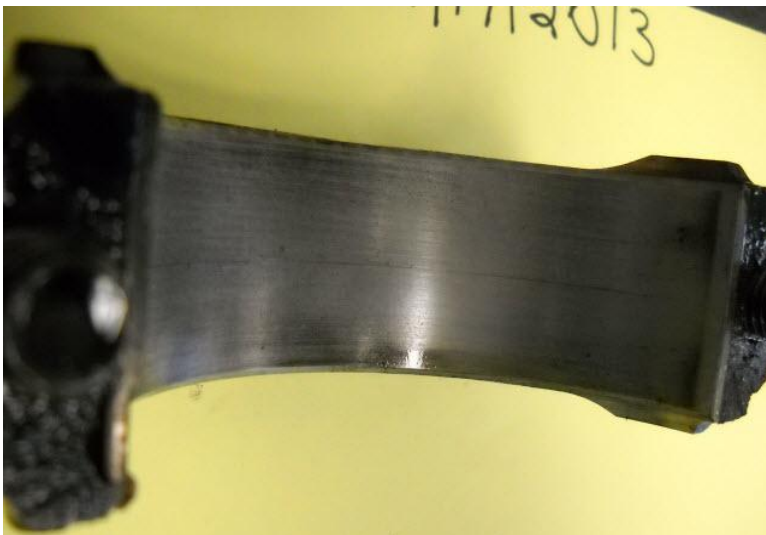
#### Reuse

Below are photos showing examples of bearings that can be reused and bearings that need to be replaced.
