| Countries: | AUSTRALIA, BRAZIL, CANADA, COLOMBIA, UNITED STATES, MEXICO, PUERTO RICO, SOUTH AFRICA | Document ID: | IK1300085 |

Title: Wabco FPB/ Quadraulic Brake Lining Replacement and uneven wear

Applies To: CE, BE, Durastar

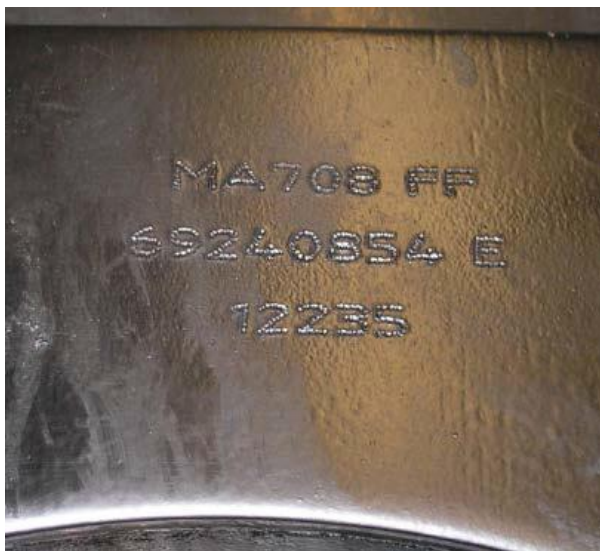
11. Take photos of the brake pad friction surface and rotor friction surface (both sides, labeled inboard and outboard).
12. Record all three lines of text stamped on the brake pad backing plate as shown below:
