WE20 - Checking Spring Band Clamp on Coolant Reservoir and Replacing it if Necessary (Workshop Campaign)

Vehicle Type: **Cayenne Diesel (92A)**

Model Year: **2014**

Concerns: **Spring band clamp on coolant reservoir**

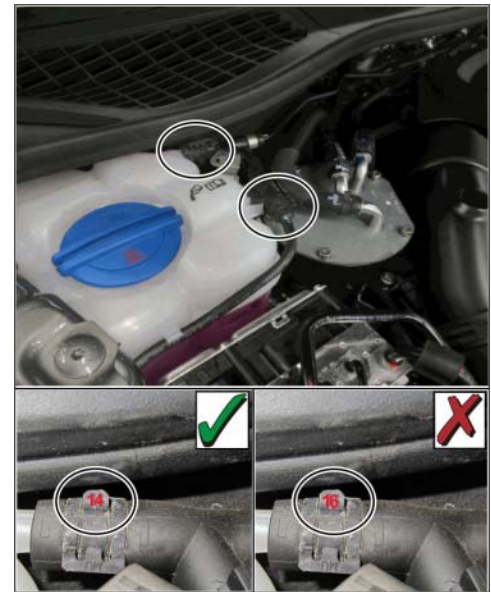
Checking spring band clamps

To do this, read off the diameter of the spring band clamps from the marking on the clip ⇒ *Checking spring band clamps:*

- Marking "14" = diameter of 14 mm.
- Marking "16" = diameter of 16 mm.
- If the diameter of the **spring band clamps** is **14 mm**, continue with **Step 4**.
- If **spring band clamps** with a diameter of **16 mm** are installed, continue with **Step 3** and **replace the incorrect spring band clamps**.

3 Replace spring band clamps.

- 3.1 Carefully unscrew the cap on the coolant reservoir and release any overpressure.
 - 3.2 Use suitable assembly pliers to open the upper spring band clamp and push it back. Unclip the coolant return hose on the coolant reservoir if necessary.

- 3.3 Pull the T-piece off the connection from the coolant reservoir and slide the spring band clamp off the T-piece.
 - 3.4 **Open new spring band clamp with a diameter of 14 mm**, Porsche Part No.: **N 906.867.01**, using assembly pliers and slide it onto the T-piece.

- 3.5 Push the T-piece onto the collar of the reservoir.
 - 3.6 Fit new spring band clamp at the same position as the spring band clamp you removed earlier using assembly pliers.

- 3.7 Replace the lower spring band clamp in the same way as the upper spring band clamp.
To do this, complete Steps **3.2** to **3.6**.
 - 3.8 Screw on cap on the coolant reservoir until you feel it locking securely.
