Group:	99-Miscellaneous
Bulletin No.:	SB-14-009
Issue Date:	07-8-2014

TECHNICAL SERVICE BULLETIN

2011MY-12MY LOOSE OR MISSING #1 CROSSMEMBER NUTS OR BOLTS

2011MY – 2012MY Hino Conventional NE8J, NJ8J, and NV8J vehicles

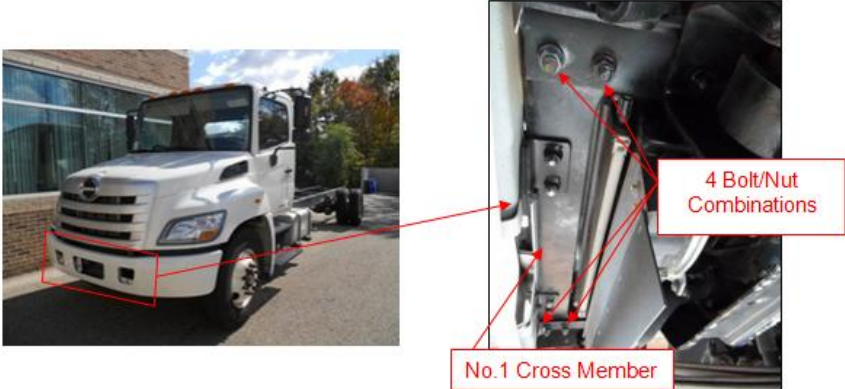
1. Locate the No.1 cross member and the 4 bolt/nut combinations. This cross member is located just behind the front bumper.

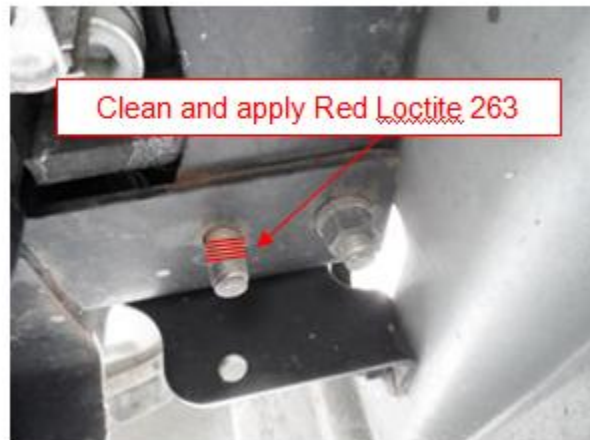
NOTE: The crossmember bolts are accessible by reaching through the opening above the front bumper.

2. Clean the threads of the new or existing crossmember bolt(s) and apply Loctite 263 to the threads of the bolt and the nut.

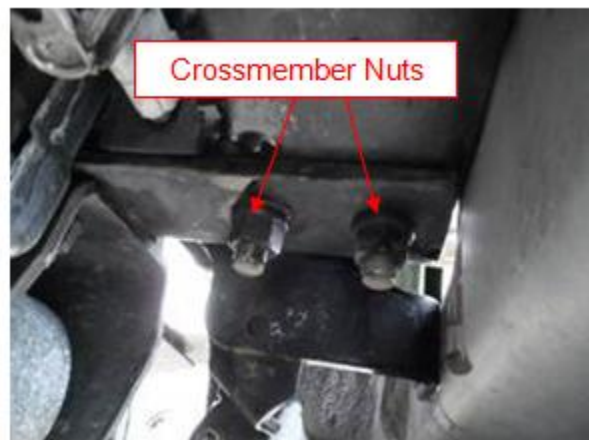
NOTICE: Only part number SZ178-14010 should be used as a replacement nut. These nuts have a friction stabilizer pre-applied to the threads.

3. After the Loctite is applied, install the new or existing crossmember nut(s) onto the crossmember bolt(s) and tighten the nut(s) to the specified torque.

Specified Torque: 95 lb-Ft (125 Nm)
