BTB 51969-00384 REV2 (1410)

Recall: Front Passenger's Airbag Inflator May Produce Excessive Pressure After Long-Term Exposure To High Absolute Humidity

Supersedes 14-030, dated September 12, 2014, to revise the information highlighted in **yellow**

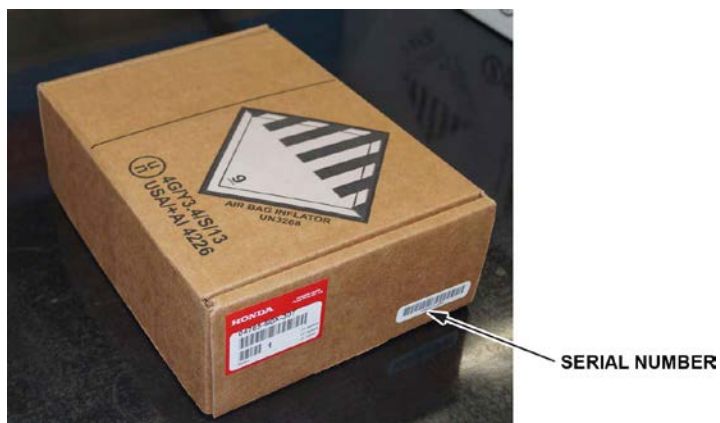
- Be careful not to damage any parts when replacing the inflator, and **follow the procedure exactly**.
 - If, before removing the airbag, you suspect that it may be the incorrect airbag for the vehicle or a counterfeit, **do not remove the airbag**. Contact your DPSM for assistance.
1. Write down the serial number located on the right side of the new inflator box. For the warranty claim to be paid, your warranty clerk must enter this serial number in the Diagnostic Trouble Codes field on the warranty claim.

18. Give the warranty clerk the inflator serial number that you wrote down in step 1. For the warranty claim to be paid, your warranty clerk must enter the serial number in the Diagnostic Trouble Codes field on the warranty claim.

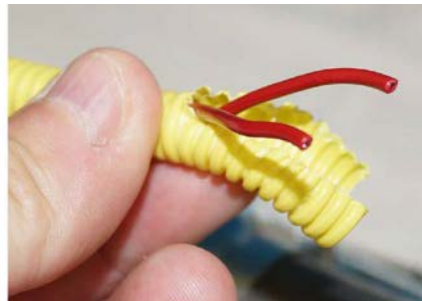
- Cut about 2 inches of the corrugated tube, then pull out the two red wires.

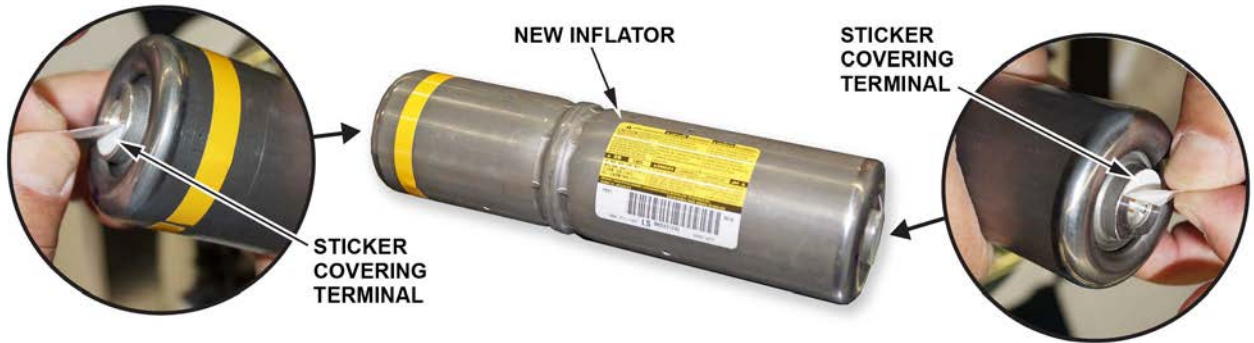
12. Remove the stickers covering the terminals on both sides of the new inflator.
