BTB 00236 (1410)

## Safety Recall: Front Seatbelts Will Not Extend or Retract Properly in Extremely Cold Weather

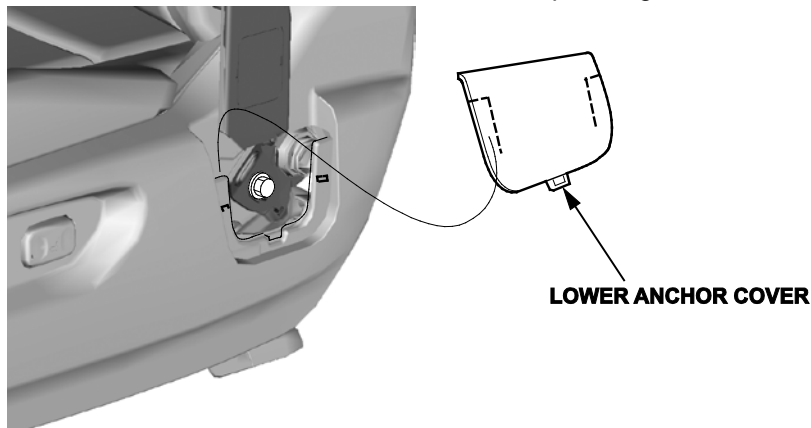
1. Do the battery terminal disconnection procedure.
2. Remove the seat belt lower anchor covers.

NOTE: Remove the MDX driver's side cover only. After you remove the lower anchor bolt in step 3, go to step 4 to disconnect the lower anchor connector on the passenger's side.

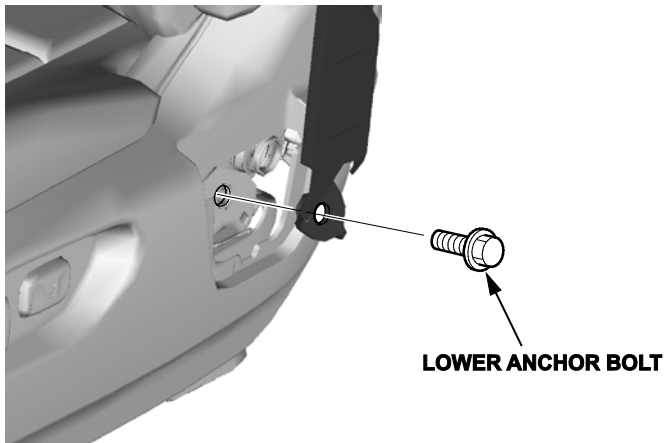
3. Remove the lower anchor bolt.

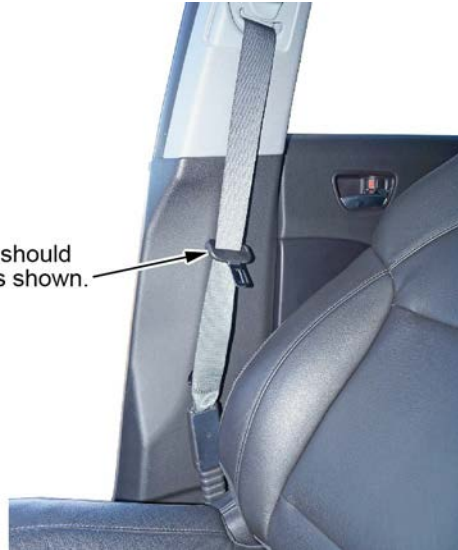
The latch plate should face the seat as shown.
