# Service Bulletin No. 409

<small>MODEL</small> D Series / J4500 Series	<small>TYPE</small> Field Change Program	<small>SECTION/GROUP</small> 7-Electrical	<small>DATE</small> May 1, 2014
<small>SUBJECT</small> LEECE NEVILLE ALTERNATOR			
<small>CONDITIONS</small>

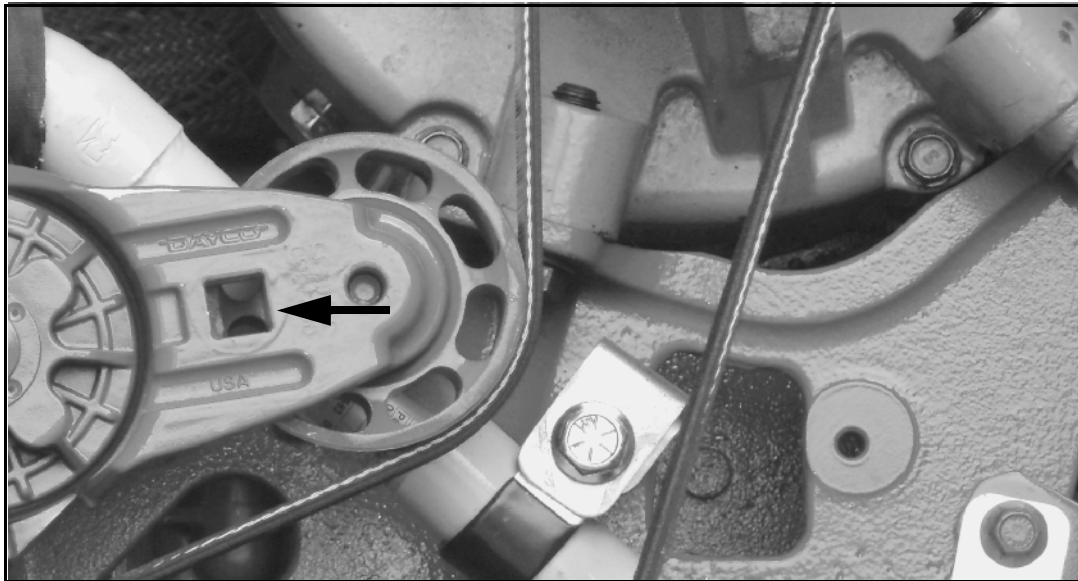
**Figure 1. D series coach installation.**

1. Turn the main battery disconnect switch to the OFF position.
2. Open the engine door(s). Locate the engine belt tensioner ( refer to Figures 1 and 2 ).

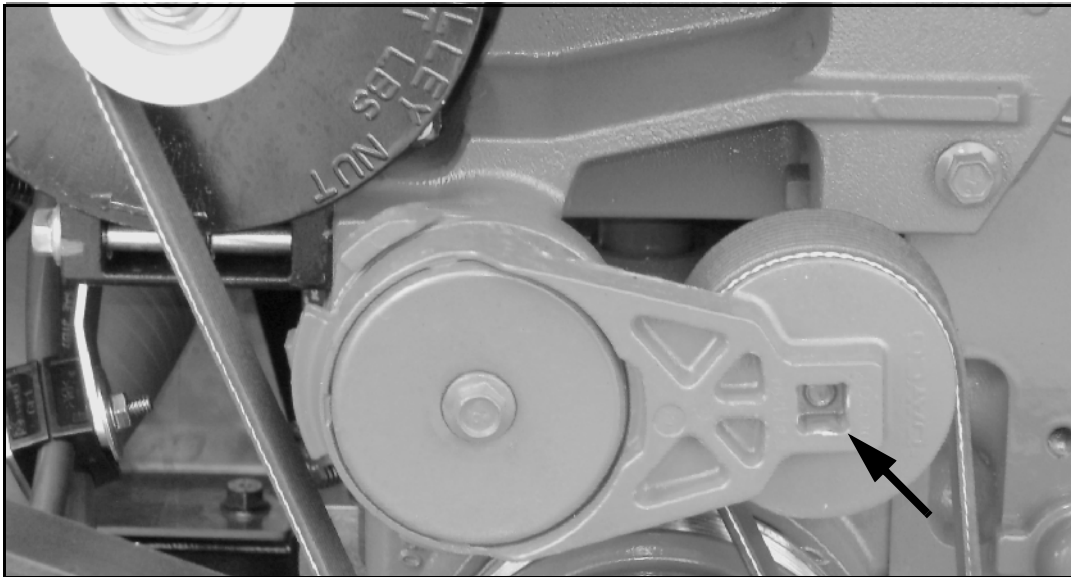
Figure 2. J4500 series coach installation.

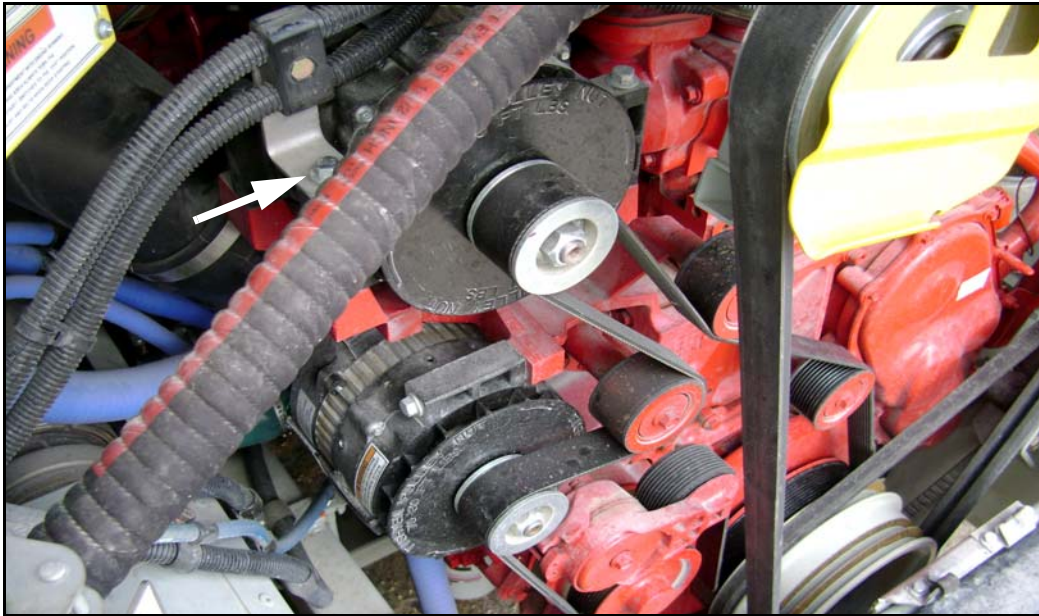
**Figure 4. D series alternator installation.**

*Although the alternator mounting installation is the same for the D Series and the J4500 Series installation, please note the mounting brackets installation for the cables on the D Series and the transmission fill tube on the J4500 Series ( Figures 4 and 5 ).*

4. Depending on the coach model, locate the transmission fill hose or cable bracket mounted to the upper alternator installation. Remove and retain the applicable hardware, to be re-installed at a later step in this procedure.
5. Locate the upper alternator mounting hardware ( refer to Figure 6 ). Remove and retain the four ( 4 ) capscrews.

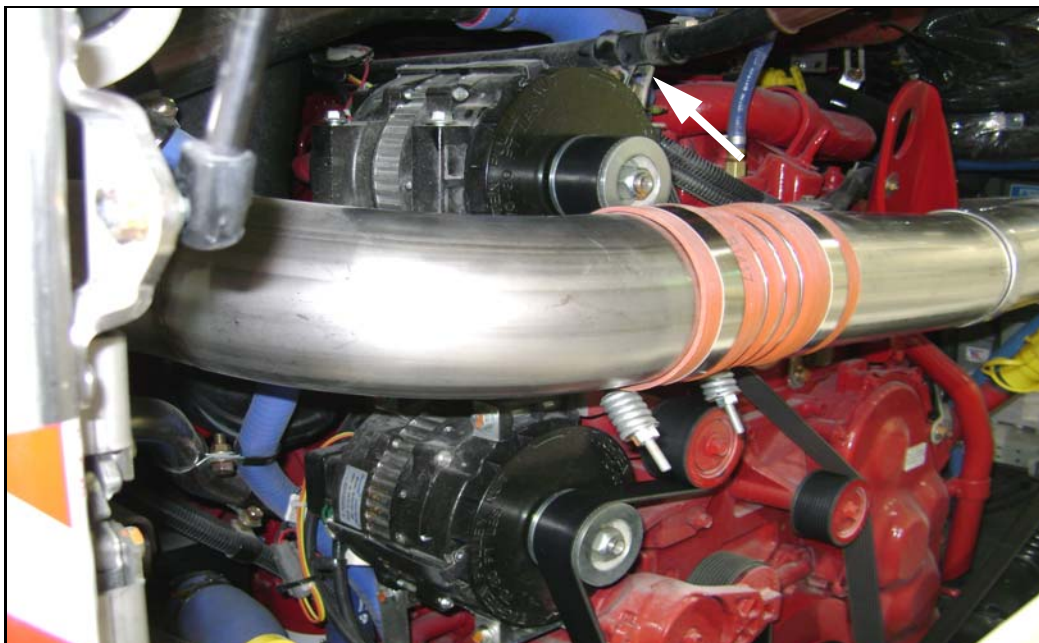
**Figure 5. J4500 series alternator installation.**

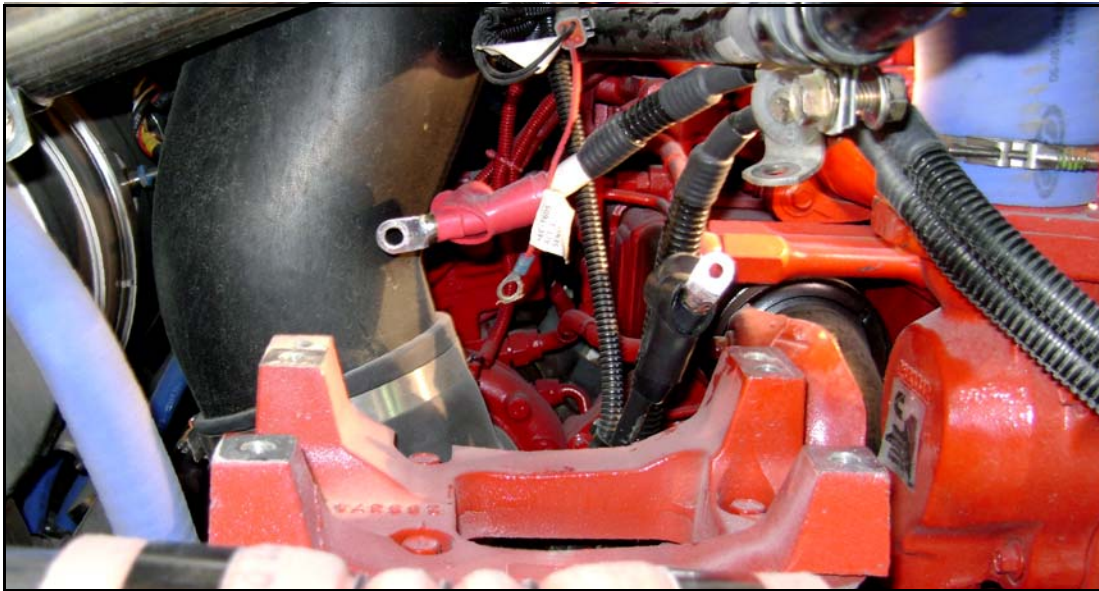
**Figure 8. Upper alternator removed from mount points.**

7. Remove the alternator from the engine compartment.

8. Orient and position the new alternator, p/n 07-03-1282RWK or 07-03-1284RWK, on the mount points.
9. Remove the nut from the GND stud. Place the GND wire ring terminal on the stud. Secure with the nut and tighten. Torque the stud nut to 75-80 in-lbs. Apply sealant to the ring terminal ensuring that the area is fully coated. Install the protective boot over the stud.

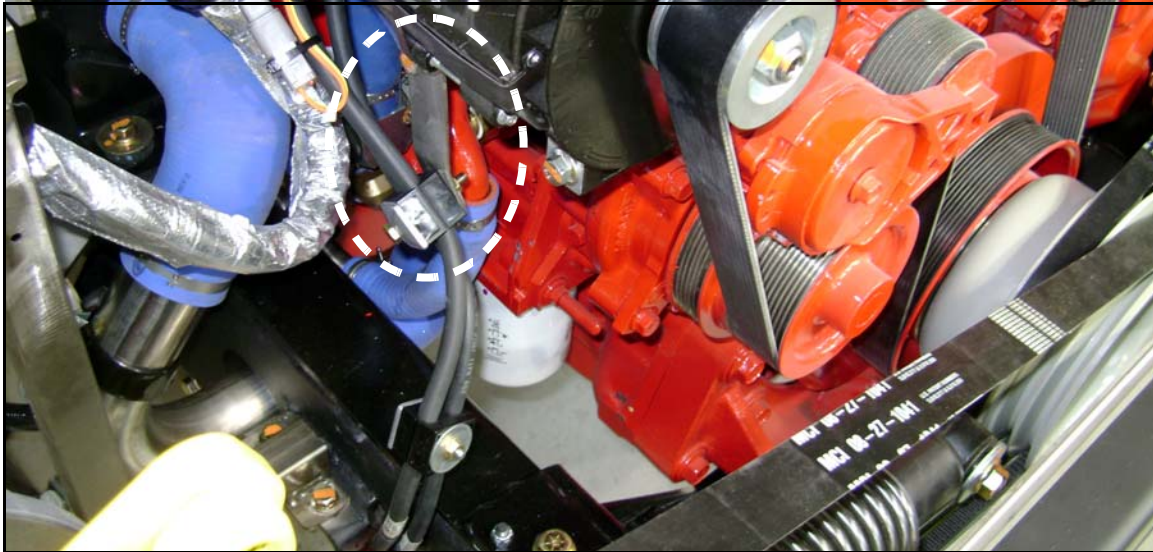
**Figure 9. J4500 Series lower alternator installation.**

*On J4500 Series coaches, locate the GND cable support bracket mounted to the lower alternator mount ( refer to Figure 9 ). Remove and retain the GND cable support bracket. Place aside to be re-installed at a later step in this procedure.*

22. If applicable by coach model, re-connect the GND cable support bracket hardware. Tighten to secure.

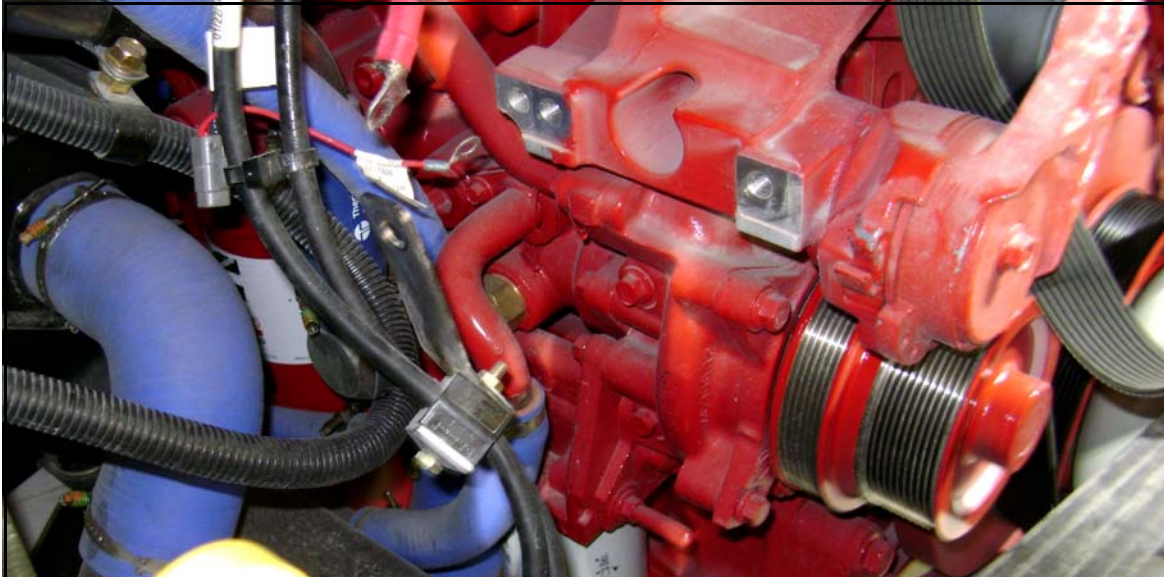
**Figure 12. Lower alternator removed from mount points.**

16. Remove the alternator from the engine compartment.

17. Orient and position the new alternator, p/n 07-03-1282RWK or 07-03-1284RWK, on the mount bracket.
18. Remove the nut from the GND stud. Place the GND wire terminal ring on the stud. Secure with the nut and tighten. Torque the stud nut to 75-80 in-lbs. Apply sealant to the ring terminal ensuring that the area is fully coated. Install the protective boot over the stud.
