Tech Tips

TT 63-14-02

2015 Jetta- Rear Tow Hook Cover Tabs Broken

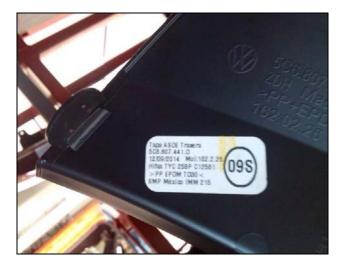
Replace the rear tow hook cover (Part# 5C6807441D 9B9) and verify the part that is being installed is of the current production level (09S) as show in Figure 1.2

If the part is of an earlier level (08S) please return the part to the PDC and order a new part.
