# Technical Bulletin

Model(s)	Year(s)	Eng. Code(s)	Trans. Code(s)	VIN Range From	VIN Range To
Passat	2012	All	All	A3_CC000001	A3_CC079113

**64 14 02** October 27, 2014 **2038703**

### Rear Door Glass Inoperative

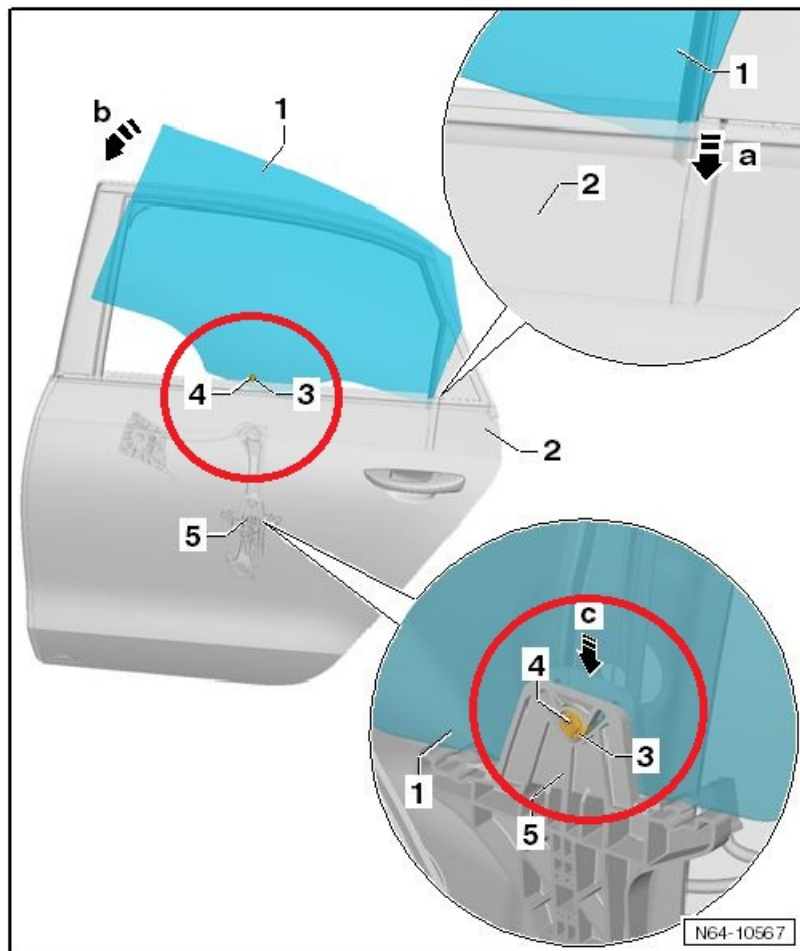
Figure 1

The rear glass cannot be opened / closed, the rear glass may fall into the door, or the rear glass motor operates but the glass does not move

The spreader plug with expanding pin for securing the door glass to the window regulator can wander loose from the glass (see Fig.1 No 3 / 4). If this occurs the door glass will no longer be secured to the window regulator.

Should this symptom occur, perform this repair on both rear door glass assemblies.

Updated rear door glass and spreader plug with expanding pin in production.

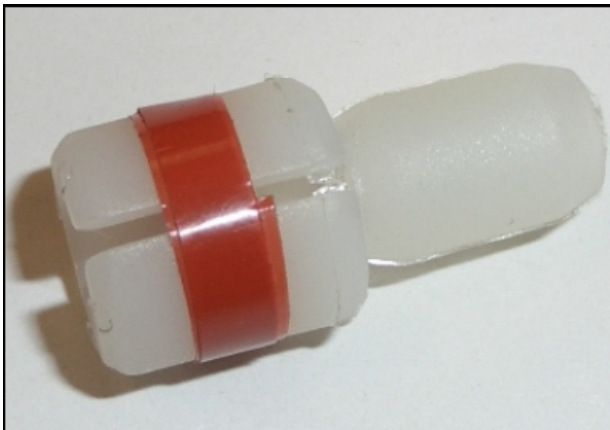
**Figure 2** (Adhesive strip shown in red for clarity)

- Using the foil tape (part number AKL.433.014.01) or vinyl tape obtained locally, cut a 55 mm long and 6 mm wide strip.
- Wrap the strip around the center of a new spreader plug (see Fig. 2).

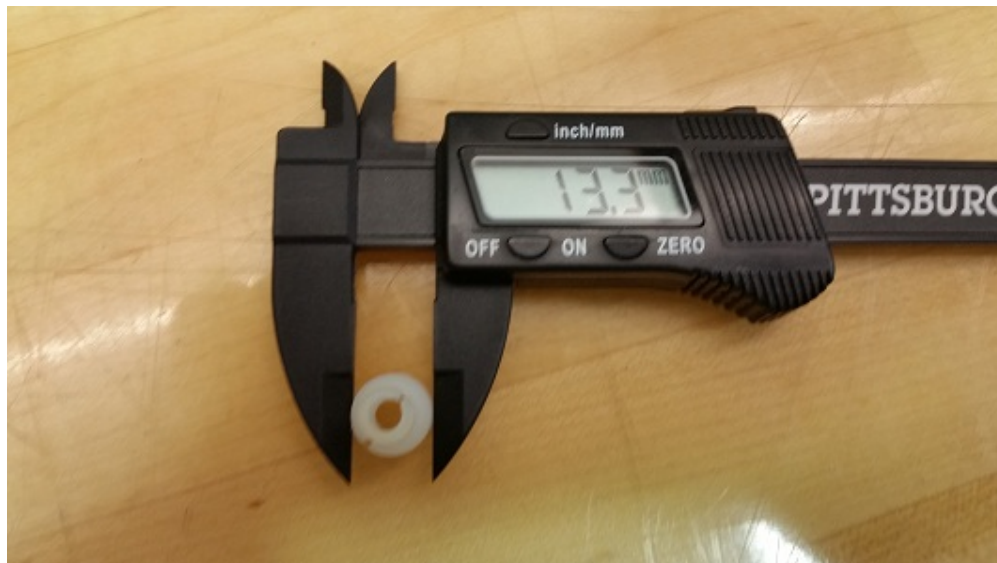
Figure 3

- Measure the diameter of the new plug with the adhesive strip. The diameter must be approximately 13.4 mm (see Fig. 3).

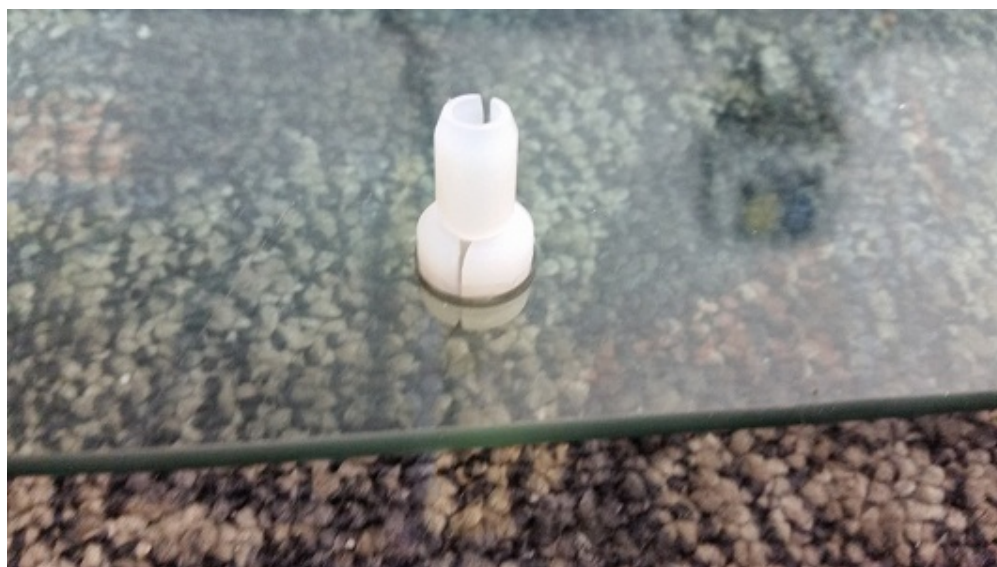
Figure 4

The adhesive strip and spreader plug must be centered in the hole (see Figure 4).
