# Technical Service Bulletin

## 44 Model Year 2013 & 2014 Alignment - Repair Authorization

44 14 47 2030275/7 January 21, 2014. Supersedes Technical Service Bulletin Group 44 number 13-39 dated July 12, 2013 for reasons listed below.

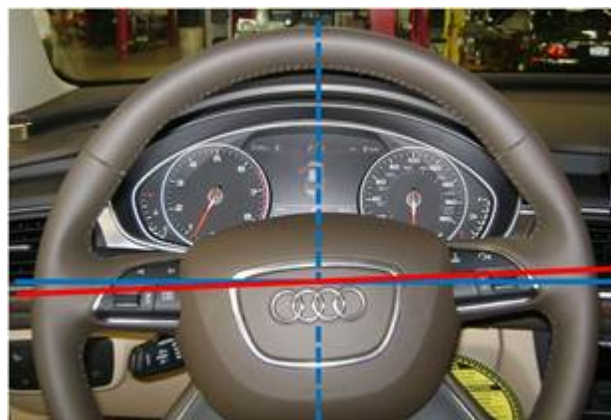
- Vehicle pulls (left or right).
- Steering wheel is not level or is off-center (Figure 1).

**Figure 1.** Steering wheel not leveled (off-center)

1. Before performing any repairs:
  - a. Verify concern with a test drive.
  - b. Ensure that the vehicle has less than 6000 miles.
  - c. Contact TAC.
2. After contacting TAC, place the vehicle on the alignment rack and perform the compensation procedure.
3. During the alignment step at which the steering gear center position is checked, perform the following:
  - a. Point the front wheels in a straight-ahead position according to the display on the alignment machine (Figure 2). Disregard the level of the steering wheel at this point.

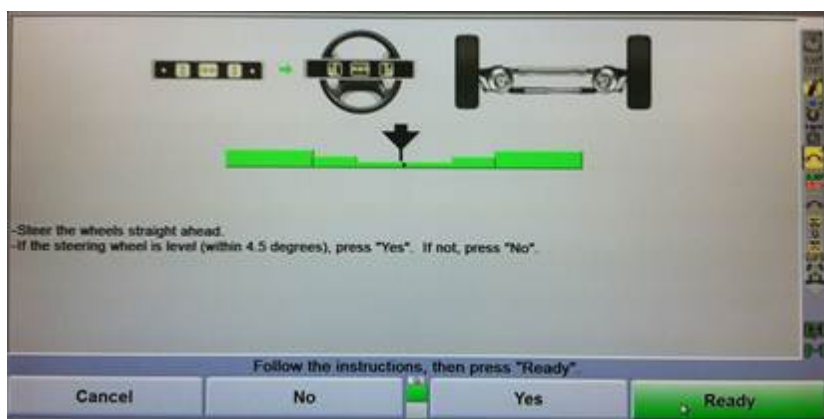
**Figure 2.** Screen shot illustrating the point at which the front wheels must be positioned straight ahead. Screen may vary based on the brand of alignment machine used.

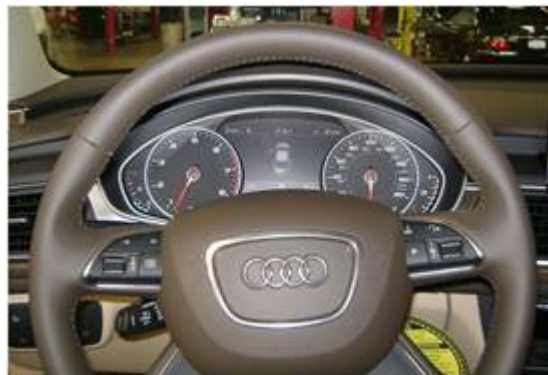
- b. Check if the steering wheel is level. If the steering wheel is not level (is off-center) by any degree, take a photo of the steering wheel (Figure 3).

**Figure 3.** Example of a steering wheel that is not level.
